Re: Noble County Highway Department Building – Structural Assessment  
1118 East Main Street  
Albion, Indiana 46701

Project No. 202502329

## **PHOTOGRAPHS**

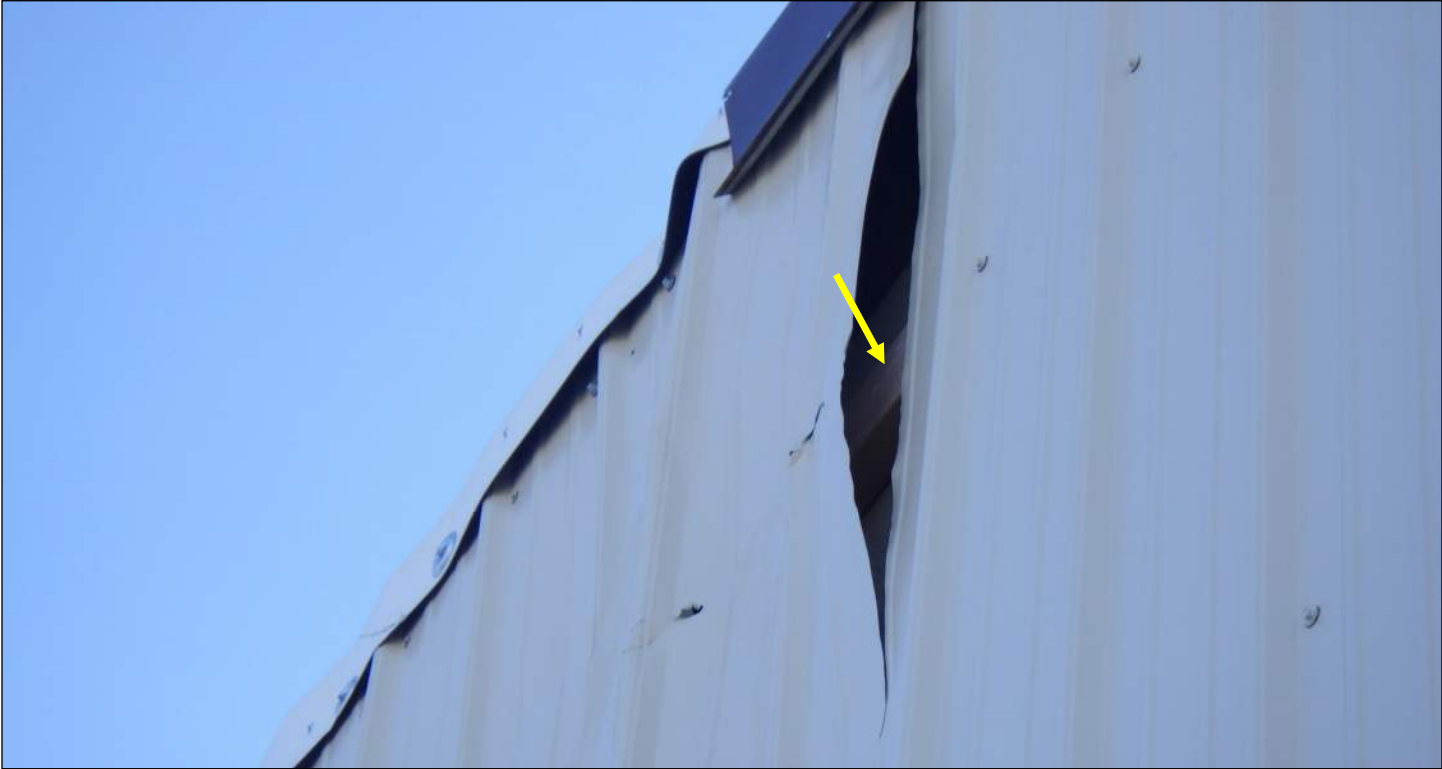
1. The exterior walls of the single-story building were clad with raised-rib metal siding (Photos 1 through 4). The siding was fastened to horizontal 2x4 furring strips spaced at 2'-9" on center (Photo 5).
  - a. Approximately 11 metal siding panels near the west end of the north elevation exhibited punctures and/or indentations consistent with impacts from the roof of the adjacent building during the storm, and collapse of the chimney (Photos 6 and 7).
  - b. Approximately three panels on the south elevation exhibited scrapes, indentations, and punctures consistent with impacts from airborne debris (Photo 8).
  - c. The other siding panels throughout the perimeter of the building appeared to be in good condition (Photos 1 through 4).

Photo 5: Wood furring strip visible behind area of damaged siding.

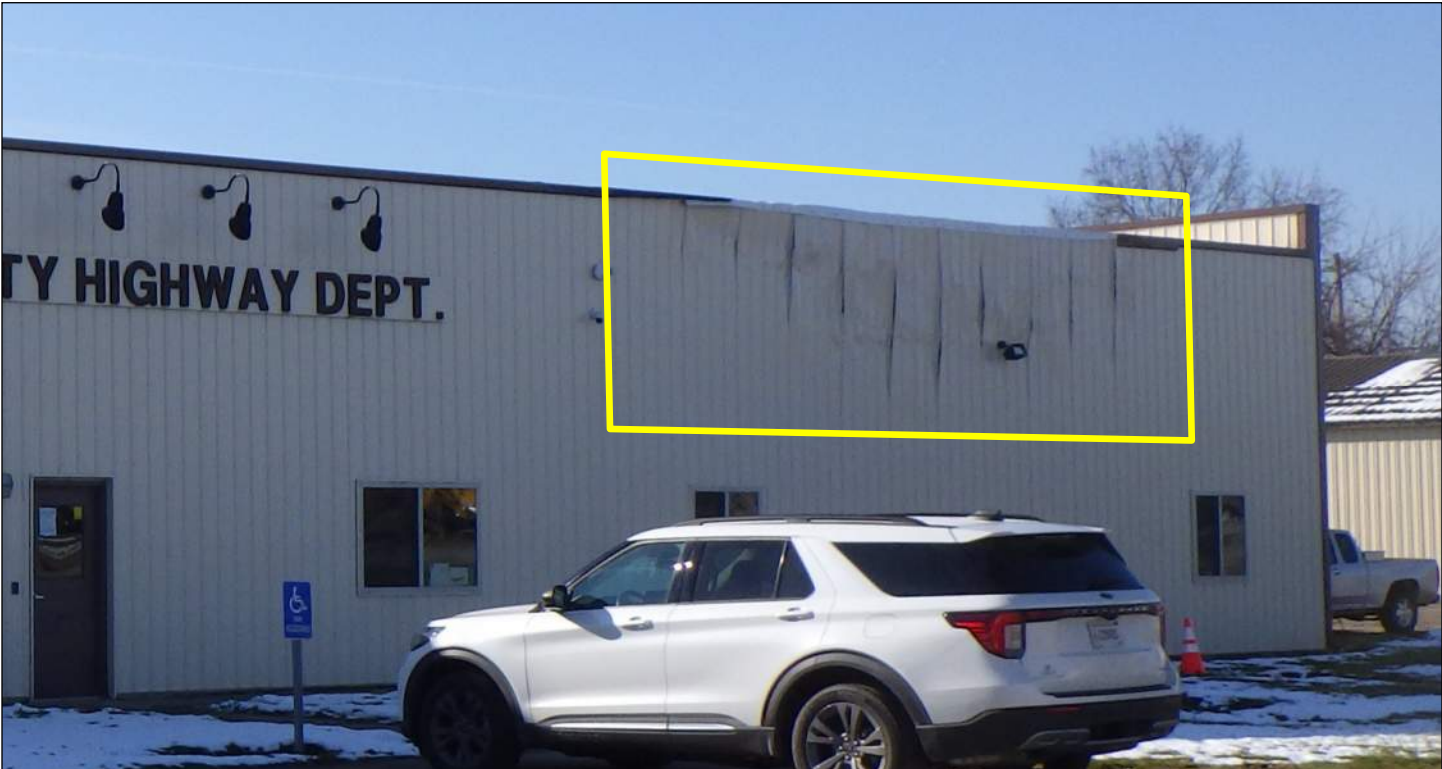
Photo 6: Storm/impact damaged siding on north elevation.

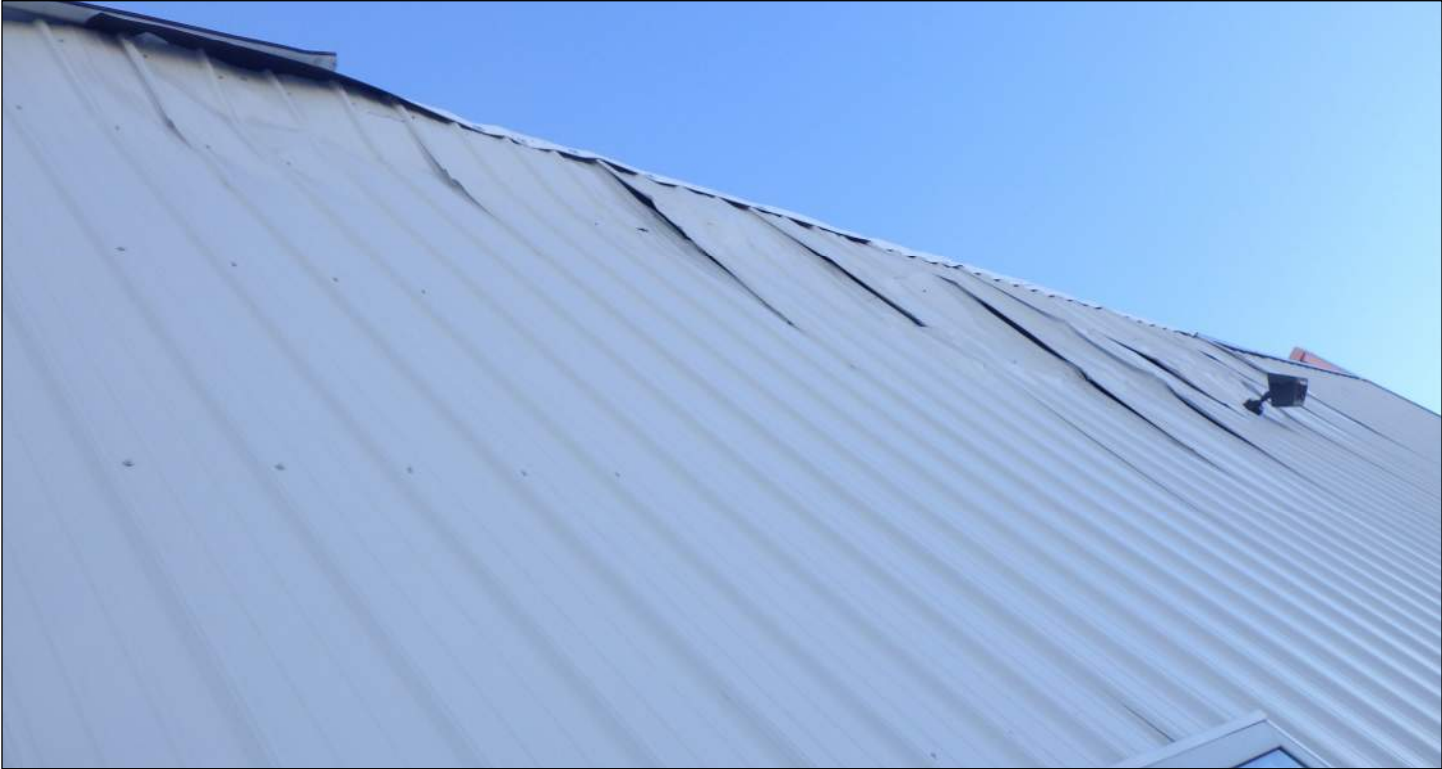
Photo 7: Closeup of storm/impact damaged siding near west end of north elevation.

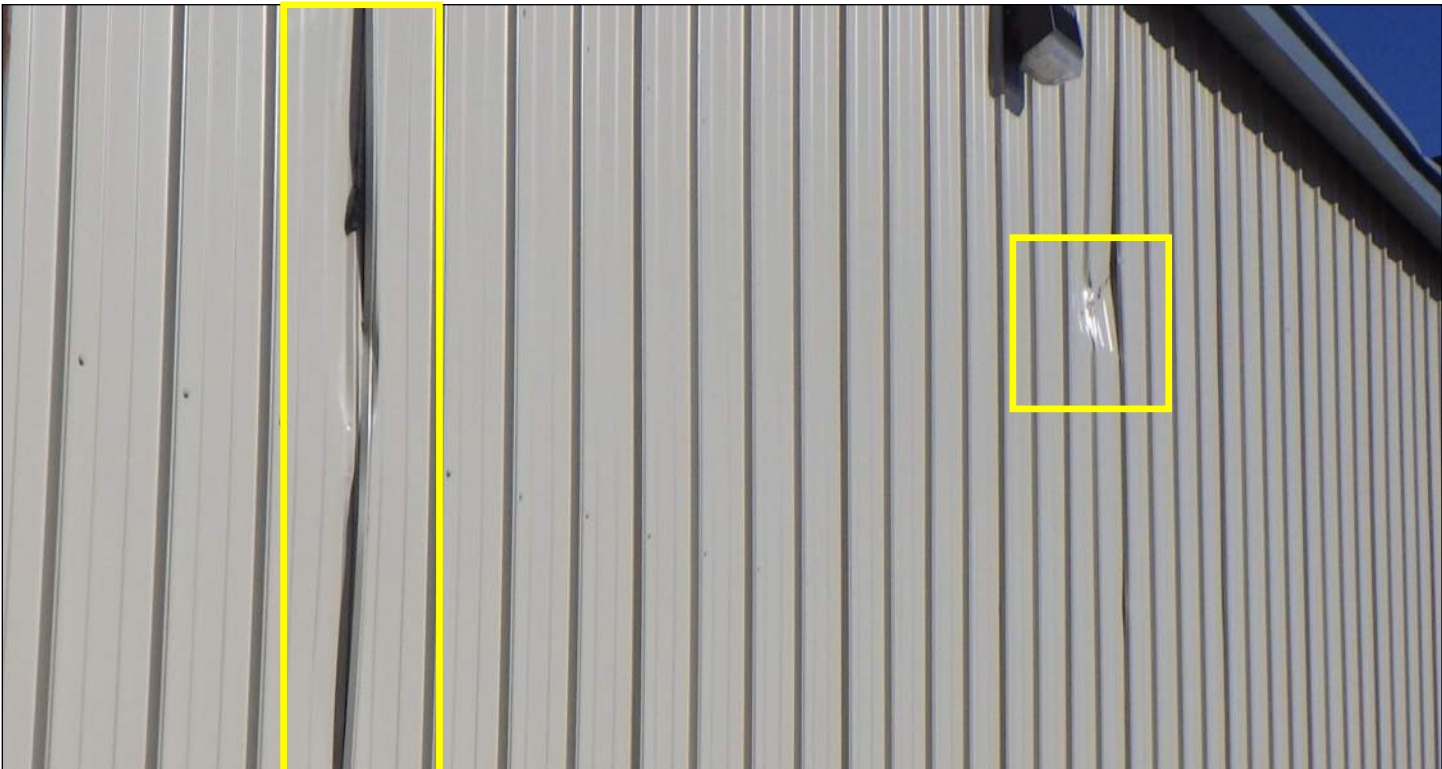
Photo 8: Scrapes, indentations, and punctures in siding panels on south elevation.

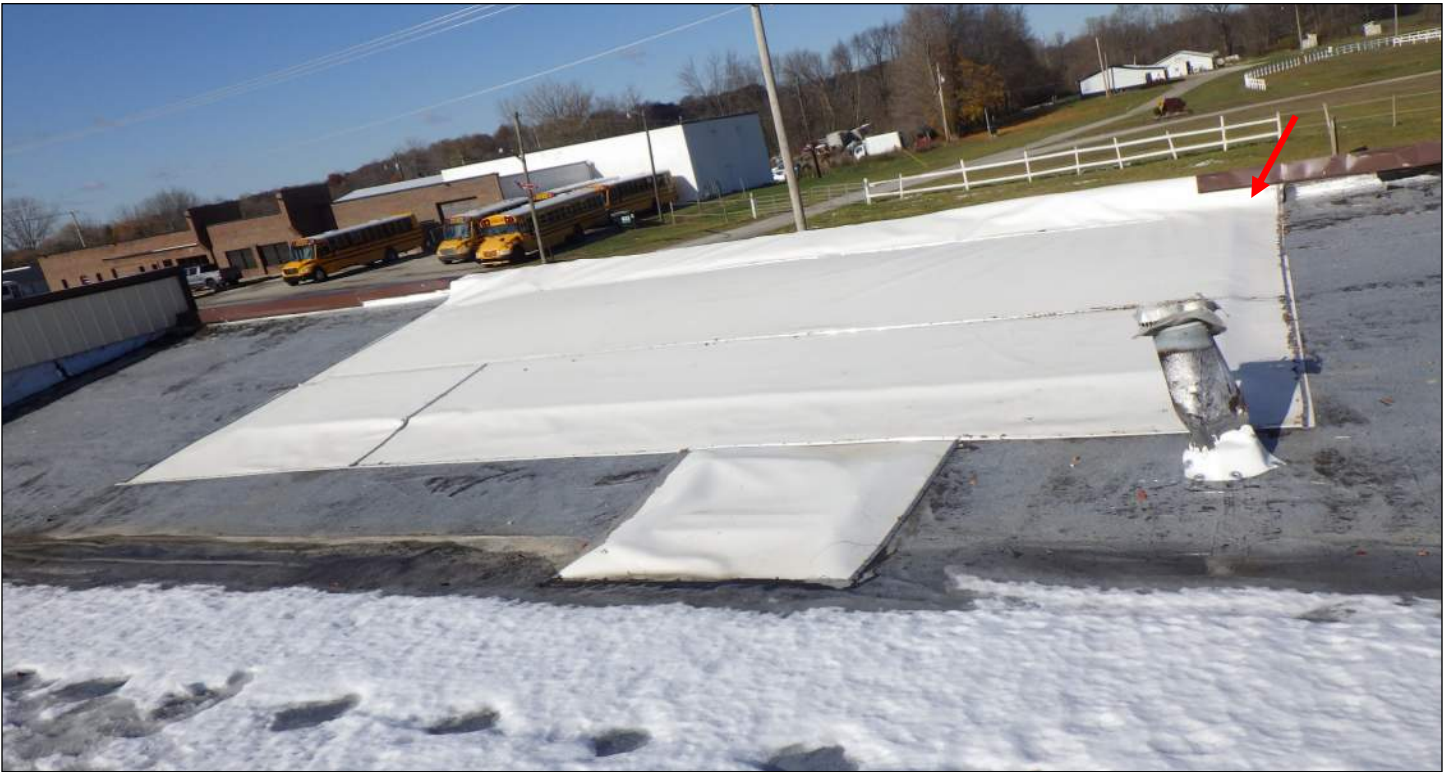
3. A temporary covering had been installed over a section of the roof near the northwest corner of the building (Photo 13).
4. Standing water was observed in the valley located between the roof over the office areas/storage areas and the roof over the garage area (Photos 14 and 15).
5. Roof drains along the valley consisted of small openings/holes in the roofing, with no drain assembly (clamp ring, strainer, etc.) installed (Photos 16 and 17).

Photo 13: Temporary covering installed over roofing.

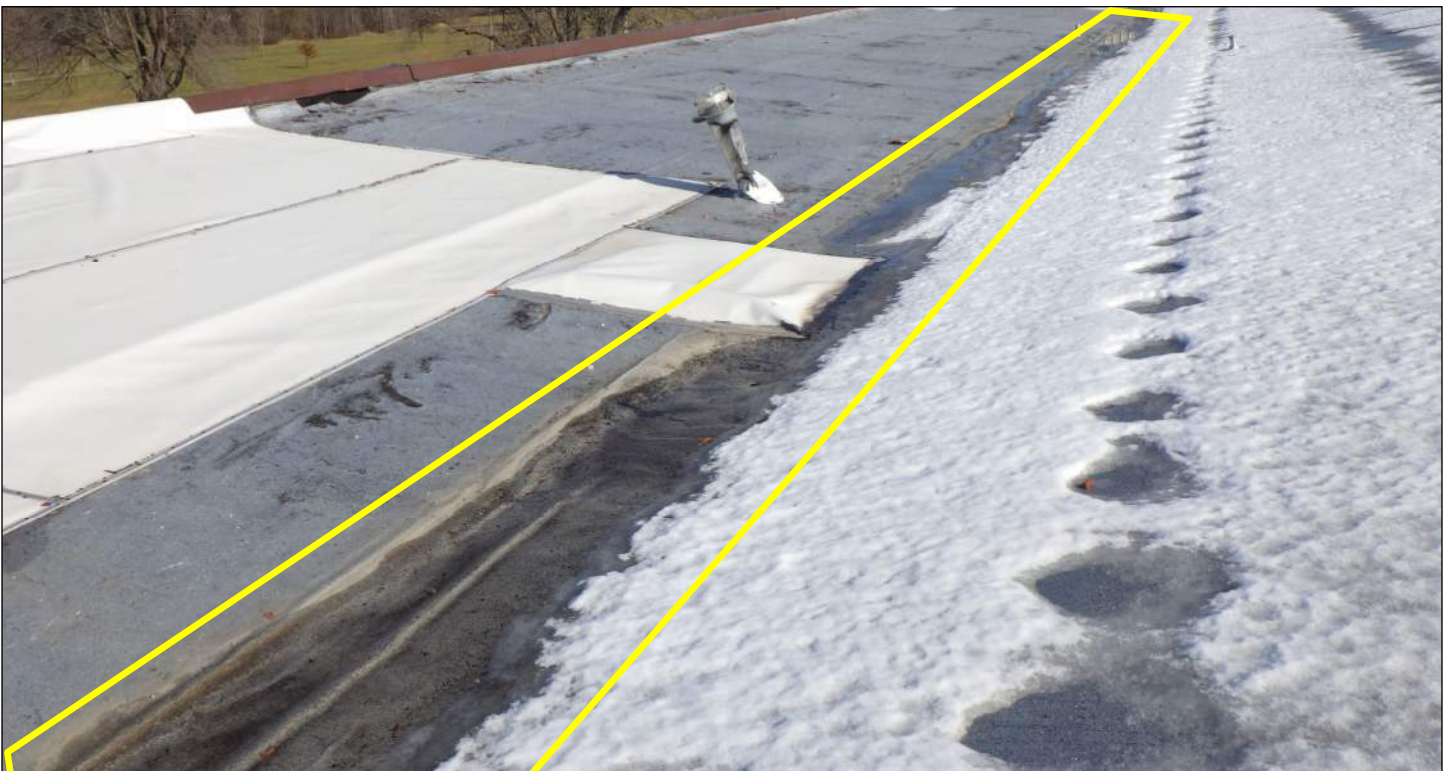
Photo 14: Standing water (boxed outline) in valley between roof over office area (left in photo) and roof over garage area (right in photo).

- In order to prevent future deterioration of the new and/or existing structure to remain, it is recommended that the roof drainage system be improved, specifically along the valley between the roof over the offices/storage rooms and roof over the garage. Such improvements could include but are not necessarily limited to, improving slope of the valley between roof drains to ensure no ponding water forms, adding additional drains, and improving existing drains (installing full drain assemblies).

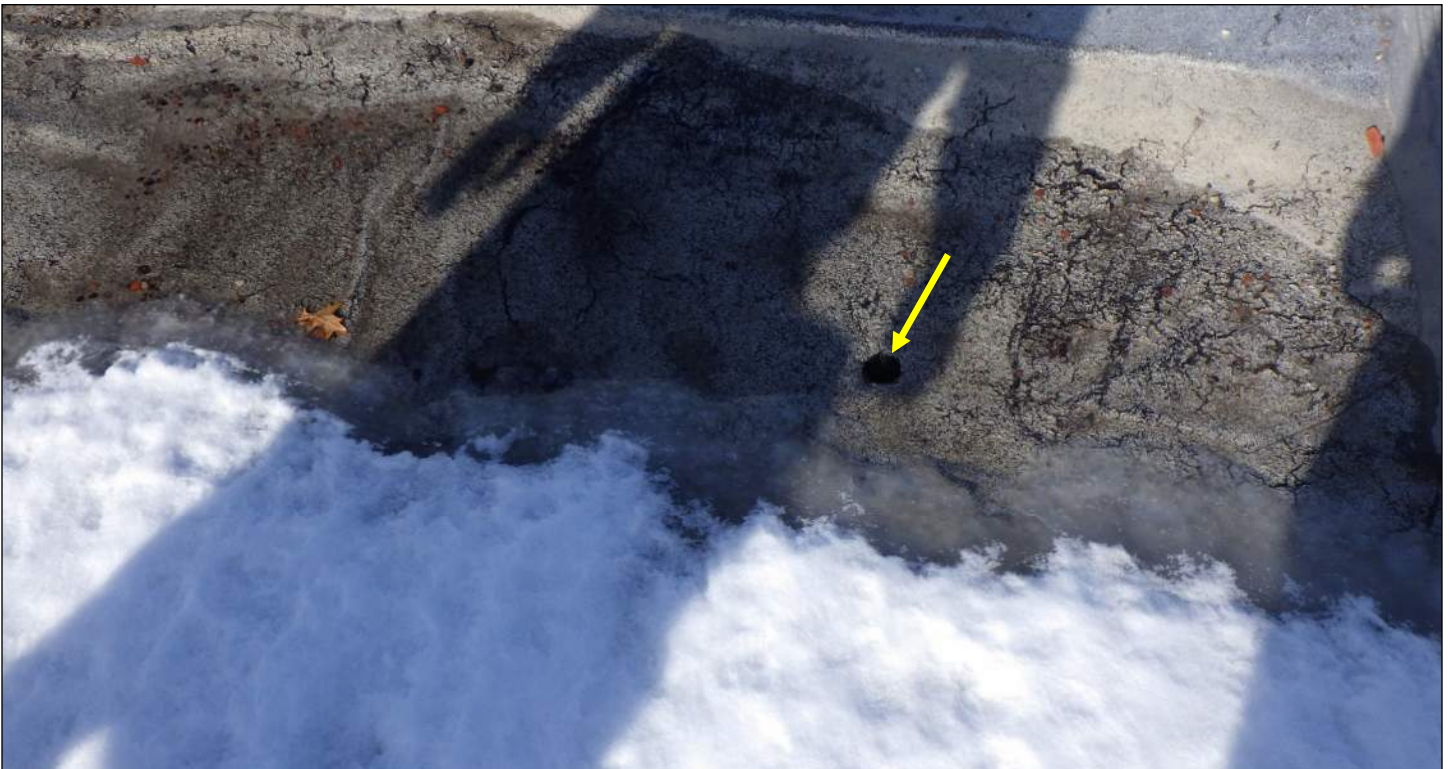
Photo 16: Drain hole in roofing.

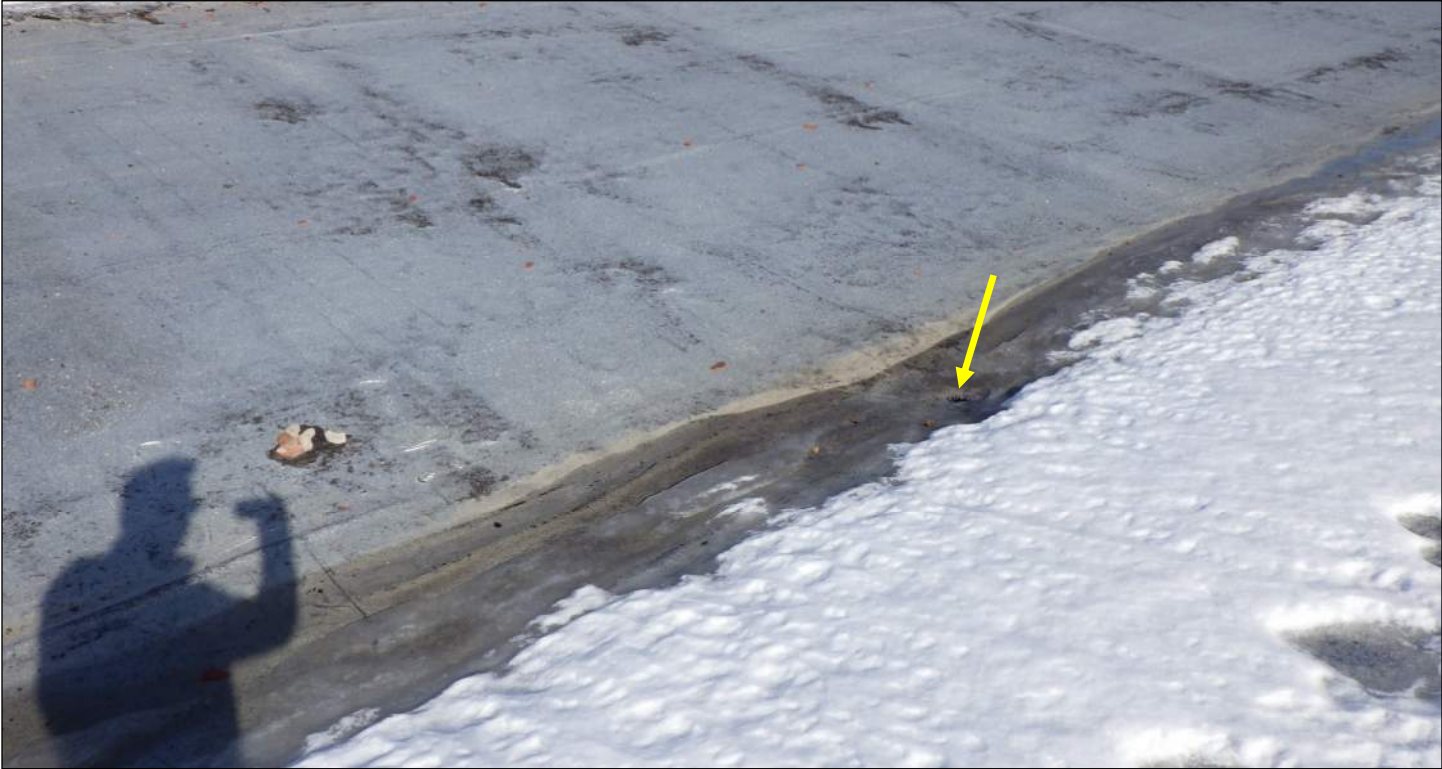
Photo 17: Drain hole in roofing.

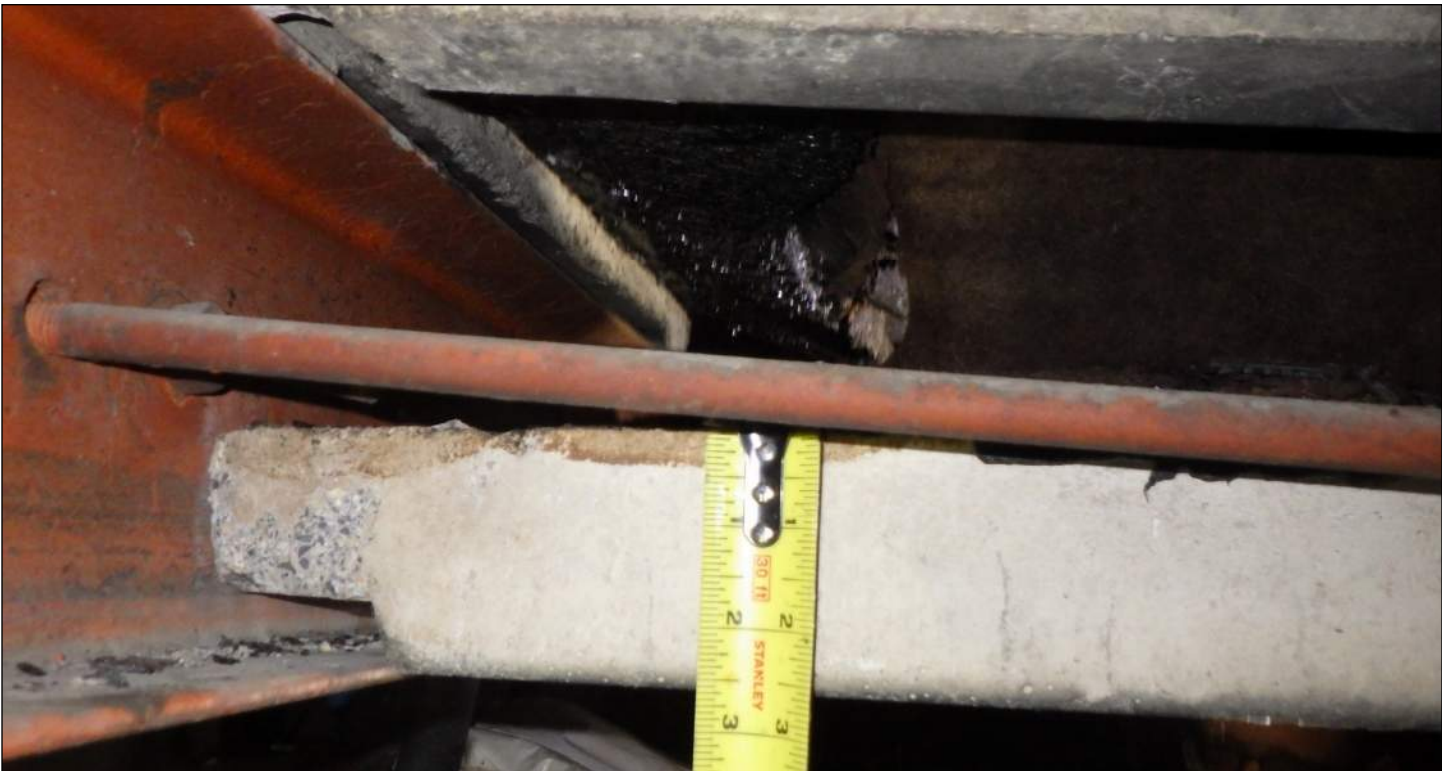
Photo 20: Side view of typical precast concrete roof panel. Note this panel in Bay 2 had partially collapsed.

- The entire roofing system should be removed from the roof area over the offices and storage rooms (Exhibit A). The damaged/deteriorated concrete roof panels could then be removed, damaged CMU and steel beams be replaced in-kind, and corroded steel beams be cleaned and repainted or replaced in-kind. The damaged concrete roof panels (approximately 123 out of 216) should be replaced in-kind, or an alternate roof deck system such as a metal deck could be installed in its place. If a metal deck system is utilized, ballast or other dead load may have to be added in order for the structure to adequately resist uplift forces (pending structural analysis). In structural design/analysis of the roof, consideration of the overall lateral system of the building should also be considered.

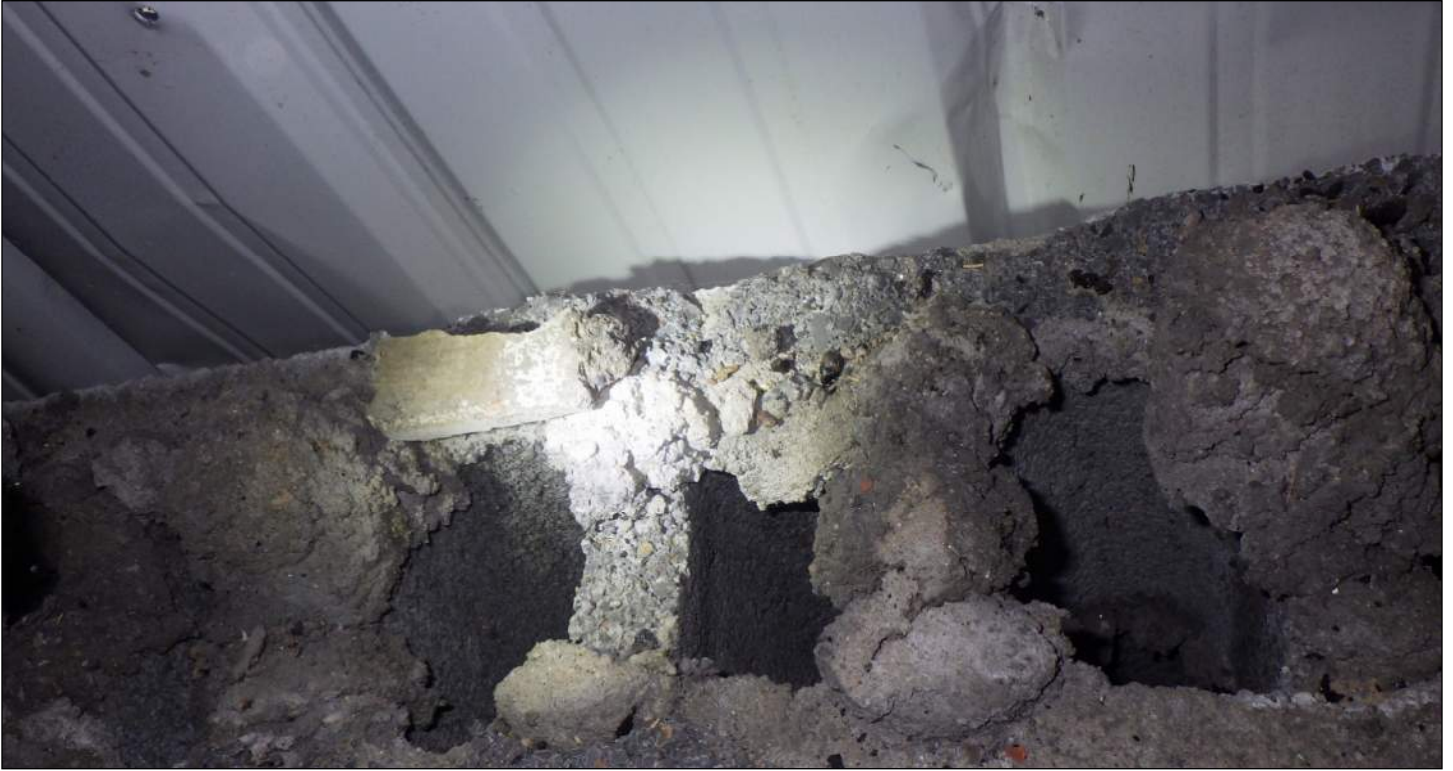
6. The attic over the office area consisted of five “bays,” each separated by interior CMU walls (Exhibit C and Photo 18).
7. The roof structure consisted of precast concrete roof panels and steel framing, supported by CMU walls (Photo 18). The roof panels were steel-reinforced precast concrete panels, sometimes referred to as “precast concrete channels” due to their channel/C-shape (Photos 19 and 20). The panels were 24 inches wide and approximately 6’-3” long. The ends of the panels were supported by steel beams spanning in the east-west direction. Based on field-measurements the steel beams along north and south CMU walls of the attic appeared to be C7x9.8 shapes, while the intermediate beams appeared to be S7x15.3 shapes. Bays 1 and 3 also had center girder beams spanning in the north-south direction approximately 19’-0”, and based on field-measurements, the beams appeared to be W12x35 shapes. All steel beams were supported by 8-inch CMU walls (exterior and interior). Where CMU had been fractured/displaced, all CMU were found to be hollow and unreinforced (Photo 21).

Photo 21: View looking downward at CMU along north wall of Bay 1. Note top of CMU is visible due to CMU displaced as result of storm/impact damage. Also note CMU is hollow and unreinforced.

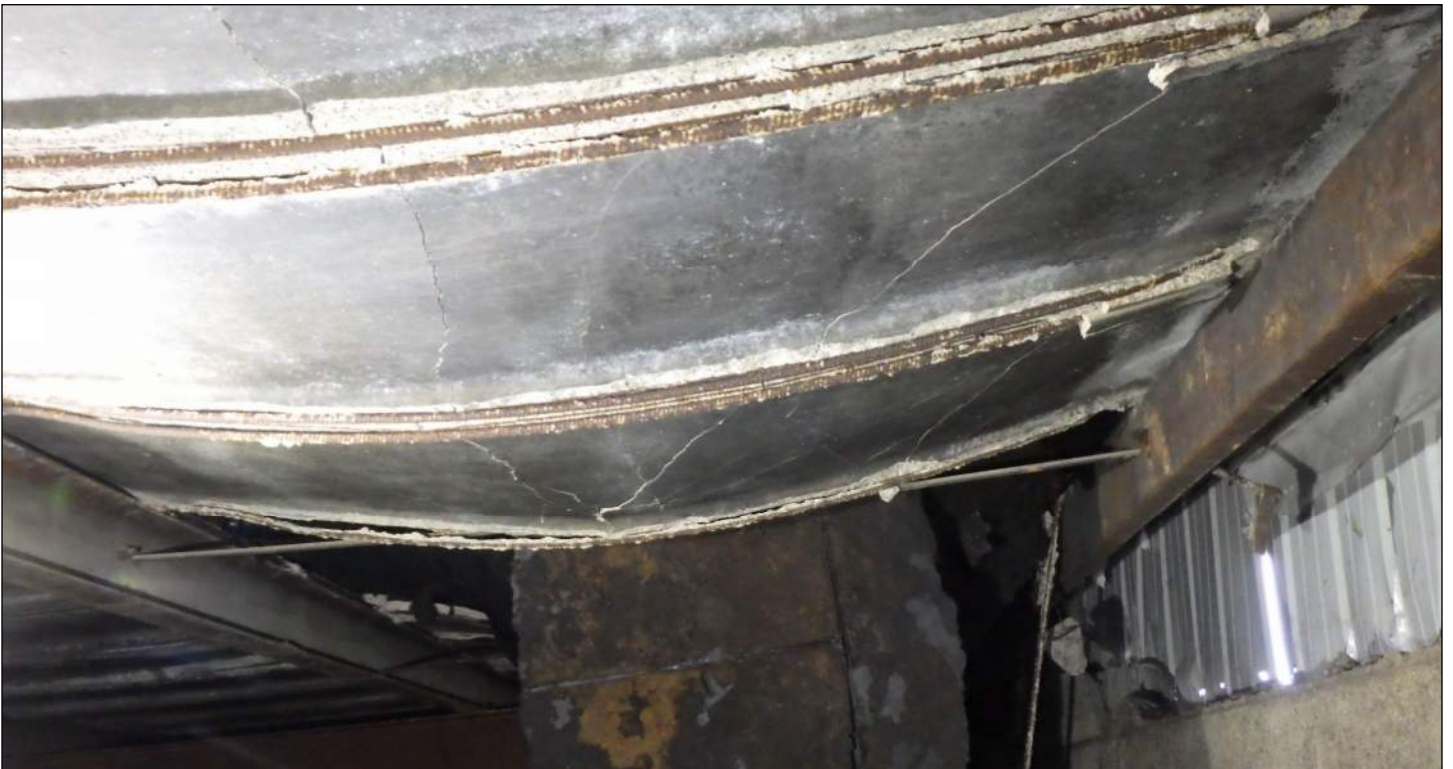
- a. Bay 1 (Exhibit C):
    - i. Approximately 37 of 48 panels were significantly damaged by impact (7) or were found to be in a deteriorated condition (30). The seven panels exhibiting impact damage were also deteriorated, cracked, and appeared to be in imminent danger of collapsing (Photo 22). Noble County personnel were notified of the danger immediately and it was recommended that they close or restrict access to the breakroom area below the panels and remove the loose panels as soon as possible. The other 30 panels exhibited moisture stains, cracks, spalls, and exposed and corroded steel reinforcing along the flanges of the C-shaped panels (Photos 23 and 24).

Photo 22: Precast concrete panels in area of chimney impact area. Note panels are deteriorated, cracked, and appear to be in imminent danger of collapse. View looking west.

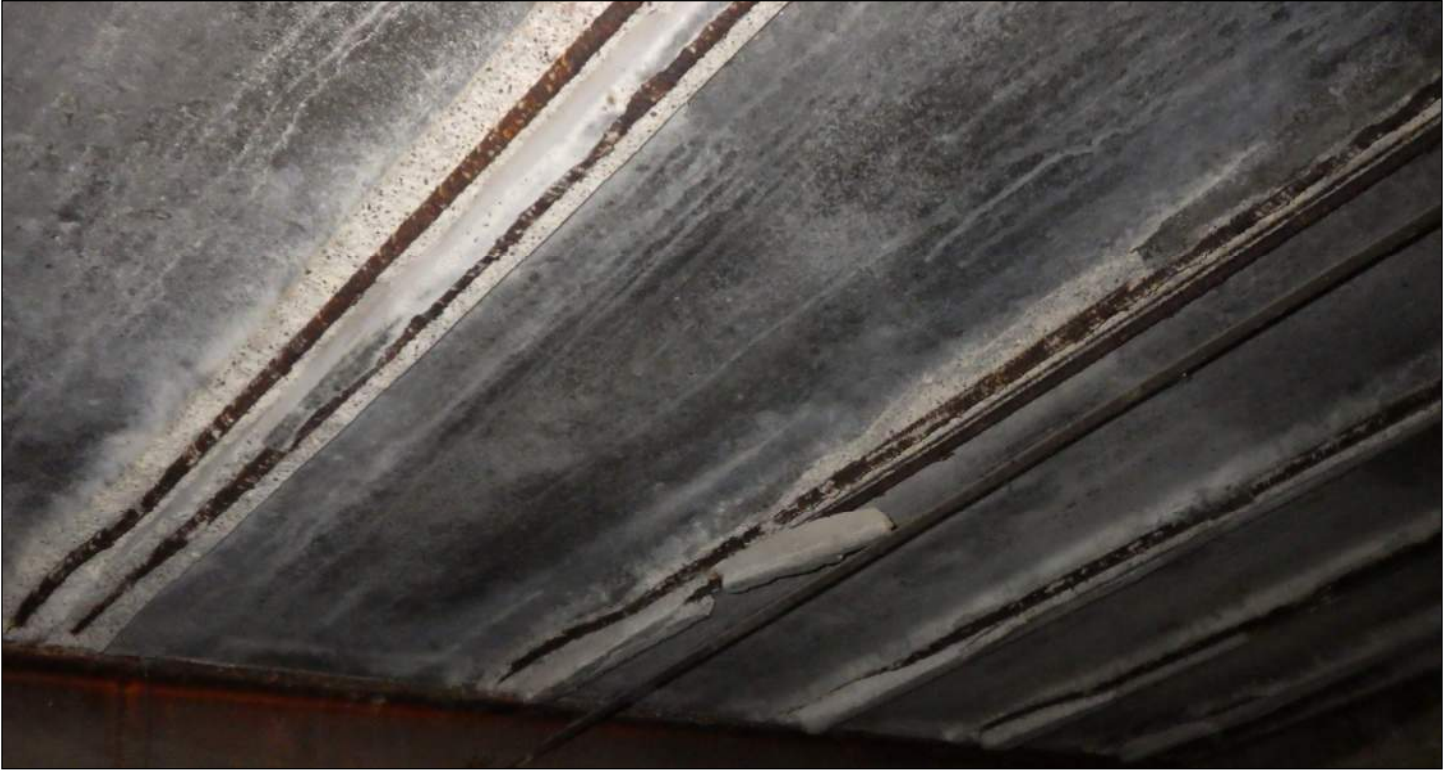
- Approximately 75 of 168 of the total concrete roof panels over the office area were storm-damaged and/or exhibited deterioration consistent with long-term exposure to moisture. Cracking along the flanges of the concrete panels is an indication of corrosion and volumetric expansion of the embedded reinforcing steel, which has manifested in spalling of the concrete where more severe corrosion is present. Additionally, two steel beams and approximately 95 square feet of the north CMU wall were damaged as result of storm/impact damage, and steel beams throughout Bay 1 of the attic exhibited varying levels of corrosion.

Photo 23: Spalled concrete along flanges of C-shaped precast concrete roof panels. Note moisture stains on panels and visible corrosion of exposed steel reinforcing along flanges.

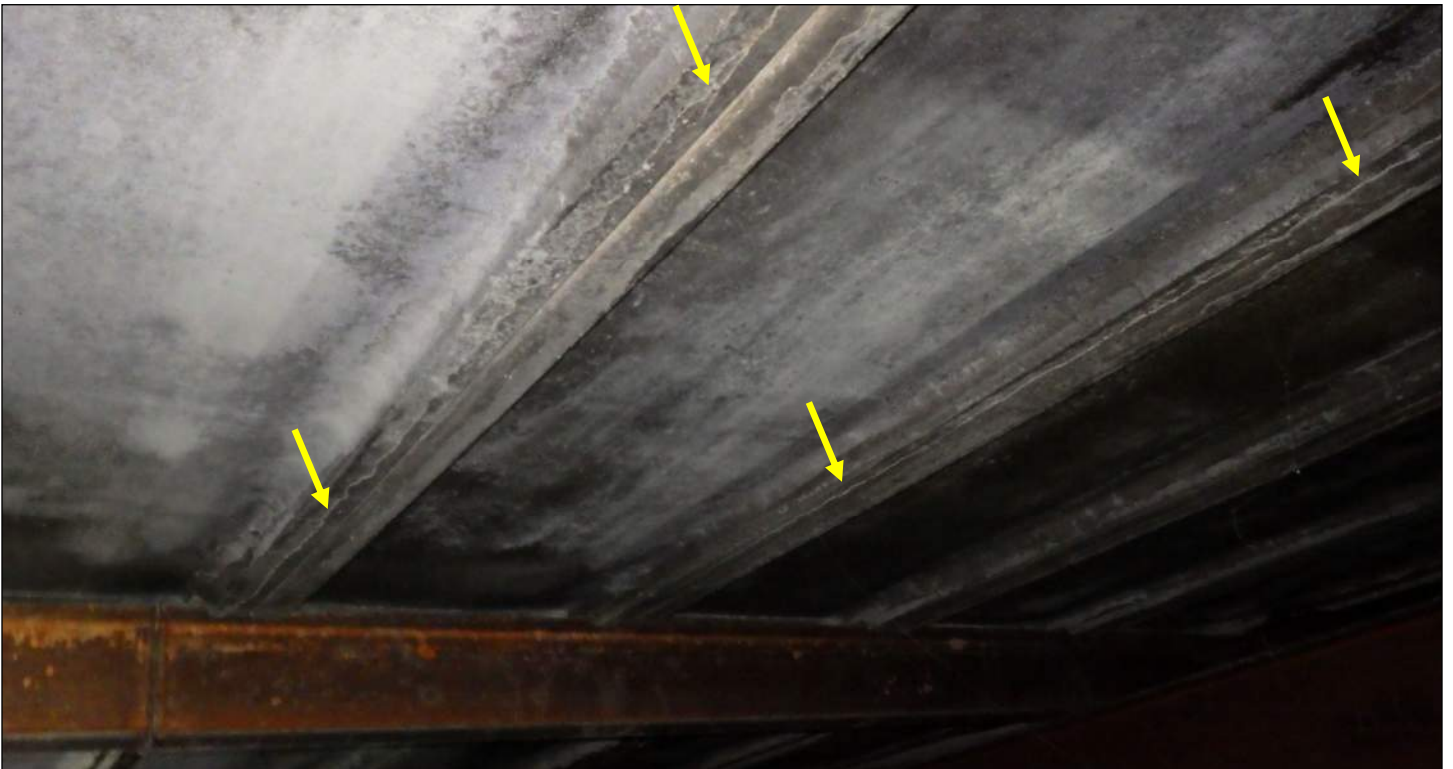
Photo 24: Cracks in flanges of C-shaped precast concrete roof panels.

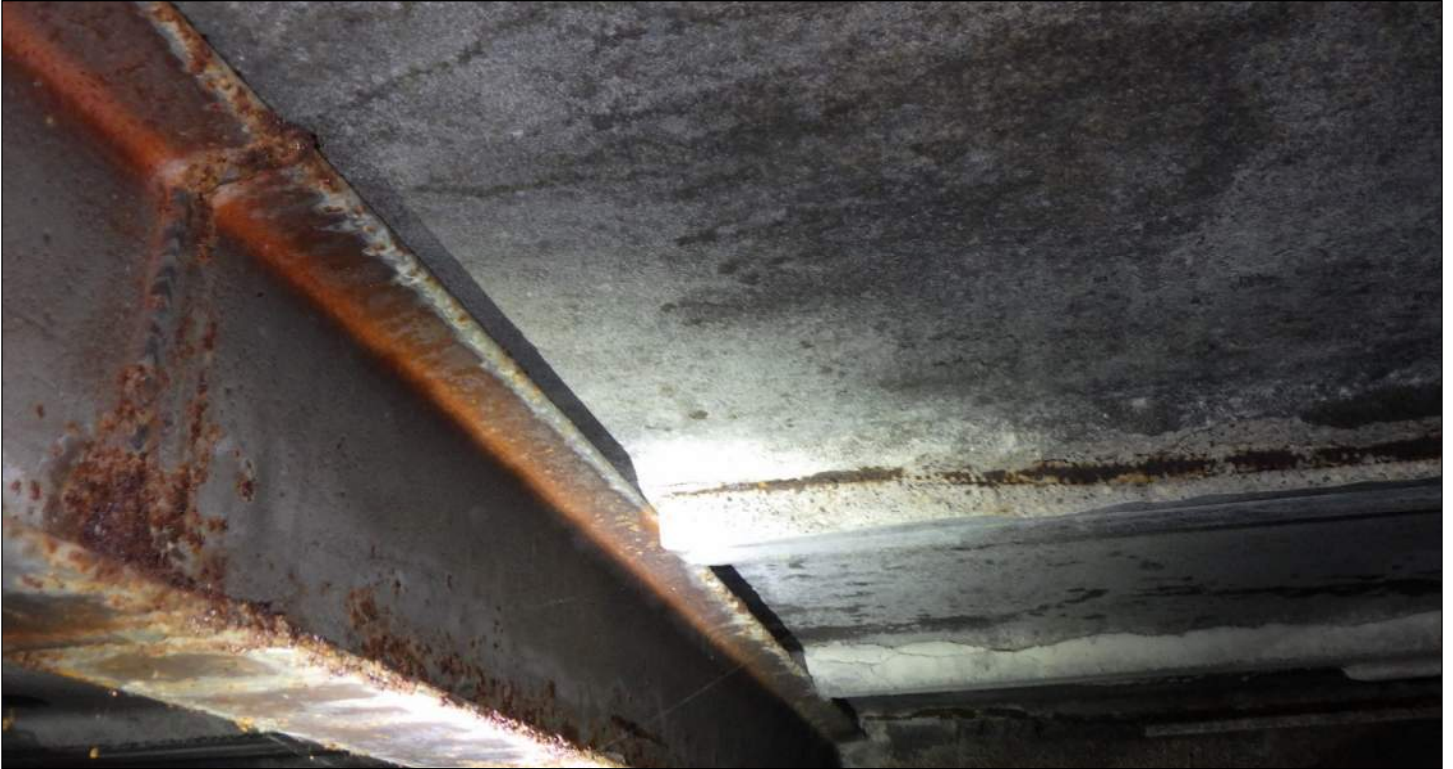
- ii. Several of the S7x15.3 beams exhibited corrosion and pitting; however, none had measurable section loss (Photos 25 and 26).
    - iii. Approximately 50 square feet of CMU on the north exterior wall had been fractured and/or displaced, consistent with the storm/impact damage to the roof/wall (Photo 27).

Photo 25: Corrosion of S7x15.3 beam.

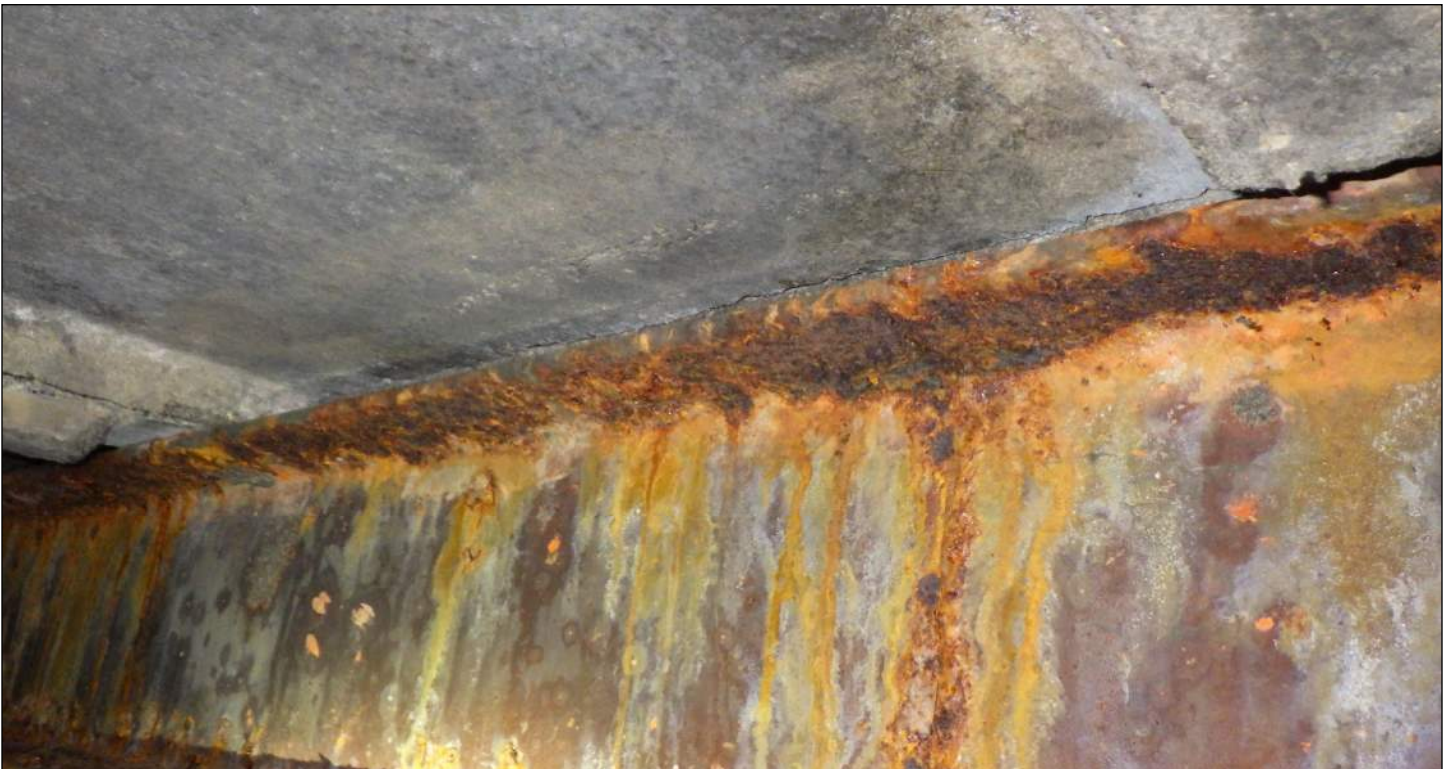
Photo 26: Corrosion of S7x15.3 beam.

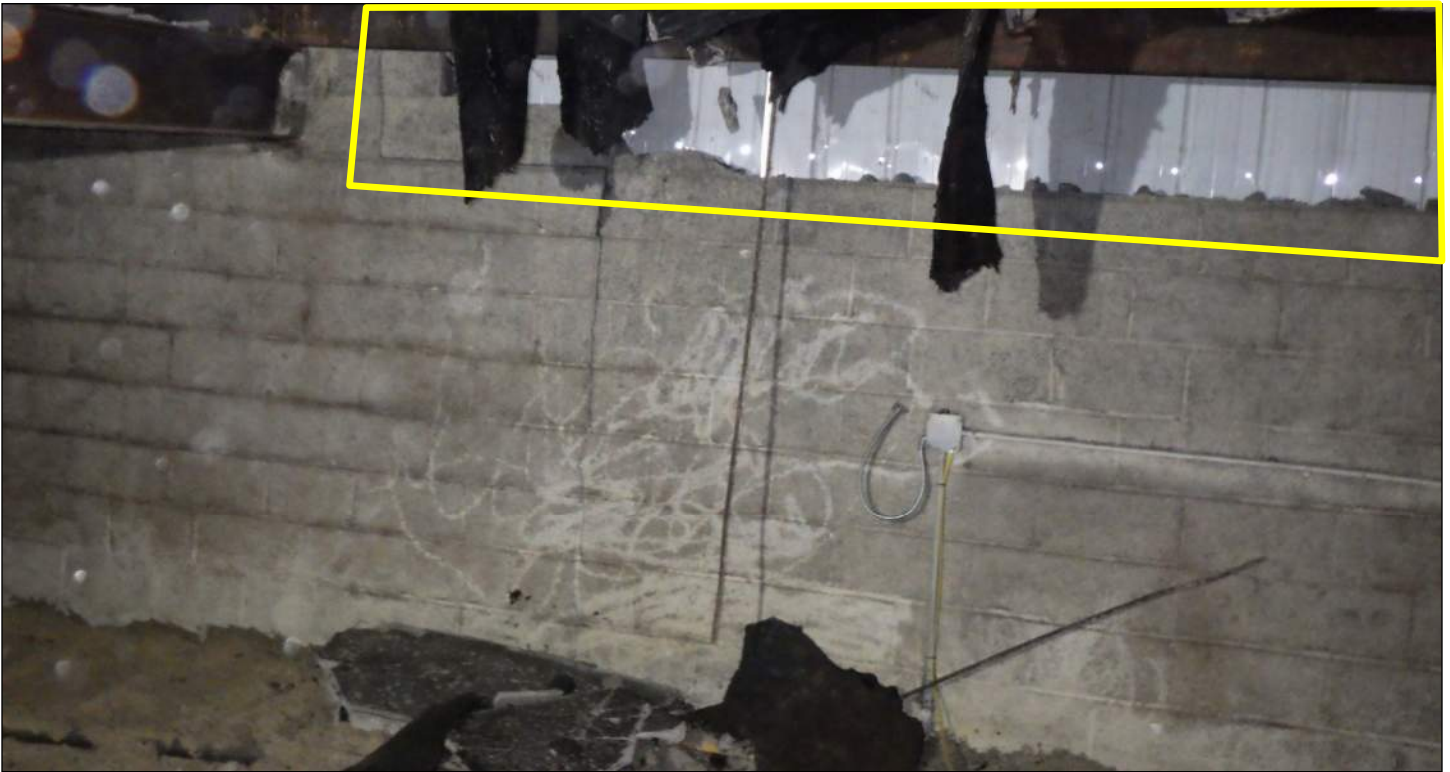
Photo 27: Fractured/displaced CMU along north wall.

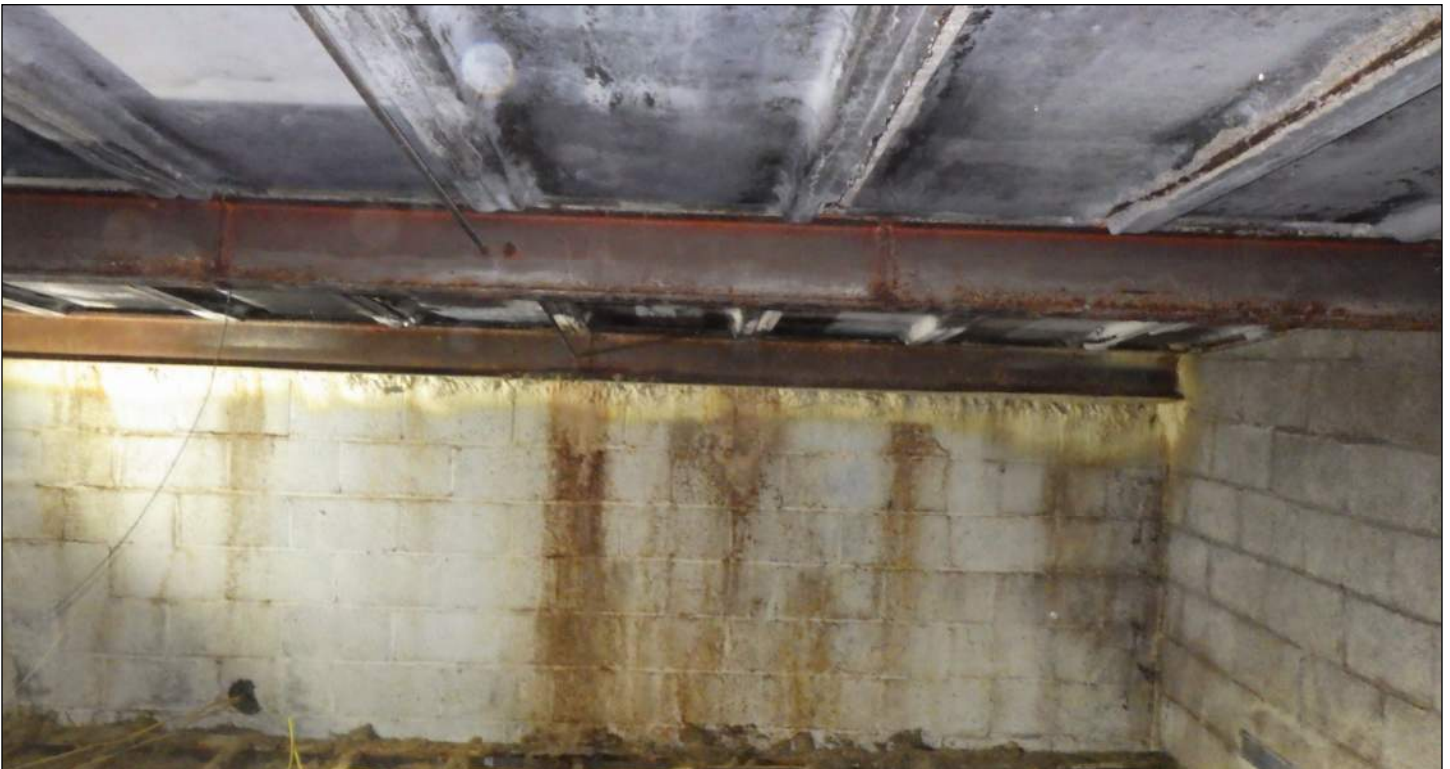
- iv. Moisture stains were observed on the face of the CMU along the south wall of the attic (Photo 28).

Photo 28: Moisture staining on CMU along south wall of attic. View looking south.

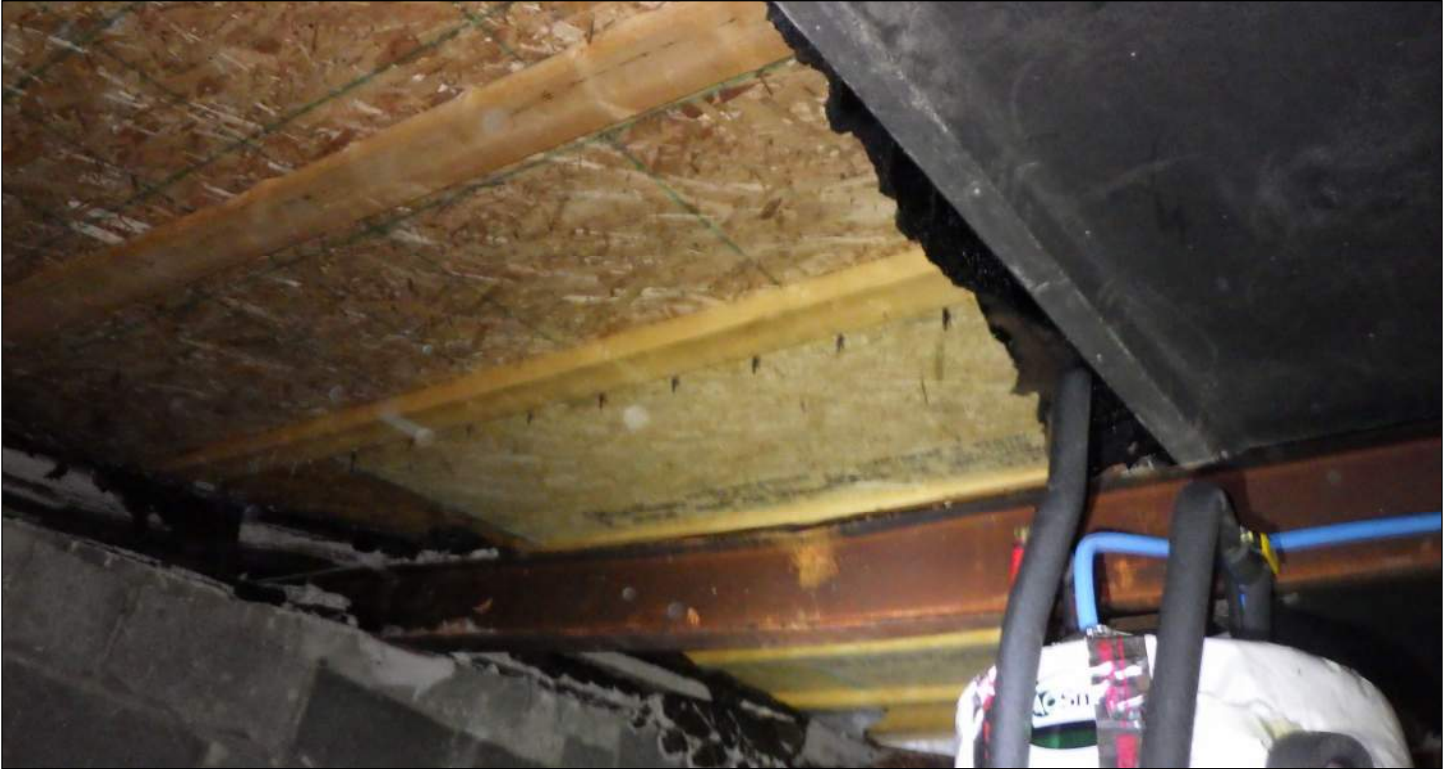
- b. Bay 2 (Exhibit C):
  - i. Approximately 12 of 24 panels were significantly damaged or displaced due to impact from the chimney (8) or found to be in a deteriorated condition (4) (Photos 29 and 30).

Photo 29: Overview of temporary oriented strand board covering installed over area of roof panels fractured/displaced by impact from chimney.
