Re: Noble County Highway Department Building – Structural Assessment  
1118 East Main Street  
Albion, Indiana 46701

Project No. 202502329

## **PHOTOGRAPHS**

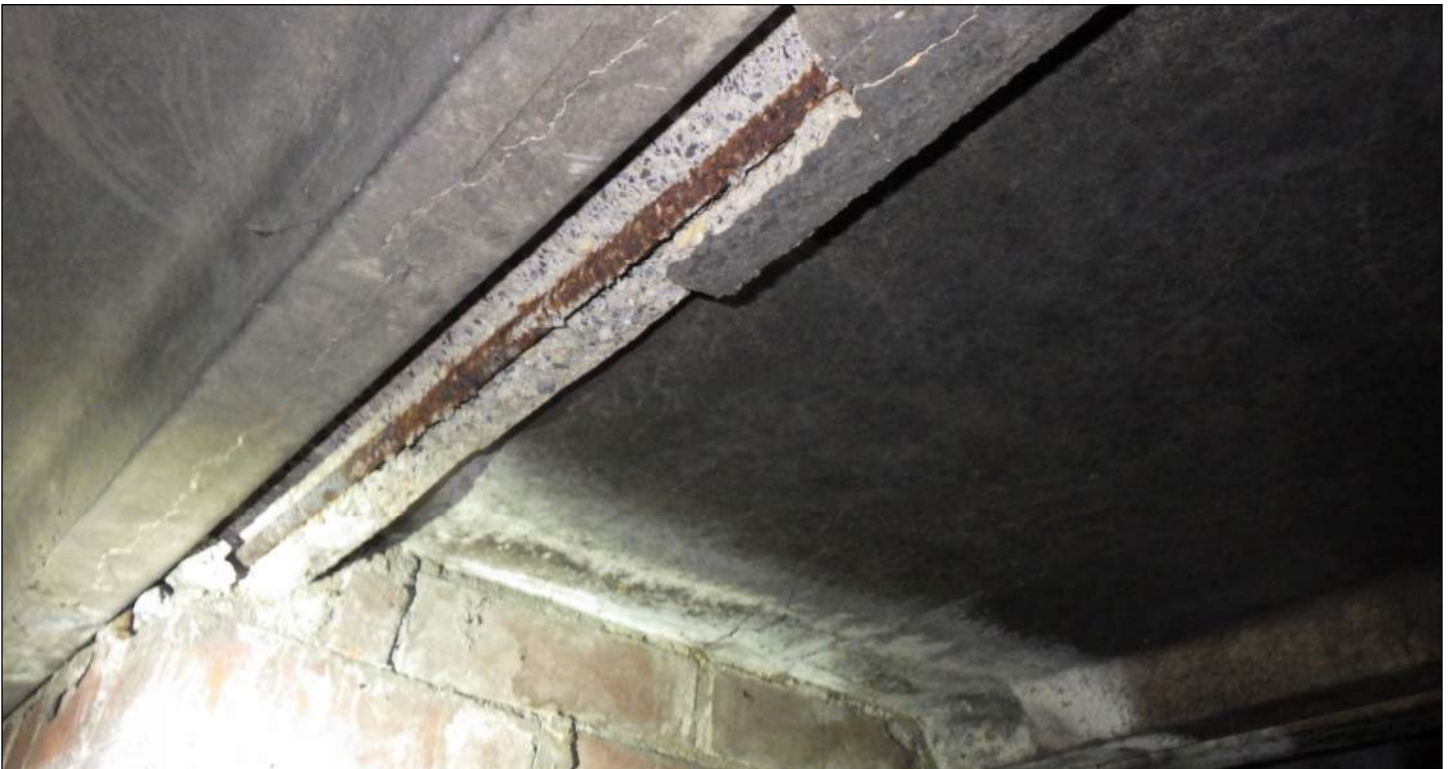
- b. Bay 2 (Exhibit C):
  - i. Approximately 12 of 24 panels were significantly damaged or displaced due to impact from the chimney (8) or found to be in a deteriorated condition (4) (Photos 29 and 30).

Photo 30: Spalled and cracked concrete along flanges of C-shaped precast concrete roof panels. Note moisture stains on panels and visible corrosion of exposed steel reinforcing along flange.

- The entire roofing system should be removed from the roof area over the offices and storage rooms (Exhibit A). The damaged/deteriorated concrete roof panels could then be removed, damaged CMU and steel beams be replaced in-kind, and corroded steel beams be cleaned and repainted or replaced in-kind. The damaged concrete roof panels (approximately 123 out of 216) should be replaced in-kind, or an alternate roof deck system such as a metal deck could be installed in its place. If a metal deck system is utilized, ballast or other dead load may have to be added in order for the structure to adequately resist uplift forces (pending structural analysis). In structural design/analysis of the roof, consideration of the overall lateral system of the building should also be considered.

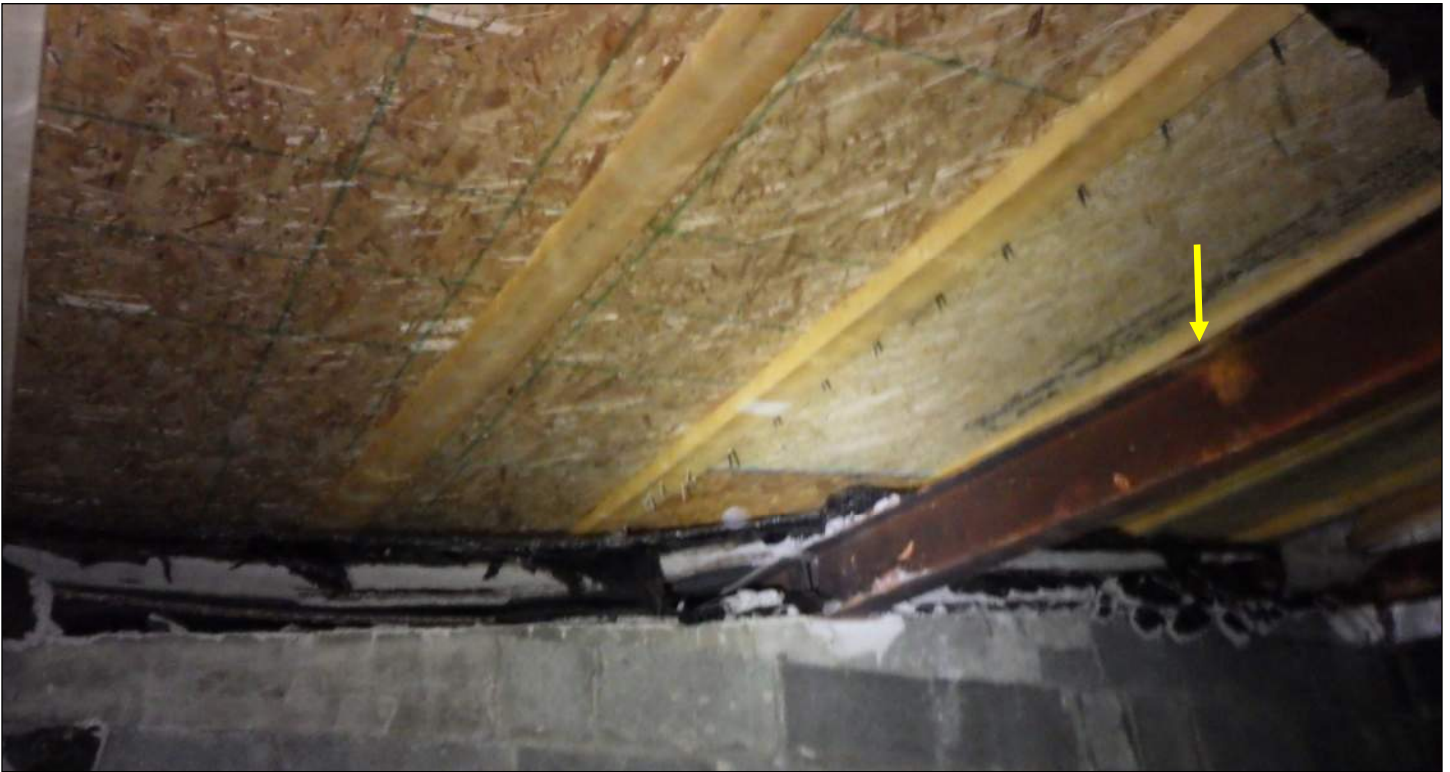
- ii. Two beams (one C7x9.8 and one S7x9.8) exhibited deformations consistent with impact damage (Photos 31 and 32).
  - iii. Approximately 45 square feet of CMU on the north exterior wall had been fractured and/or displaced, consistent with the storm/impact damage to the roof/wall (Photo 32).

Photo 31: Bent/twisted S7x9.8 beam under area of displaced concrete roof panels.

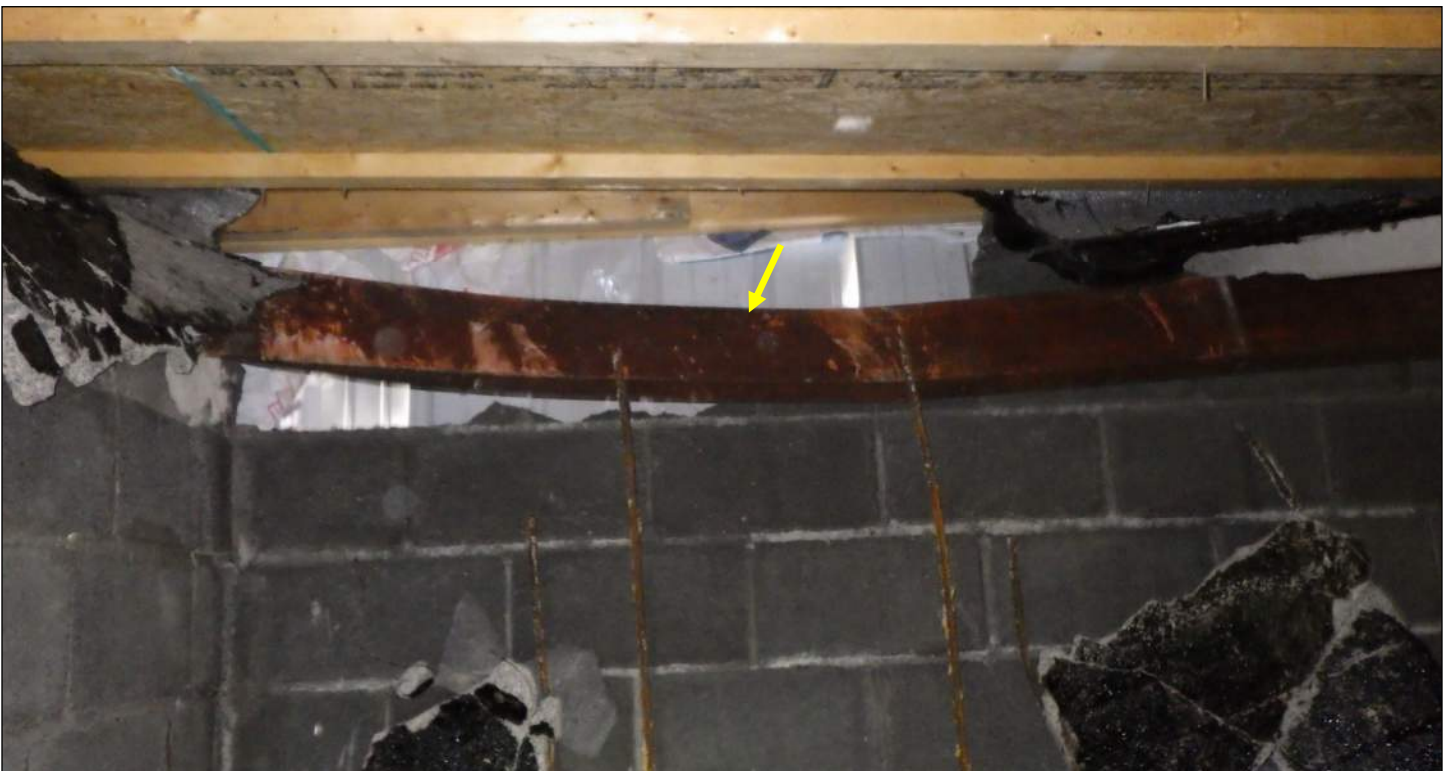
Photo 32: Bent/twisted C7x9.8 beam (arrow) along north exterior CMU wall. Also note fractured/displaced CMU behind damaged beam.

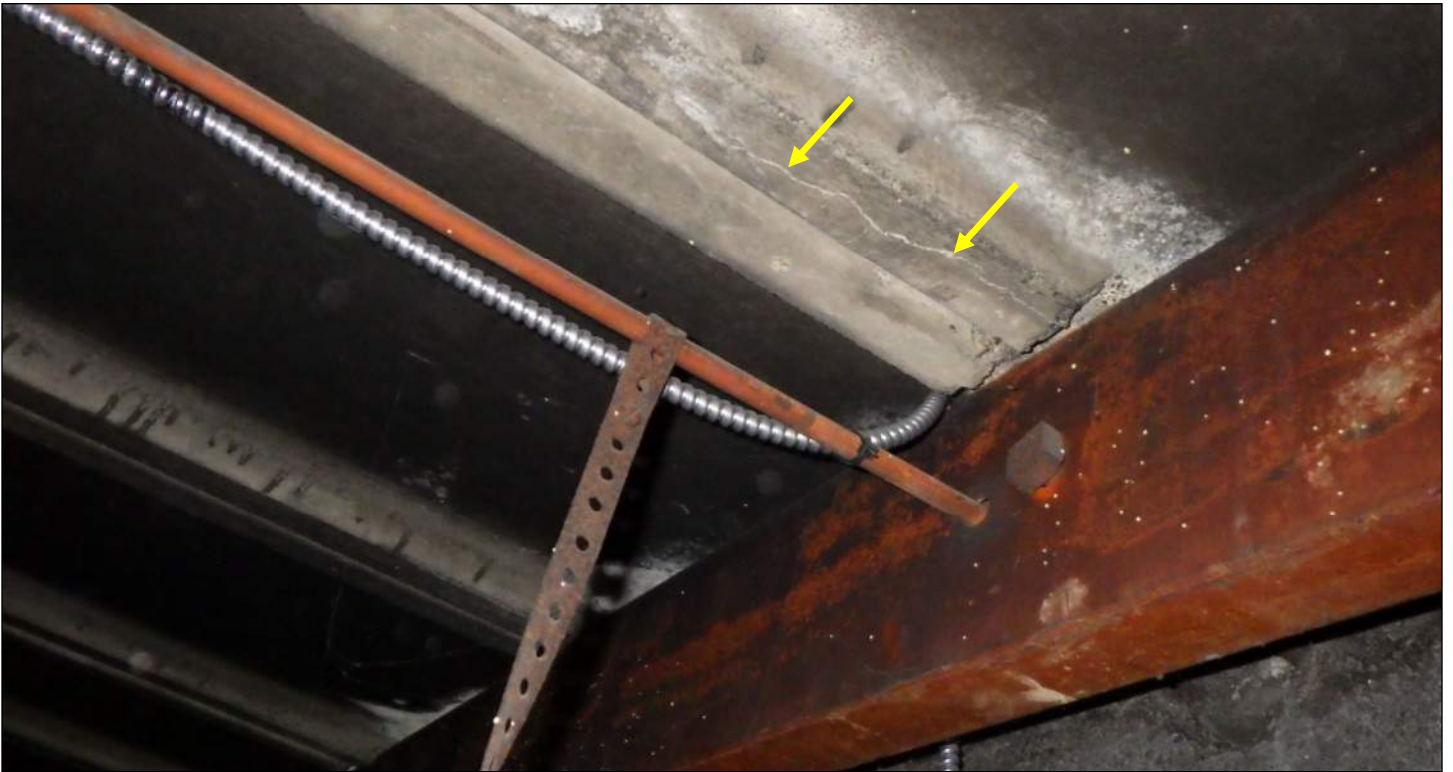
- c. Bay 3 (Exhibit C):
  - i. One panel (of 48 total) exhibited a crack along the flange of the panel (Photo 33).
  - ii. Moisture stains were observed on the face of the CMU along the south wall of the attic (Photo 34).

Photo 33: Crack in flange of roof panel (arrows). Also note moisture stains on panel.

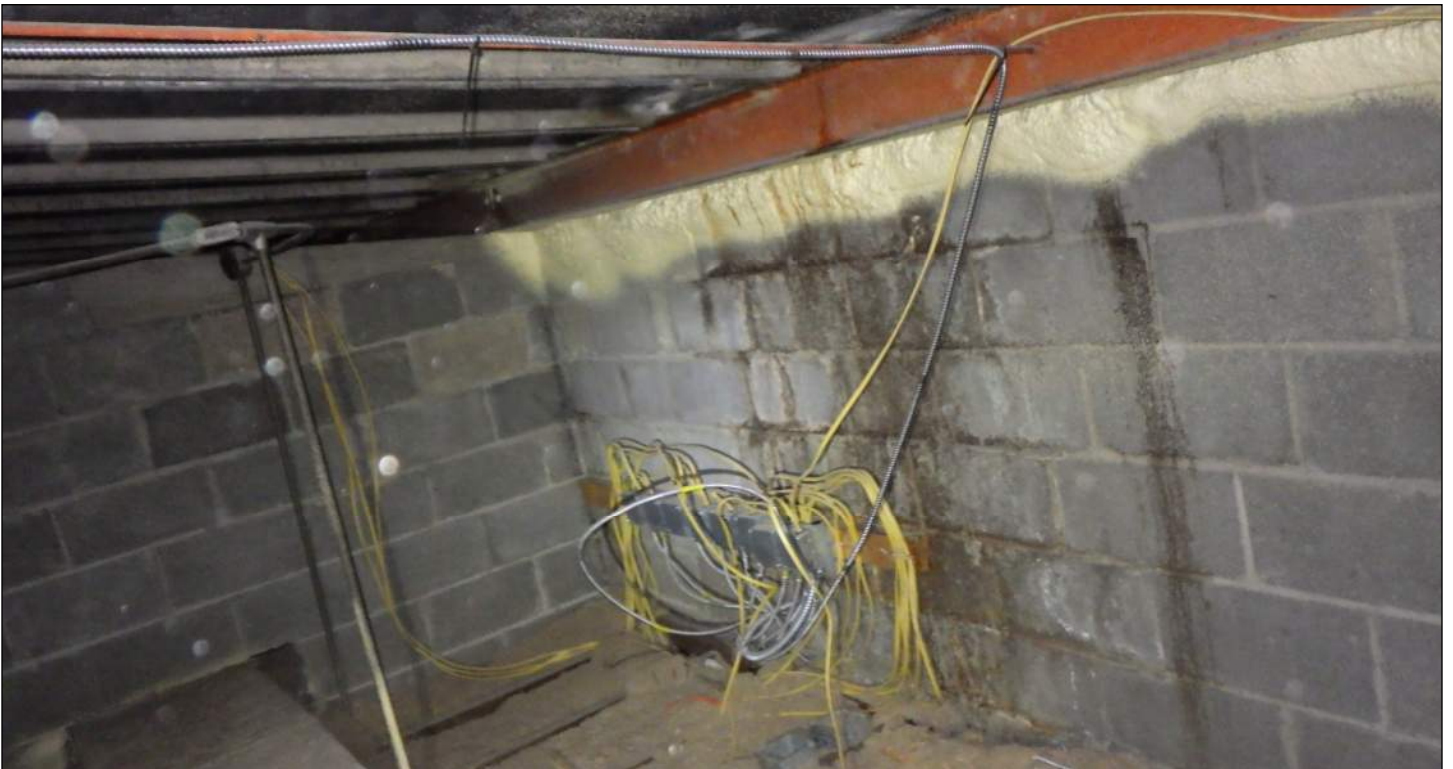
Photo 34: Moisture staining on CMU along south wall of attic.

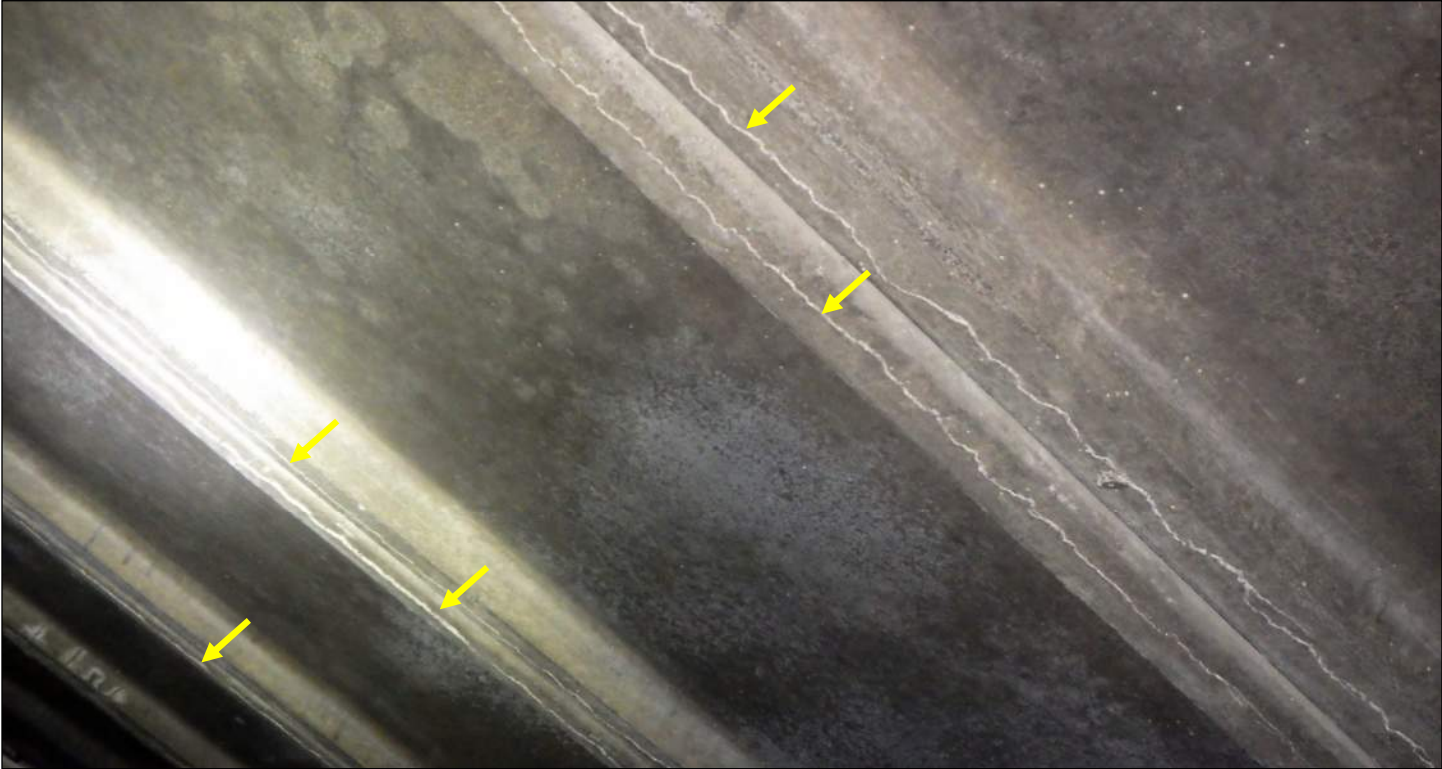
- d. Bay 4 (Exhibit C):
  - i. Approximately 10 of 24 panels exhibited cracks along the flanges of the panels (Photo 35).
  - ii. A vertical crack was observed in the CMU along the north exterior wall (Photo 36). The edges of the crack were rounded and the surfaces of the CMU within the crack were stained (Photo 37), indicating the crack had not formed recently.

Photo 35: Cracks in flanges of roof panels.

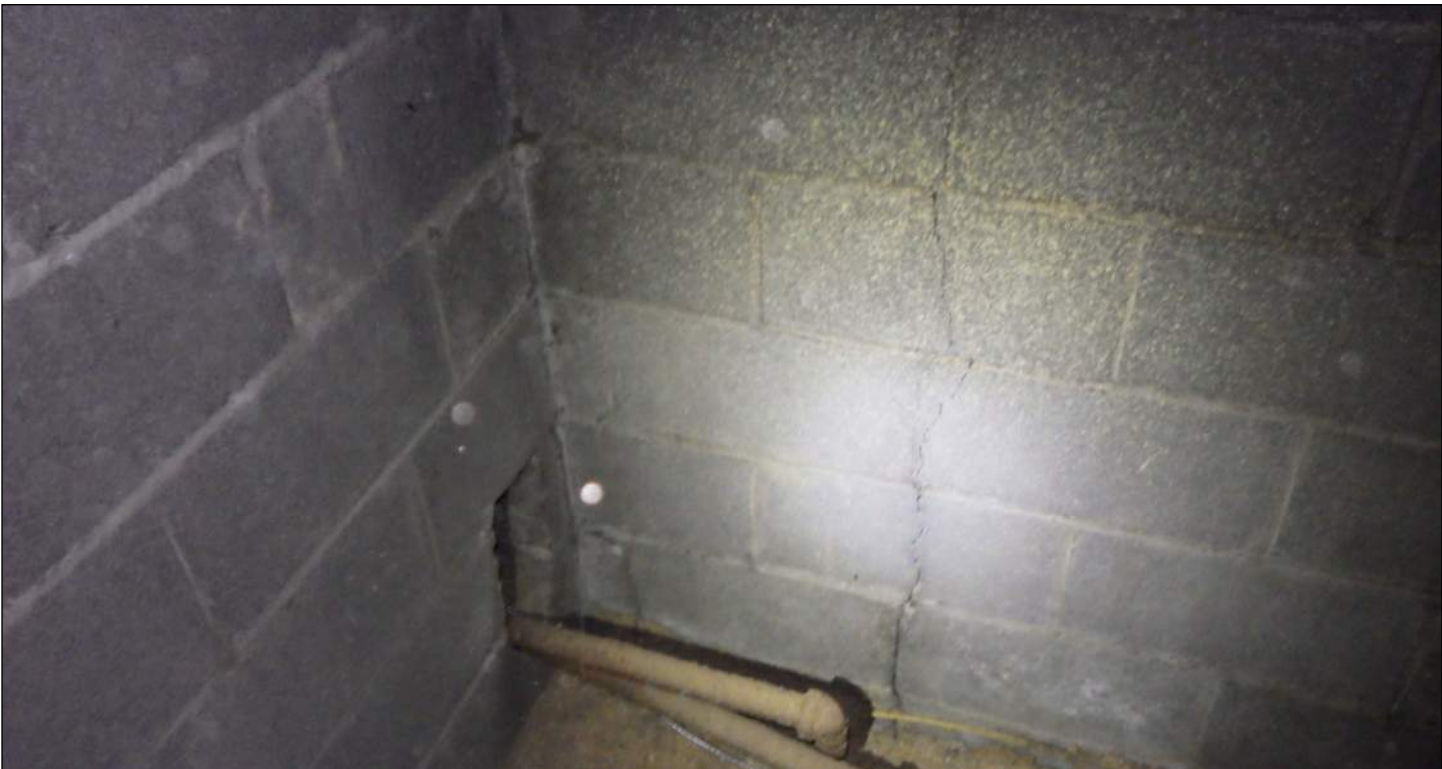
Photo 36: Vertical crack in CMU along north exterior wall.

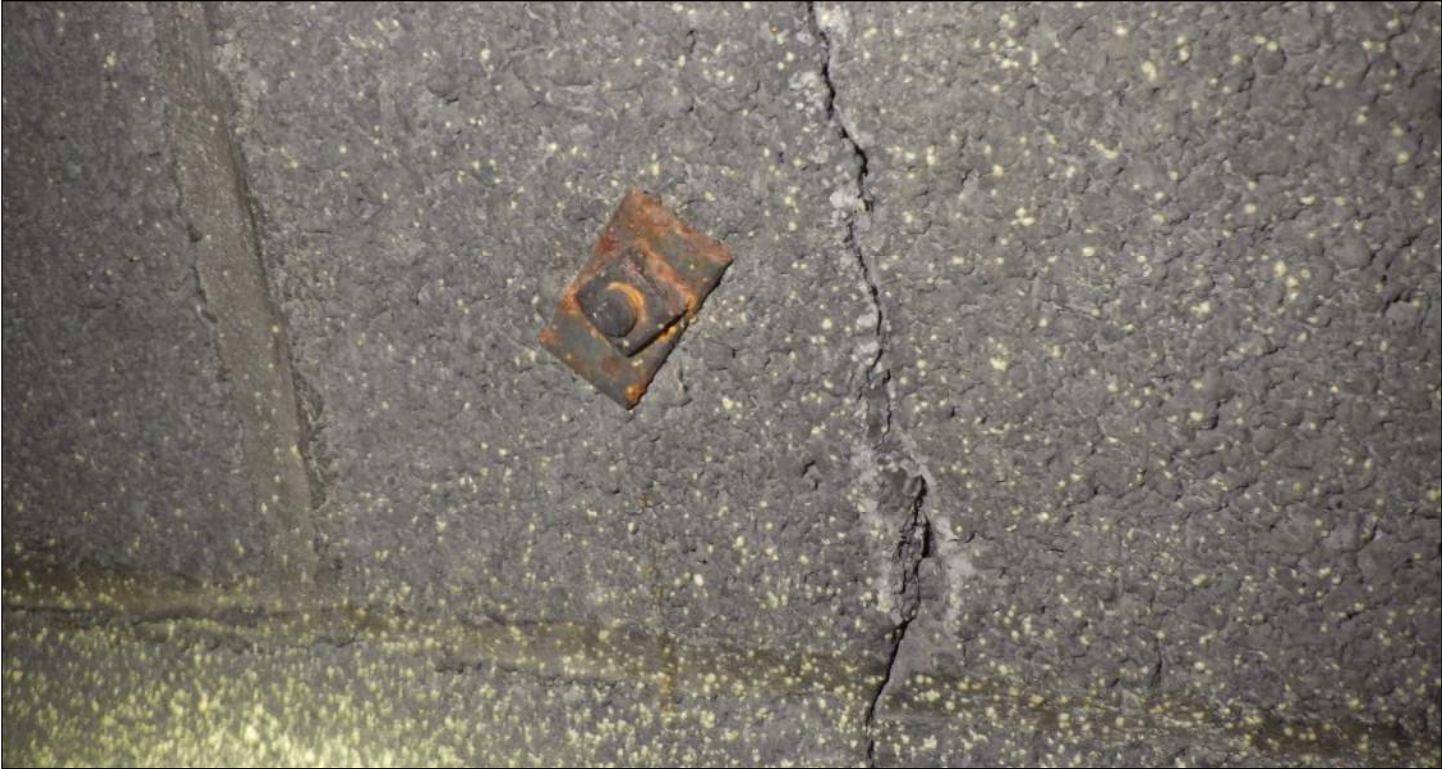
Photo 37: Closeup of crack in CMU shown in previous view.

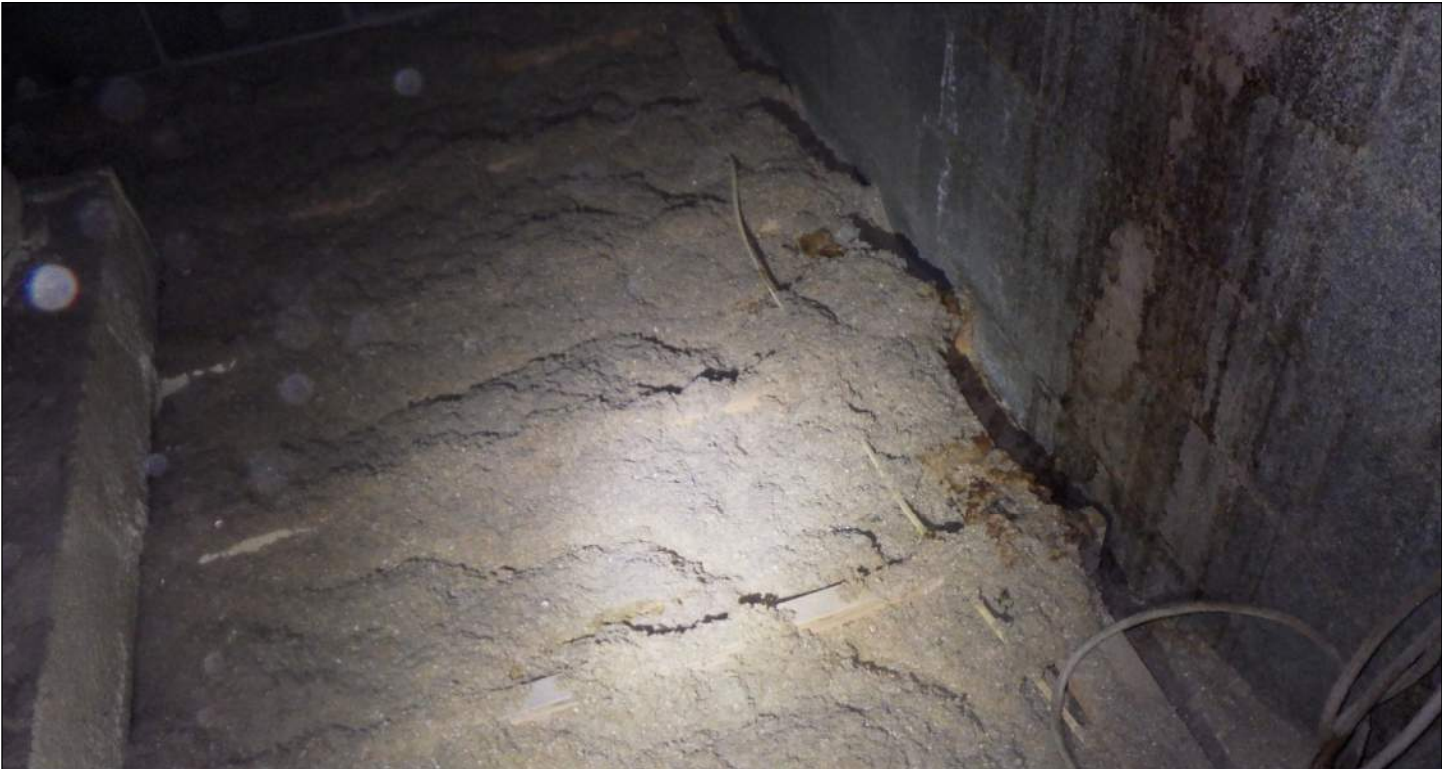
- iii. Moisture stains were observed on the face of the CMU along the south wall of the attic (Photo 38).
- e. Bay 5 (Exhibit C):
  - i. Approximately 15 of 24 panels exhibited cracks along the flanges of the panels (Photo 39).

Photo 38: Moisture staining on CMU along south wall of attic.

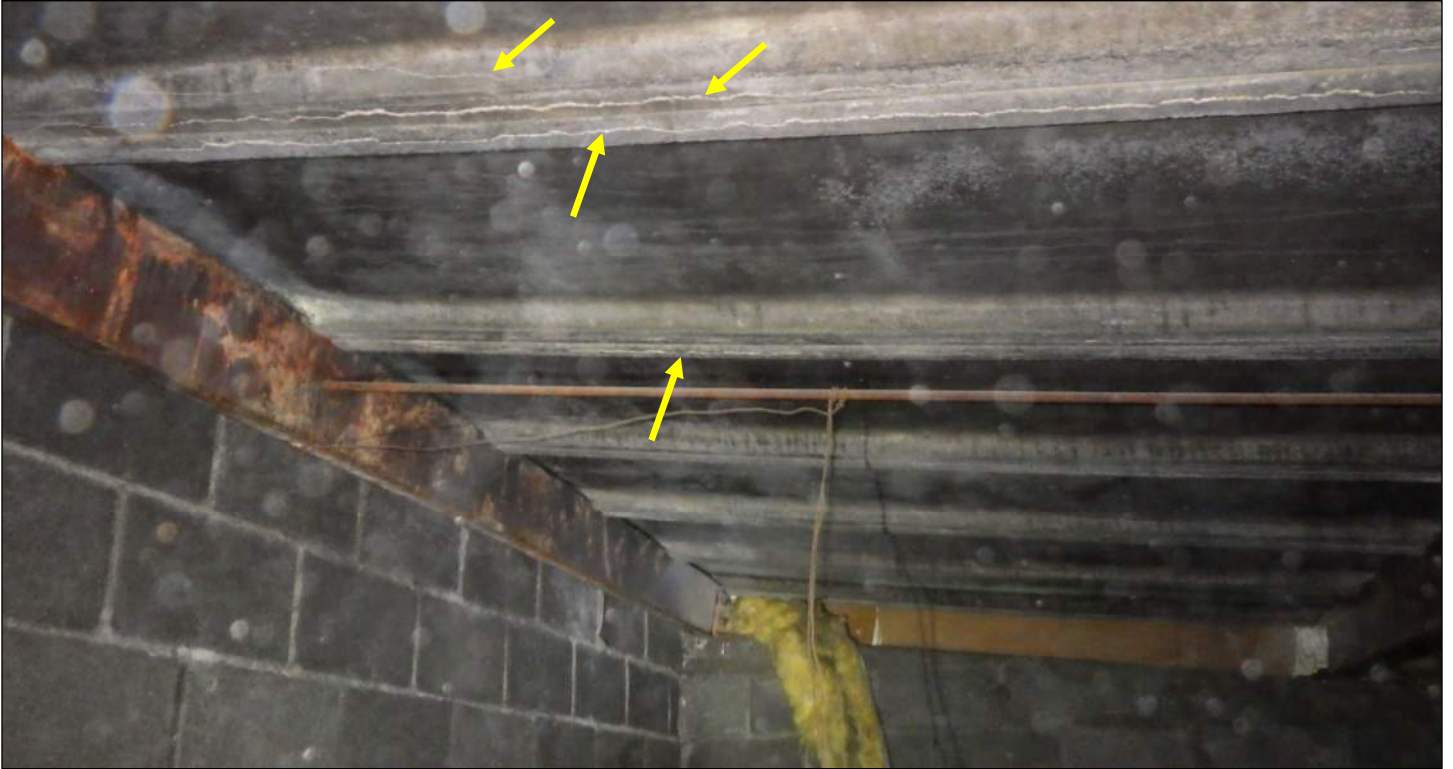
Photo 39: Cracks in flanges of roof panels.

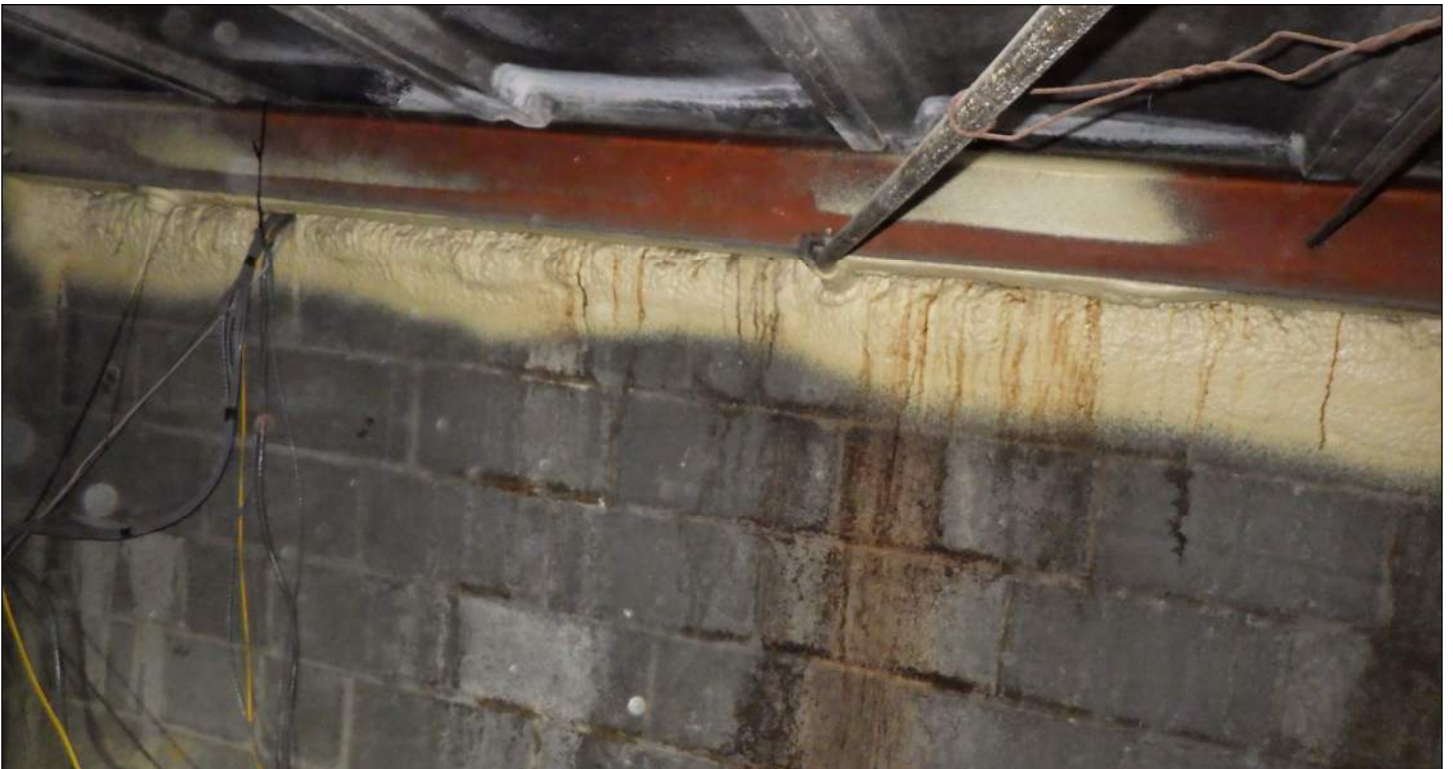
- ii. Moisture stains were observed on the face of the CMU along the south wall of the attic (Photo 40).

Photo 40: Moisture staining on CMU along south wall of attic.

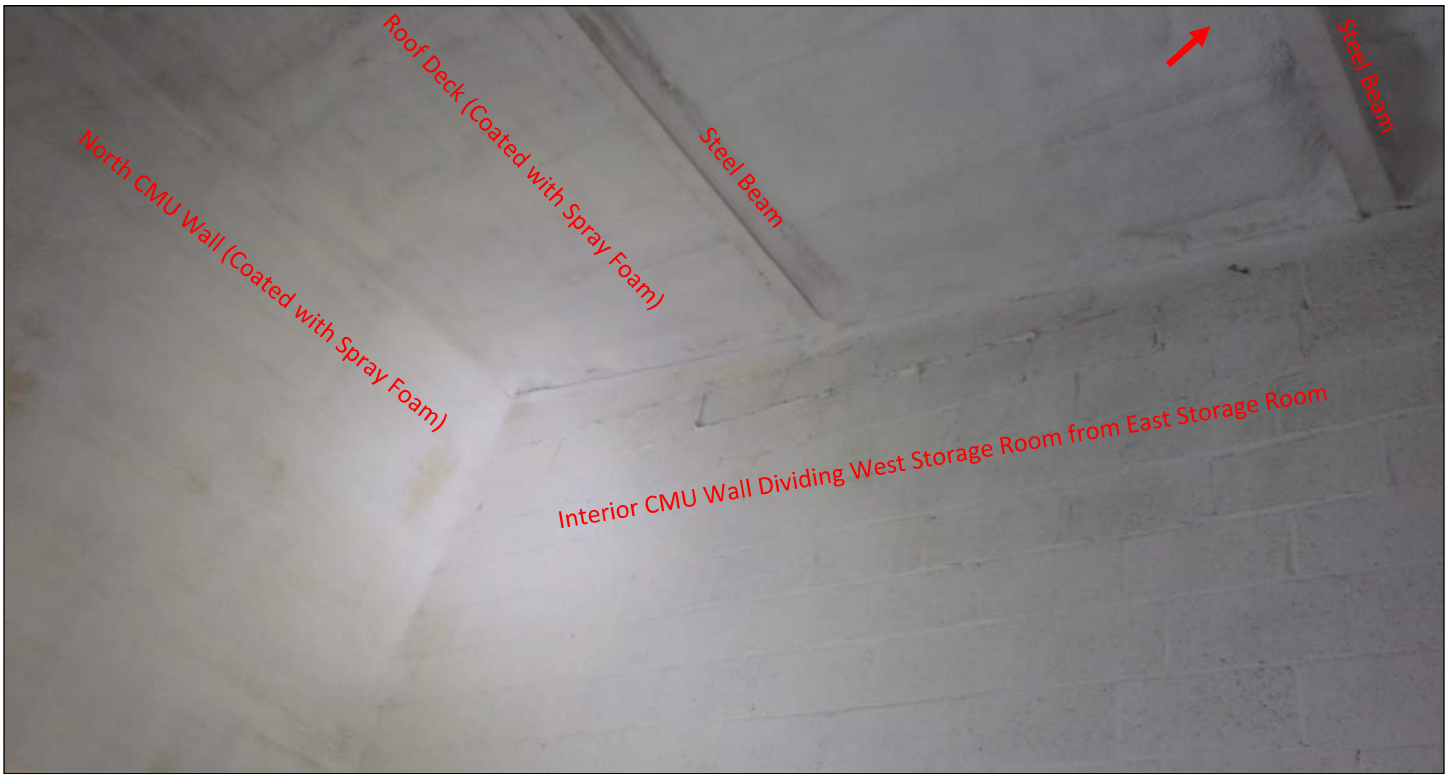
- 8. The storage areas consisted of two rooms, with a CMU wall dividing the space into an east storage room and west storage room. The structure consisted of roof deck, steel roof beams, and CMU walls. The roof deck, exterior north wall, and the exterior east wall had been fully covered with spray foam (Photos 41 through 45). A portion of the CMU wall dividing the office space from the west storage room had also been coated in spray foam (Photo 44).
  - a. The roof deck was not visible from below as it was fully covered with spray foam; however, moisture stains were observed on the spray foam throughout the roof deck (Photos 41 through 45).
  - b. Rust spots were observed on the bottom flanges of the roof beams (Photos 41 through 45).
  - c. Moisture stains were observed on the spray-foamed north exterior CMU wall and east exterior CMU wall (Photos 41 through 45).

- The roof deck over the storage areas was concealed by the spray foam coating; however, based on spacing of the roof beams and location of the storage areas (also along north exterior wall), it is assumed that the roof structure over the storage areas matched that over the office area. Moisture stains were observed throughout the spray foam on the underside of the roof deck and rust spots were observed on the exposed portions of the roof beams. Therefore, it is likely that the majority of the concrete roof panels above this area (presumably approximately 48 panels) are in a deteriorated condition due to long-term exposure to moisture.

Photo 41: Overview of west storage room, looking up and to the northeast. Note moisture stains on roof deck and north CMU wall.

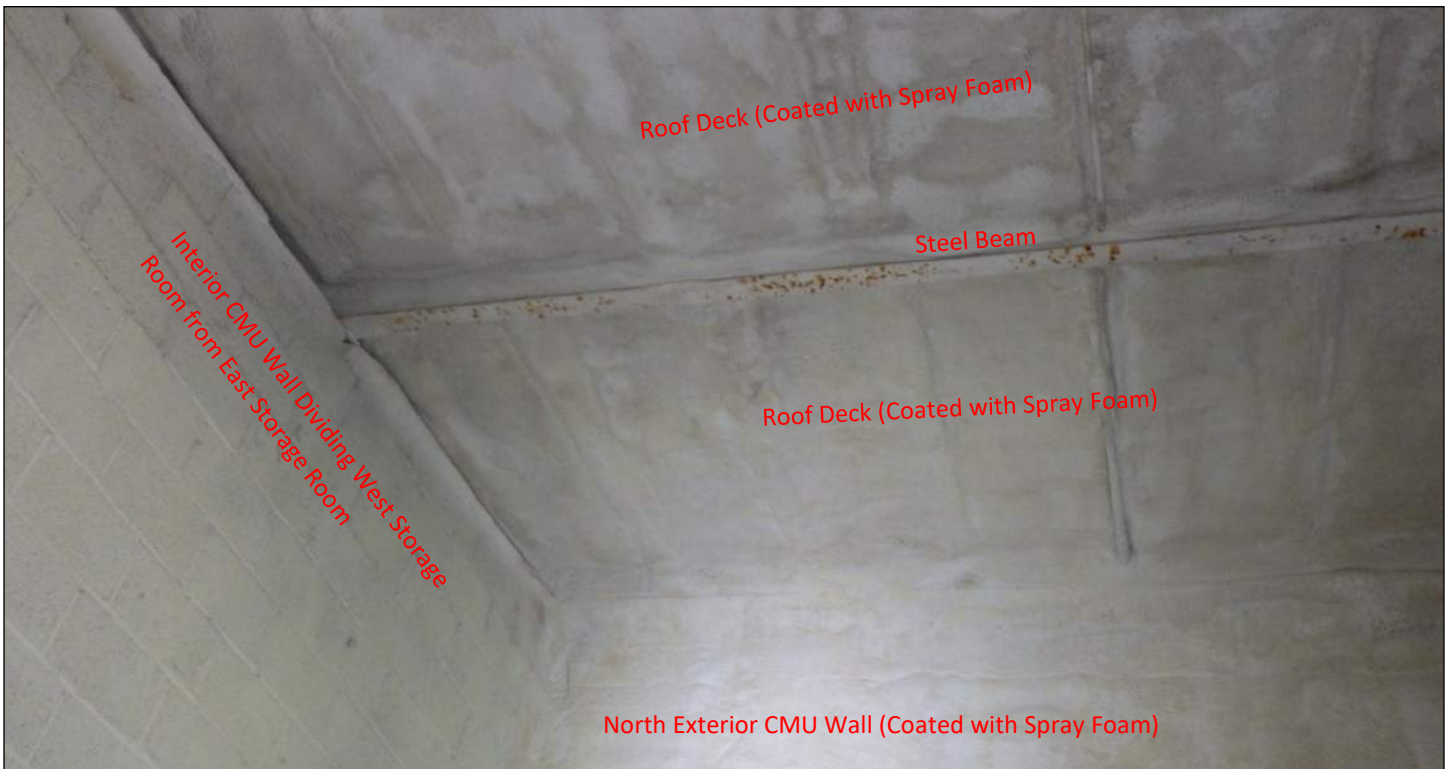
Photo 42: Overview of east storage room, looking up and to the northwest. Note moisture stains on roof deck and north CMU wall. Also note rust spots on steel roof beam.

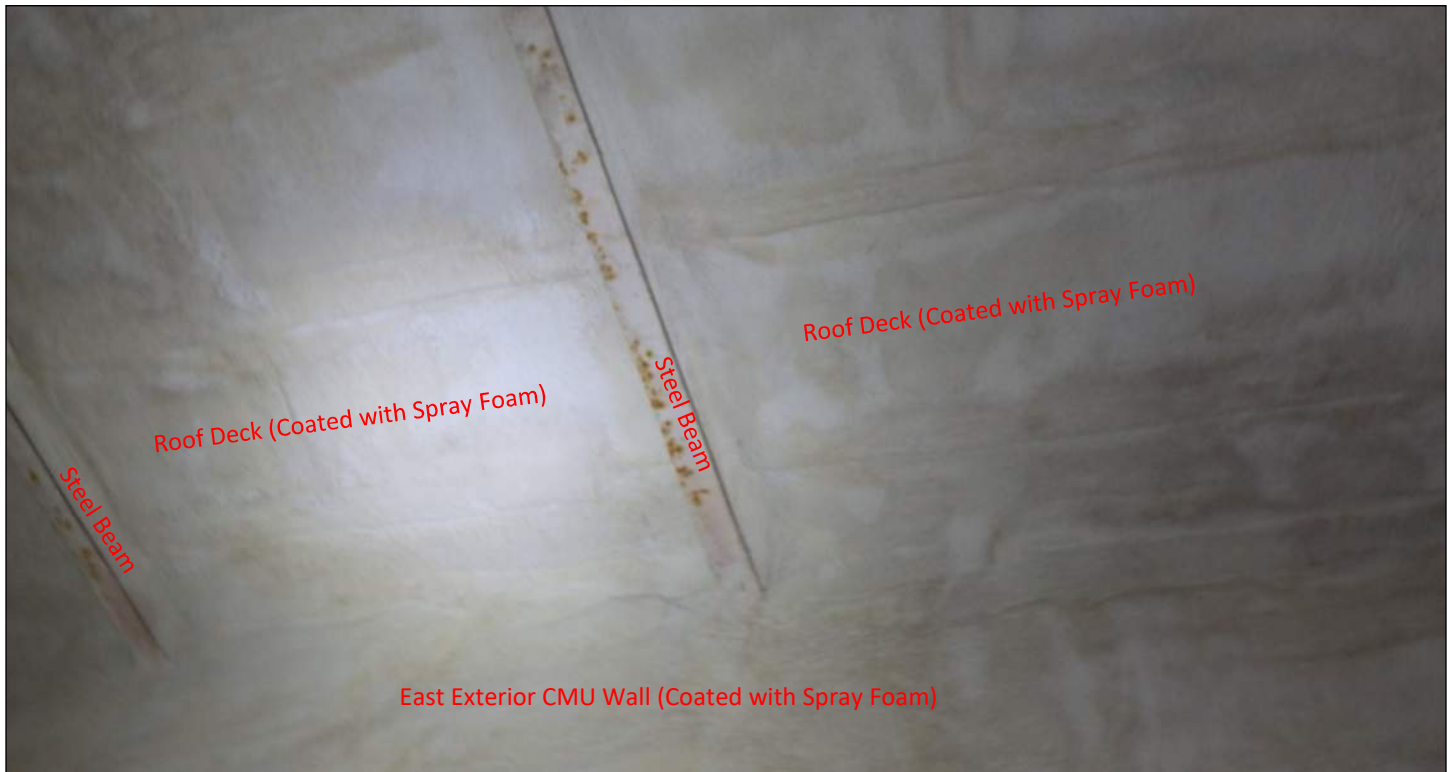
Photo 43: Overview of east storage room, looking up and to the east. Note moisture stains on roof deck and north CMU wall. Also note rust spots on steel roof beam.

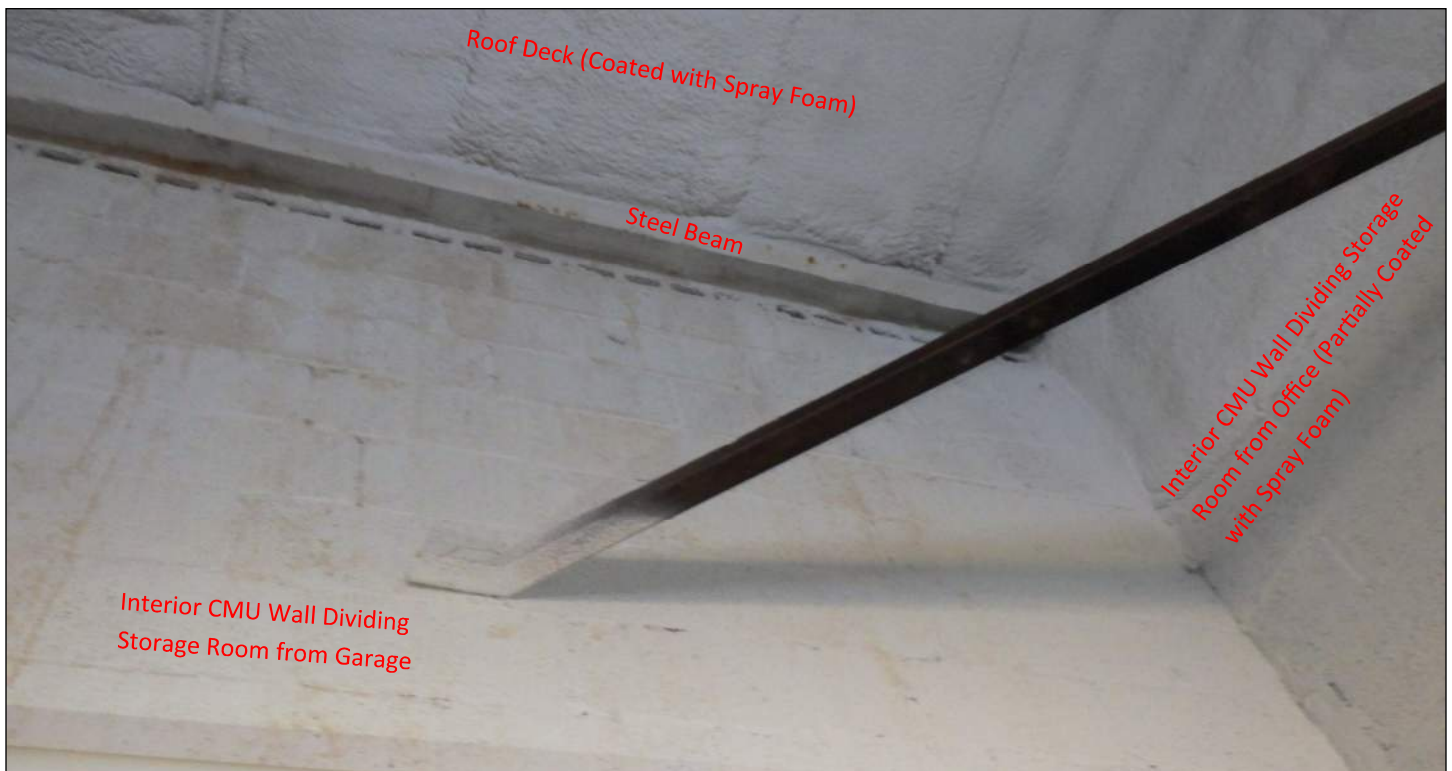
- d. Moisture stains were observed on the south CMU wall dividing the storage rooms from the garage (Photos 44 and 45).
- e. A thin vertical crack was observed in the CMU wall separating the east storage room from the garage (Photo 45). The edges of the crack were rounded and there was paint observed within the crack, indicating it had not formed recently.

Photo 44: Overview of west storage room, looking up and to the southwest. Note moisture stains on south CMU wall. Also note rust spots on steel roof beam.

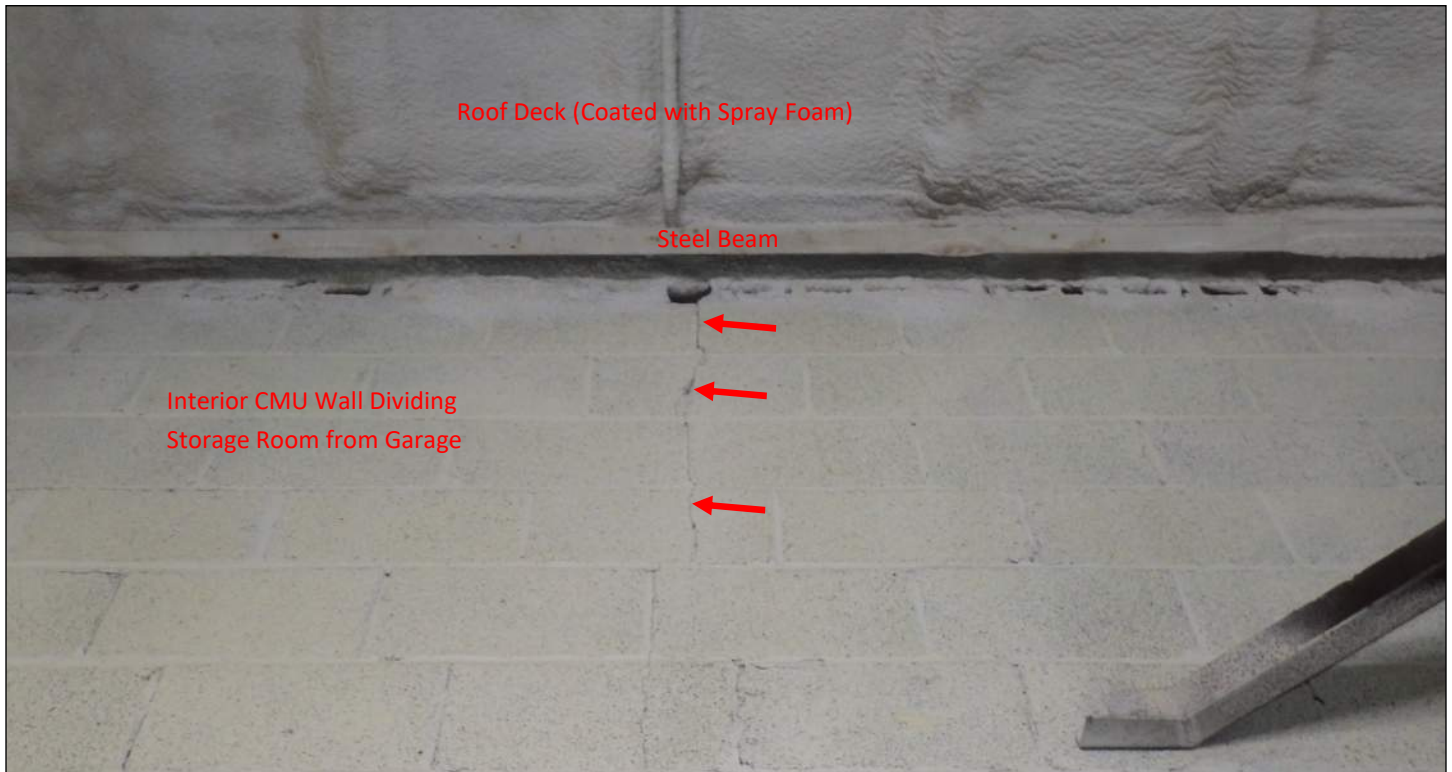
Photo 45: Overview of east storage room, looking up and to the south. Note vertical crack in CMU (arrows). Also note moisture stains on roof and rust spots on steel roof beam.

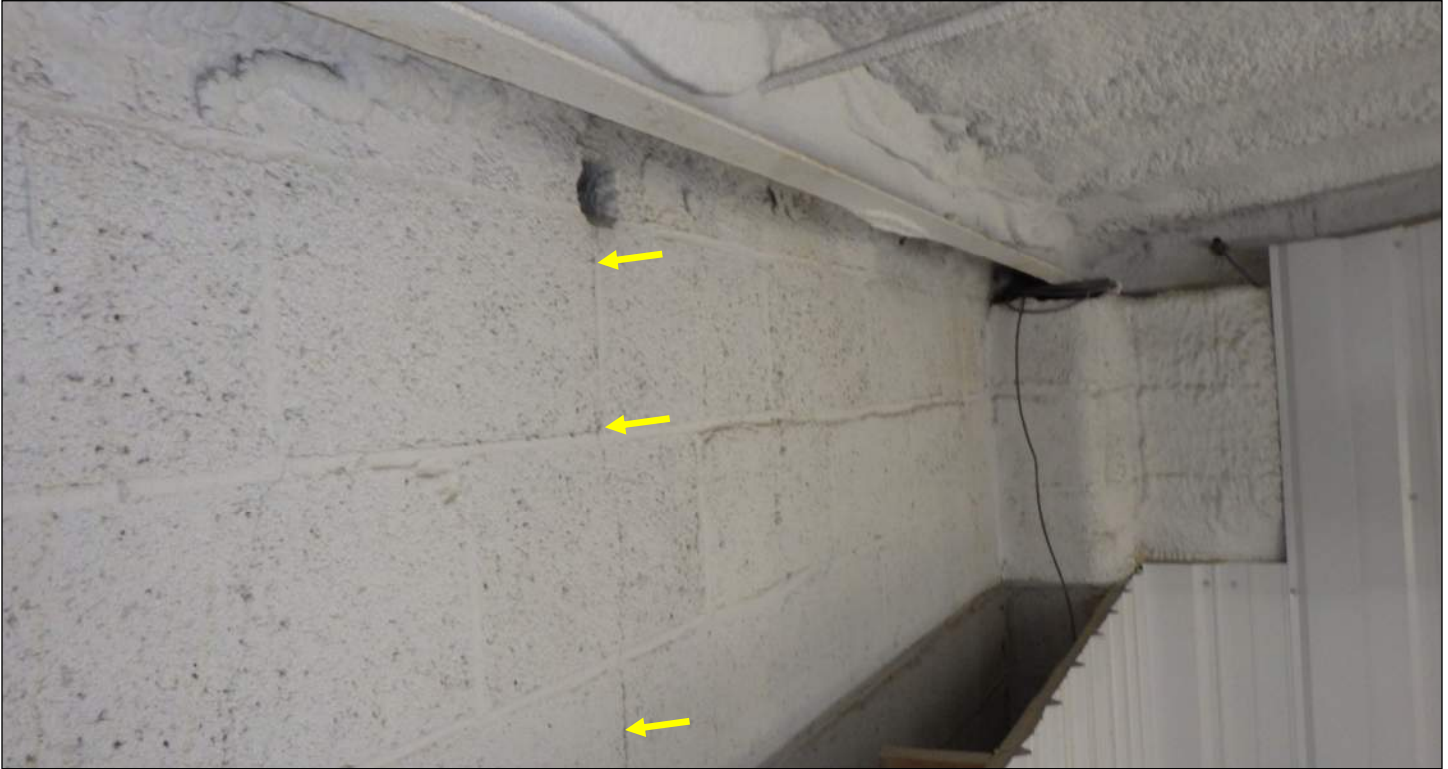
- c. The CMU pilasters and walls were mostly concealed by interior metal wall panels and spray foam (Photos 52 and 53). Where not spray foamed, the CMU did not exhibit any sizeable cracks or spalls (Photos 54 through 56); however, one thin crack was observed on the north wall (Photos 54 and 55), opposite of the crack on the north face of the same wall in the east storage room (Photo 45).

Photo 57: Overview of CMU wall section above metal panels. Note thin vertical crack in CMU that aligns with crack on other side of wall in east storage room (reference Photo 45).

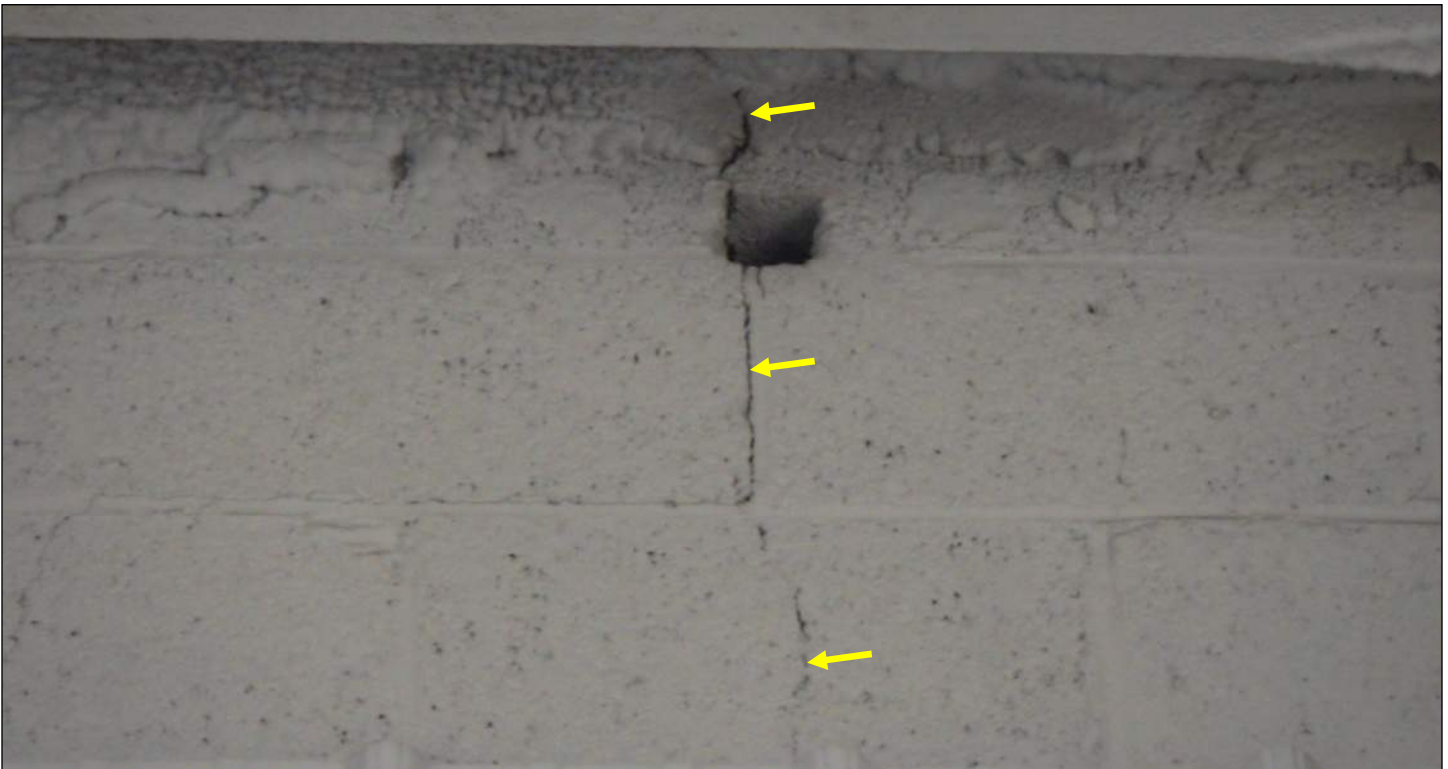
Photo 58: Closeup of crack shown in previous photo. Note rounded edges of CMU along crack and paint within crack.

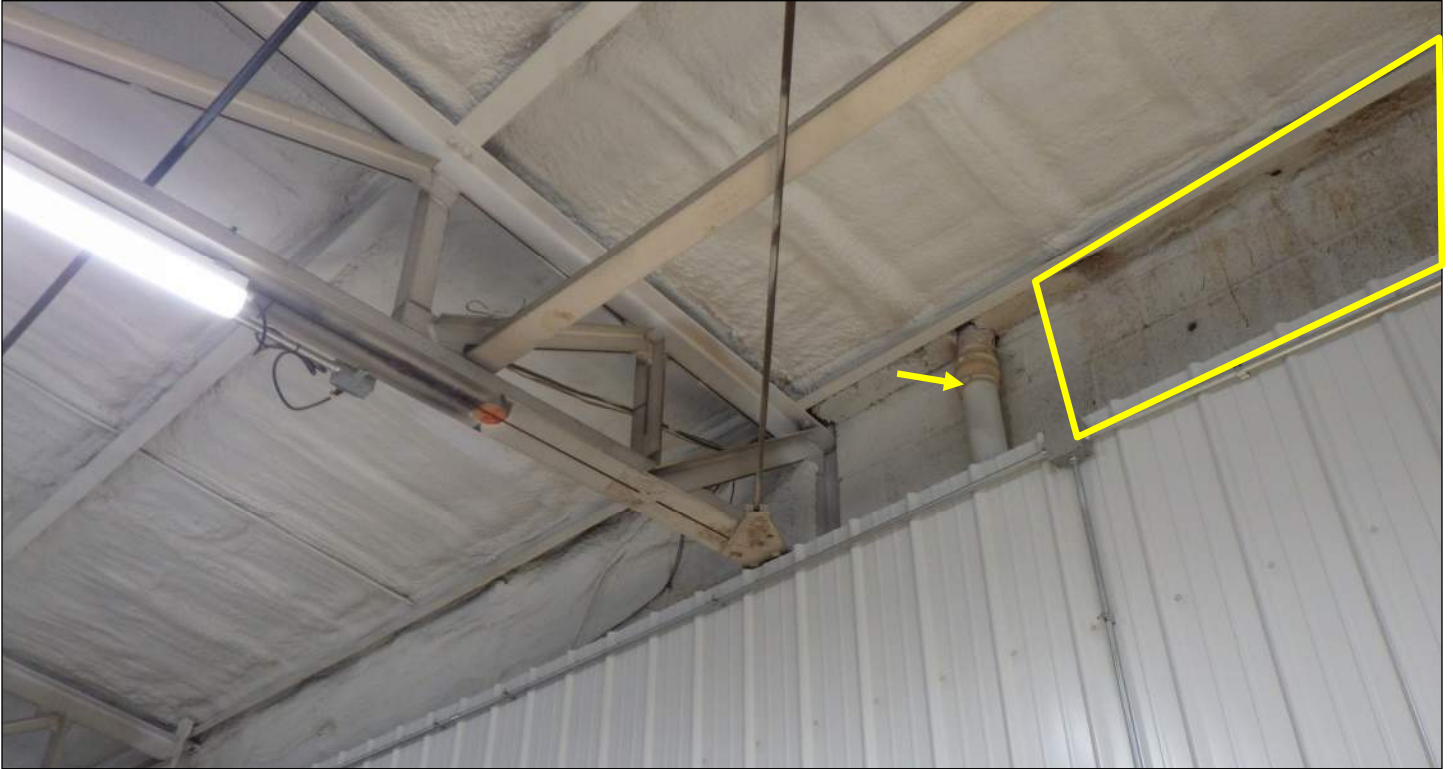
- d. Moisture stains were observed on the north CMU wall at roof drain locations (Photos 59 and 60).

Photo 59: Moisture staining on north CMU wall (box outline), adjacent to roof drain (arrow).
