Re: Noble County Highway Department Building – Structural Assessment  
1118 East Main Street  
Albion, Indiana 46701

Project No. 202502329

## **PHOTOGRAPHS**

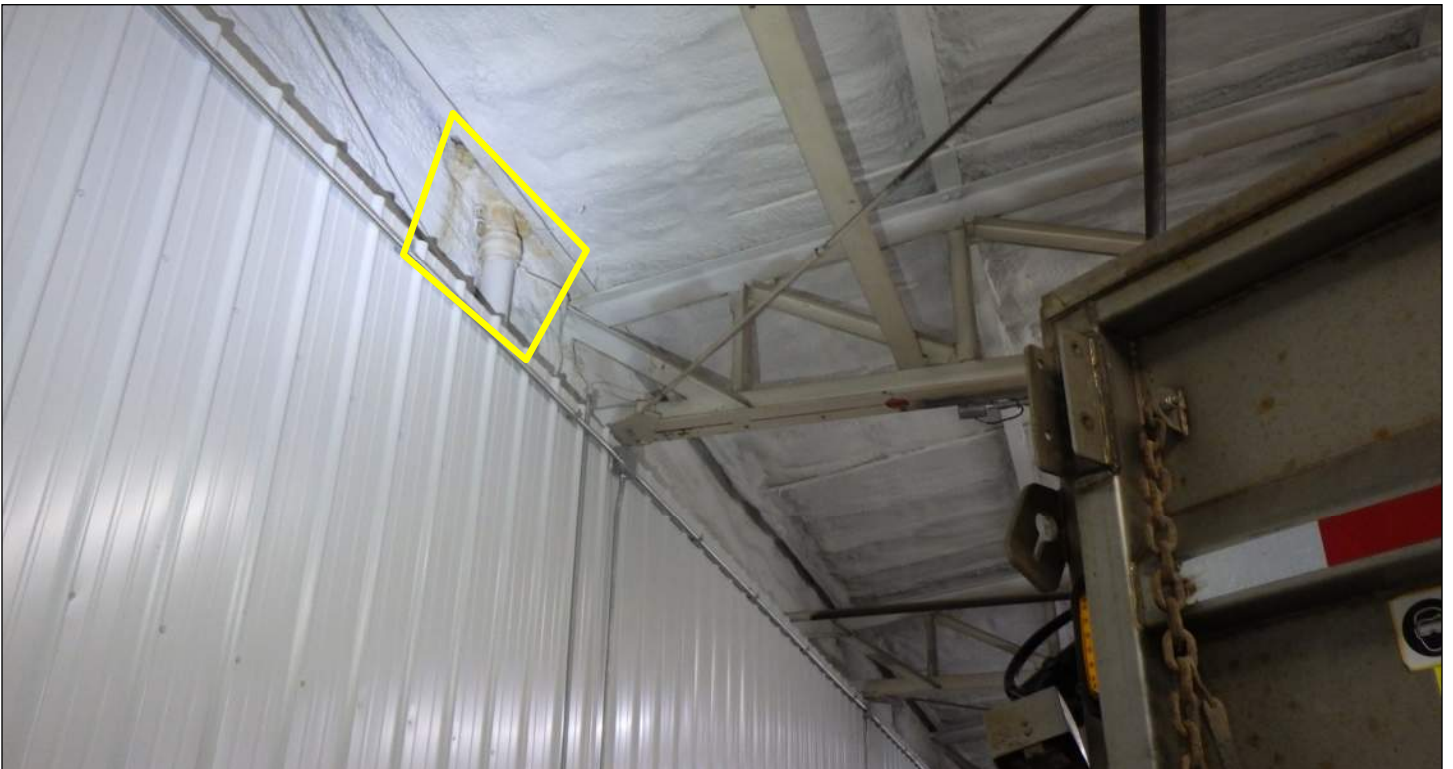
- d. Moisture stains were observed on the north CMU wall at roof drain locations (Photos 59 and 60).

Photo 60: Moisture staining on north CMU wall (wall coated in spray foam) at roof drain.

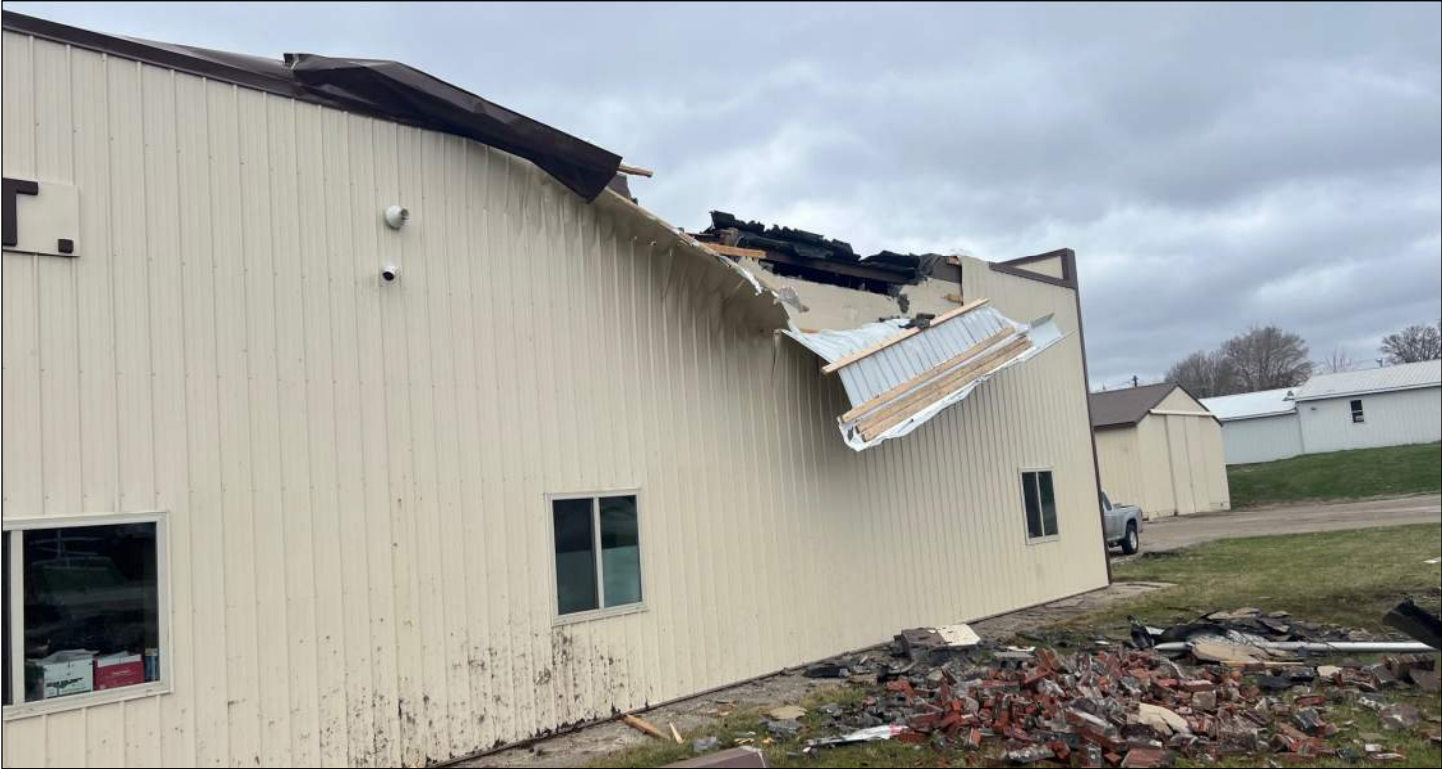
Image 3: Closeup of north wall storm damage.

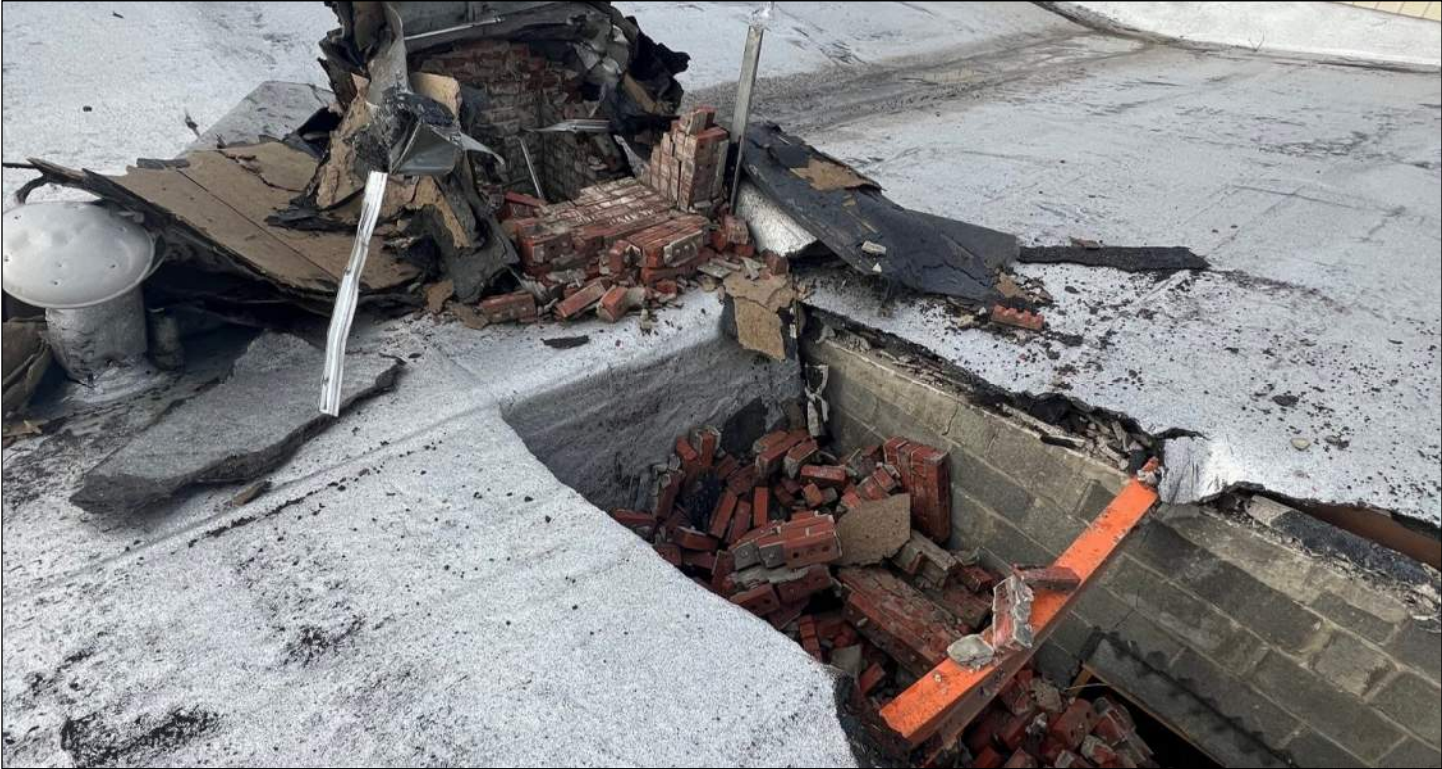
Image 5: Closeup of roof storm damage.
