# Geomorphic Reconnaissance for Channel Stability Management

## Peterson Ditch

Kosciusko County, Indiana

January, 1999

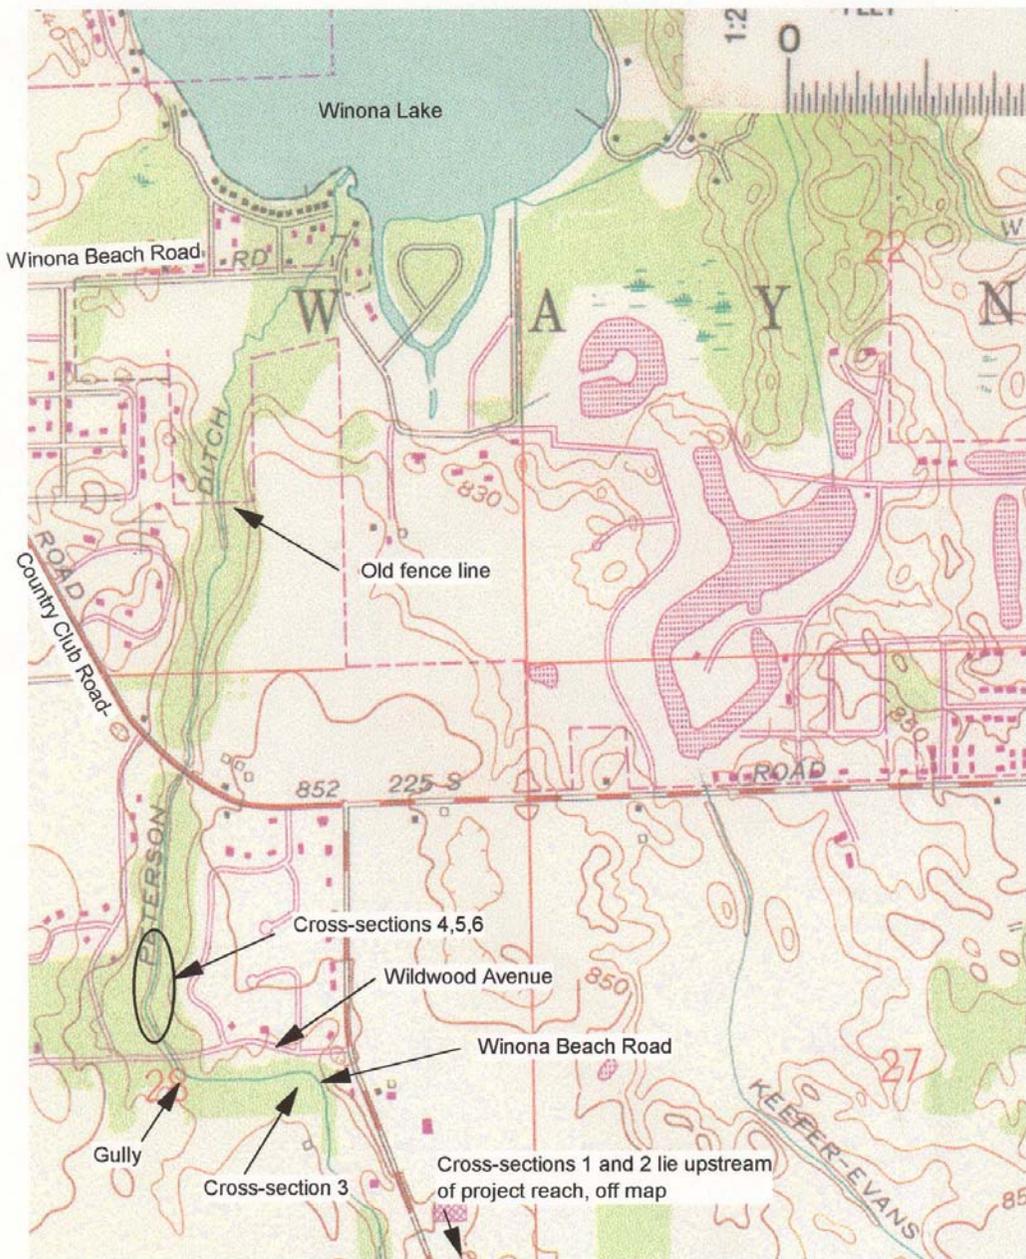
Figure 1. Location map, Peterson Ditch, Kosciusko County, Indiana from Warsaw 7.5' quad map, 1957, revised 1981, 1994

Additionally, I located a gully (noted on Figure 1) entering the upper end of the project reach. Such gullies can produce large quantities of sediment.

Ongoing channel dredging upstream of the project reach greatly disturbs channel stability and may be a manageable source of sediment. Additionally, sediment from farmland erosion, especially from rowcropped areas and gullies entering Peterson Ditch, is likely a more significant source of sub-sand-sized particles. These sources should be identified and managed if possible.

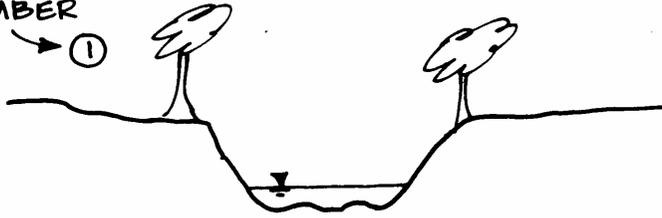
①

DOWNSTREAM OF  
300 S. BRIDGE

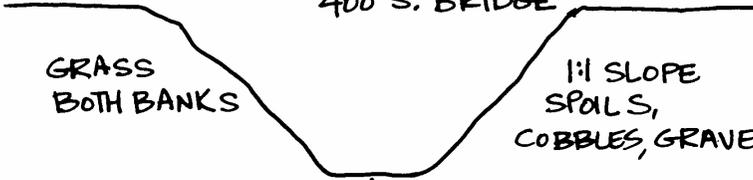
②

DOWNSTREAM OF  
400 S. BRIDGE

GRASS  
BOTH BANKS

1:1 SLOPE  
SPILLS,  
COBBLES, GRAVEL

COBBLES, BOULDERS

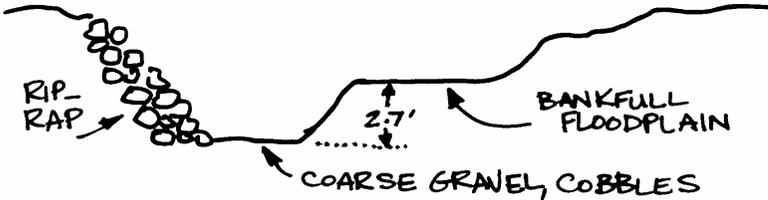
③

constructed channels that provide no flood storage. I found clearly expressed bankfull floodplain surfaces at points in the project reach. These surfaces have formed at elevations averaging 2.5 feet above the channel bed. My rough calculations of the bankfull discharge show it to have a value of about 110 cfs with an average velocity of about 2.5 feet per second (fps). Cross-sections 3 and 6 (at the end of this report) show typical bankfull floodplain morphology.

MOWN GRASS

RIP-  
RAP

BANKFULL  
FLOODPLAIN

COARSE GRAVEL, COBBLES

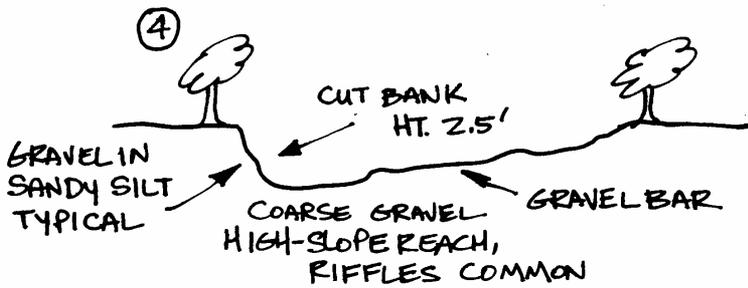
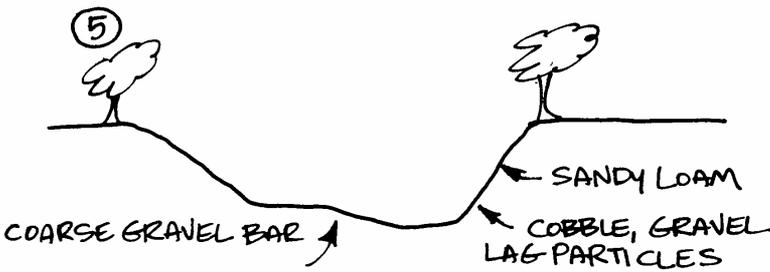
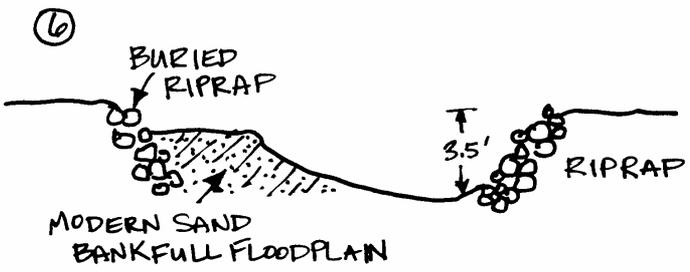
CROSS SECTION SKETCHES  
PETERSON DITCH  
NOVEMBER, 1998  
S. GOUGH

At a few points downstream of Country Club Road, individual landowners have stabilized banks with riprap. Cross-section 6 shows one such section, including a riprap-protected bank over which the channel has deposited a bankfull floodplain composed primarily of sand. At points in this section, landowners have established a ground cover of mown grass at the bank edge. Turf grass is not particularly effective in controlling bank erosion. If possible, these areas should be planted in woody vegetation--either shrubs or trees.

In general, present-day rates of bank erosion appear to be very low throughout the project reach. The channel has obviously meandered as it has recovered from past channelization, but lateral movement of cutbanks has been accompanied by floodplain building on point bars, as is typified by cross-section 6 – as the channel moves, a bankfull floodplain is typically built on the opposite bank. This balances the sediment budget for the reach, i.e. there is no net export of sediment. There may be some “substitution” of sediment, i.e. eroded silty soils in cutbanks may be exchanged for coarser sand. However, because bank erosion rates are obviously low, as are bank heights (usually < 3.0 feet), the potential for sediment production is not significant with respect to lake water quality impairment. Perhaps more importantly, this channel probably nearly as stable as it could possibly be (short of lining it with concrete), meaning that widespread application of bank protection measures would have little effect and might even result in an increase in fine sediment production from construction activities.
