**Comprehensive Indiana Forestry Best Management Practices**

**Monitoring Results**

**1996-2016**

**By: Duane McCoy & Jennifer Sobecki**

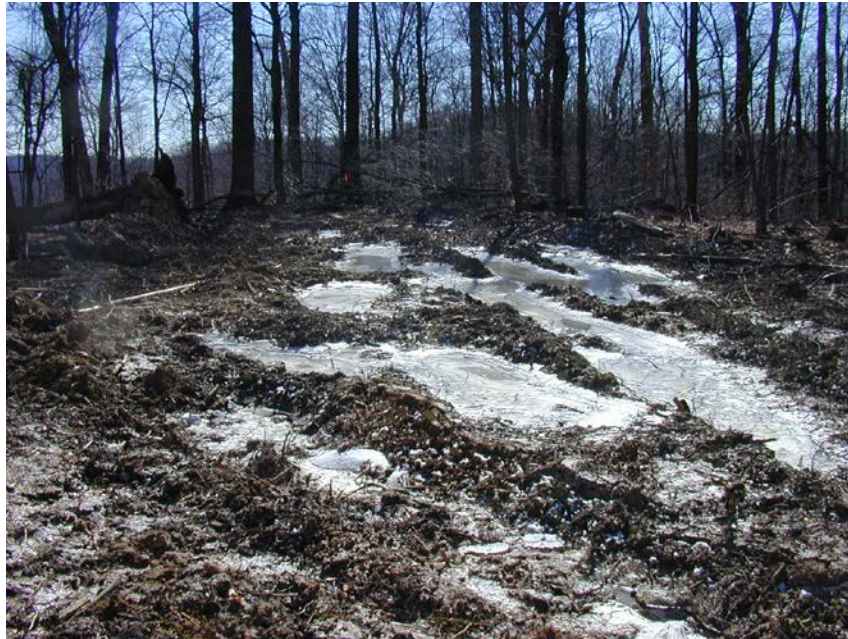
Log landing that was used during a wet period, causing rutting and the site to collect runoff.

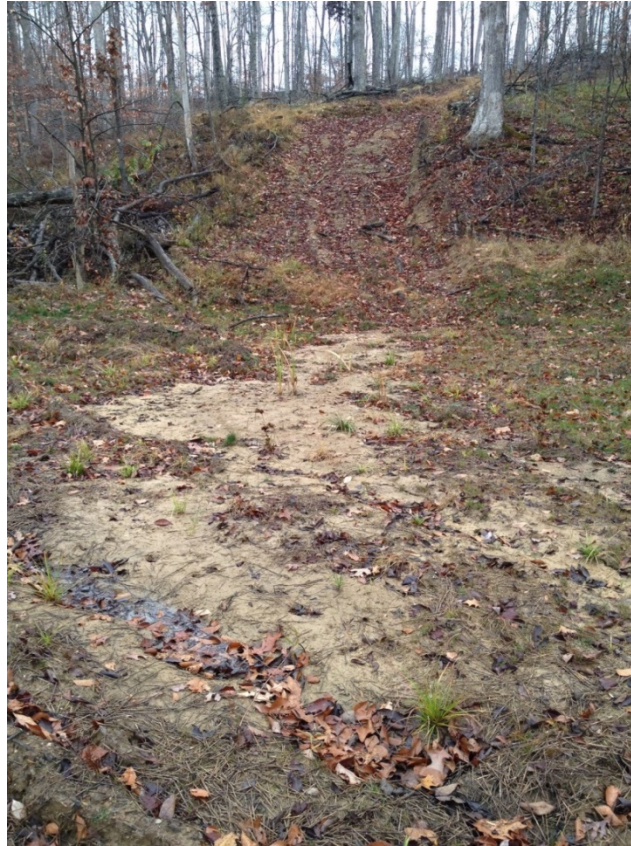
Skid trail not closed out, causing erosion and sediment plume to build up on log yard.

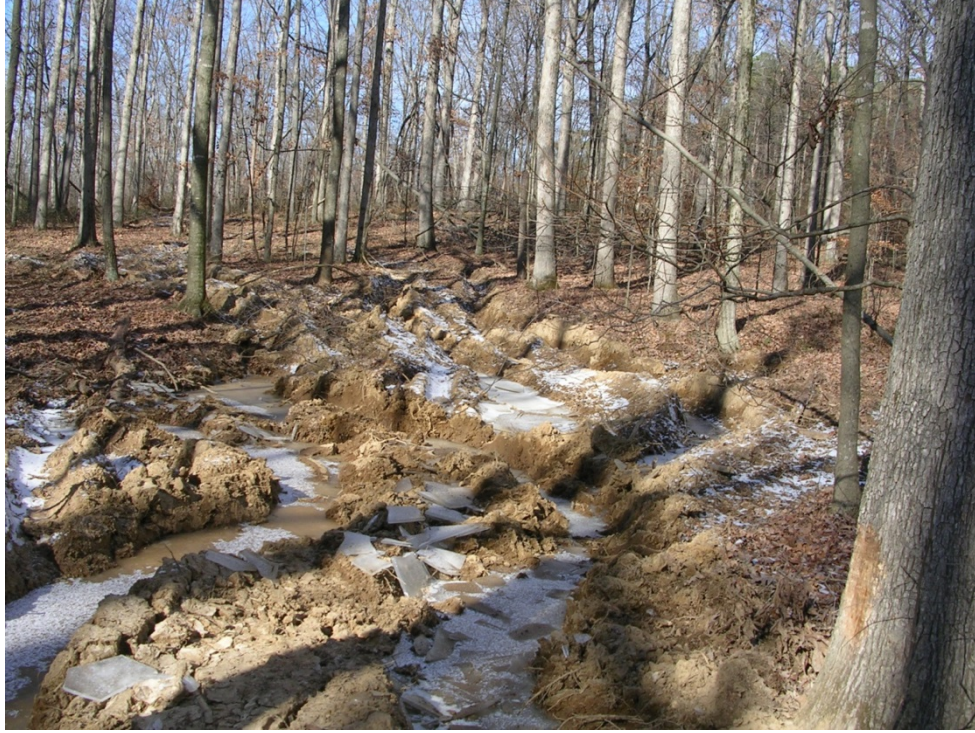
Extreme skid-trail rutting due to operations taking place during wet winter conditions.

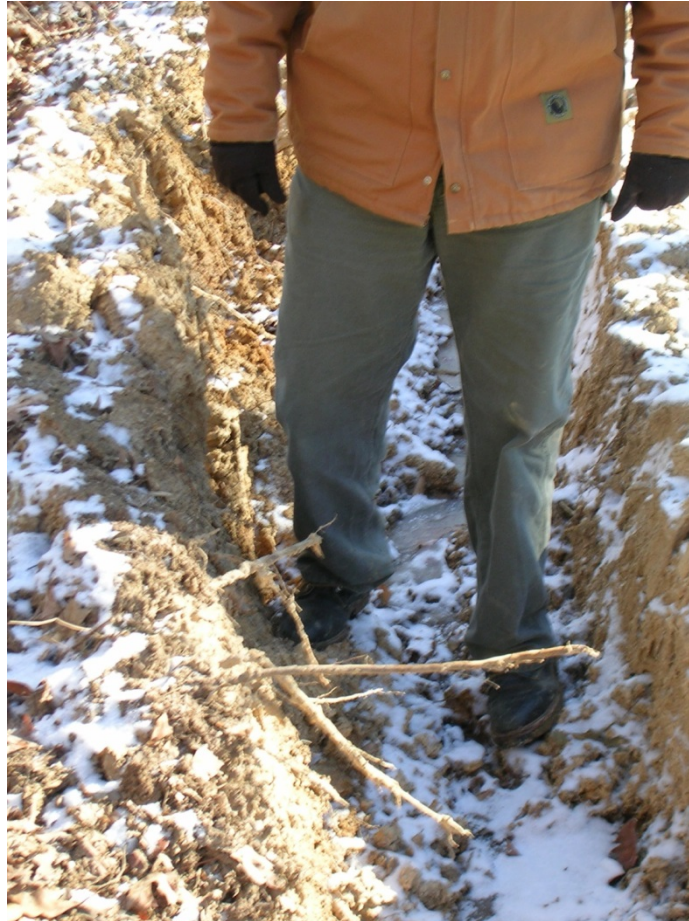
Deep skid-trail ruts, causing tree root damage.

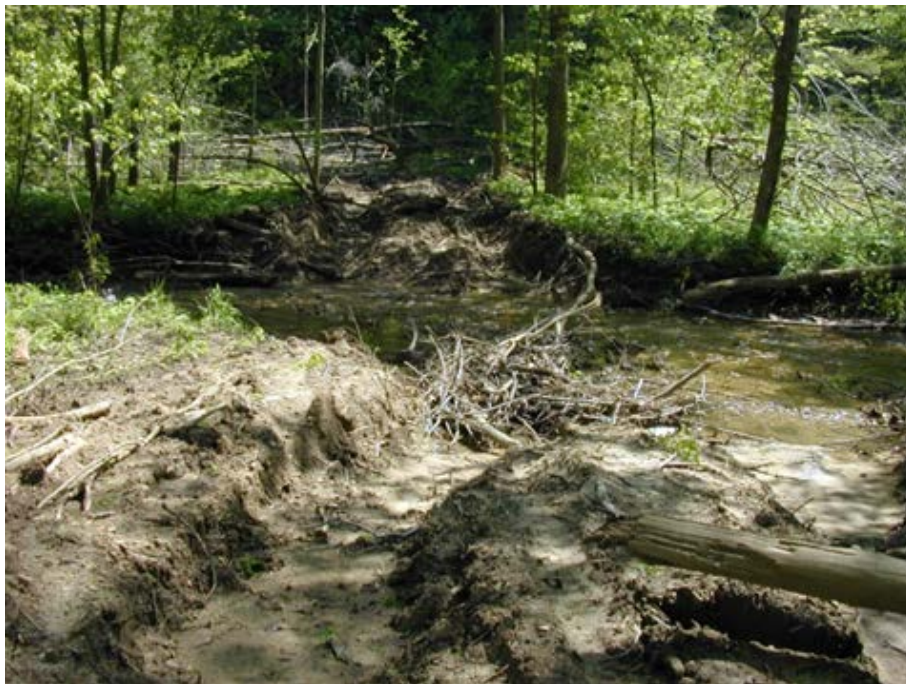
A poorly applied and implemented stream crossing with no attempt to repair.

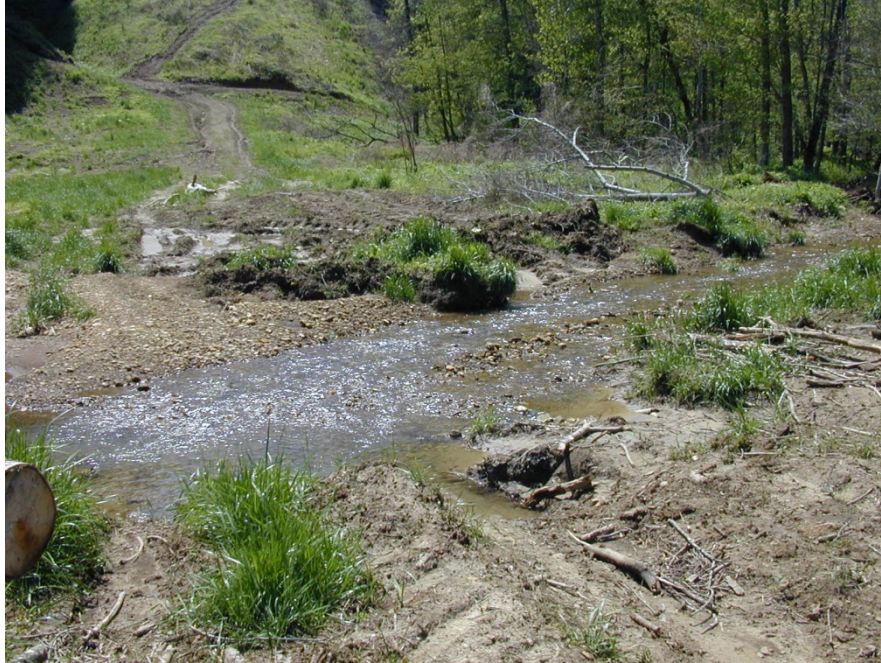
No water diversions before stream crossing. No stream bank stabilization/re-vegetation.

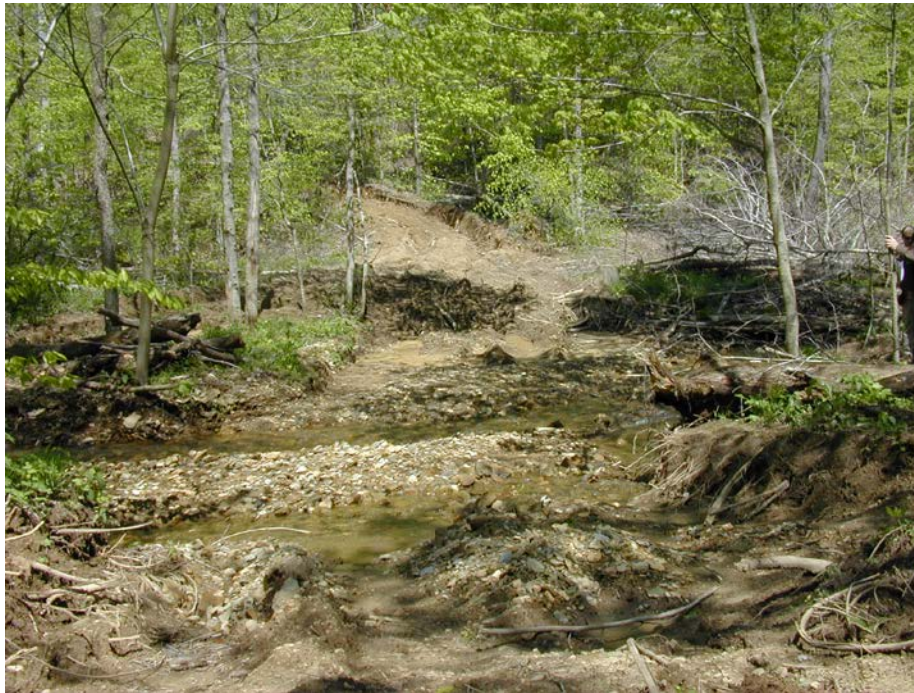
Poorly executed and stream crossing not closed out after harvest completed.

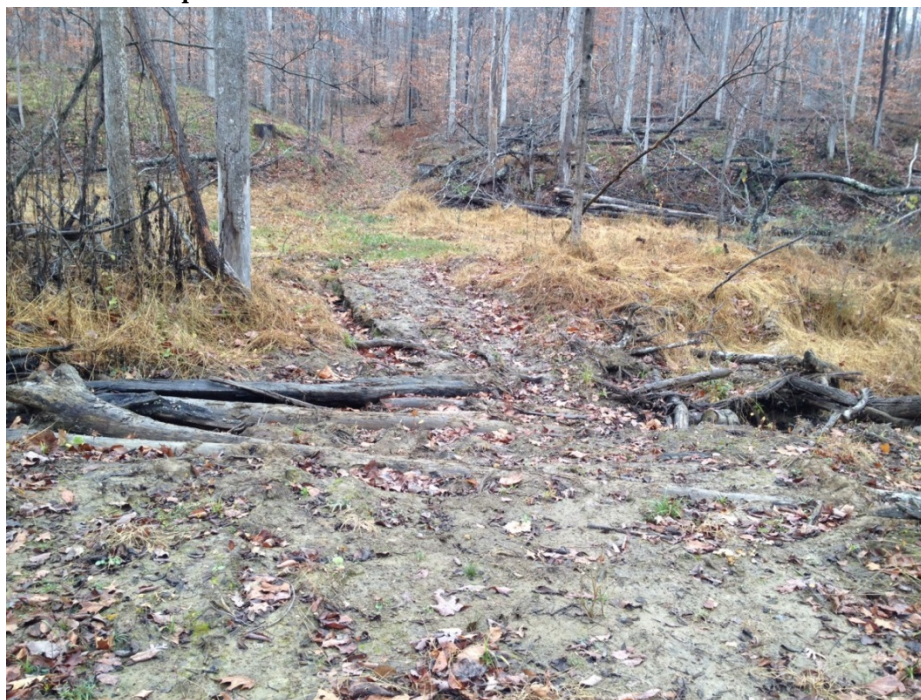
**Corduroy logs and soil left in intermittent stream crossing cause obstruction of flow. Impacts from this kind of BMP departure can lead to sometimes extreme erosion and sedimentation. The stream will reroute itself to find ways around the obstruction. This results in destabilization of the stream banks and bed stream both upstream and downstream of the obstruction.**

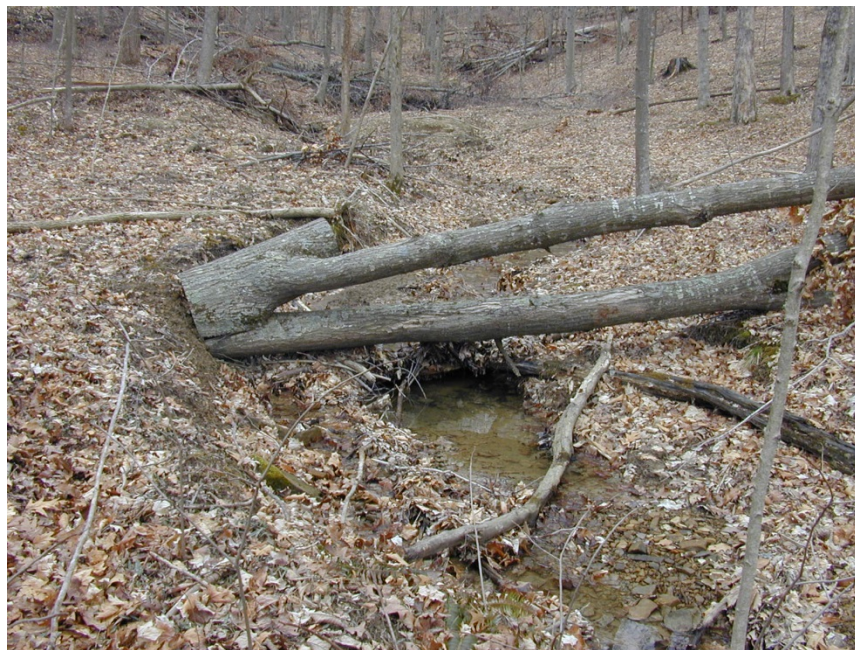
Logging debris in streams can obstruct stream flow, leading to the stream carving a new bank, which results in erosion and sedimentation going directly into the stream.
