PRELIMINARY HISTORIC BRIDGE ALTERNATIVE ANALYSIS REPORT

BUSINESS 37 NORTH OVER BEANBLOSSOM CREEK

Location: 0.1 Miles South of I-69, Monroe County, Indiana BRIDGE FILE #: MONROE NO. 913; NBI #: 5300130

DATE: NOVEMBER 2023

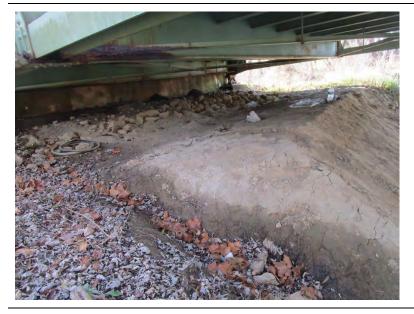
PHOTO 4: TYPICAL FLOOR SYSTEM

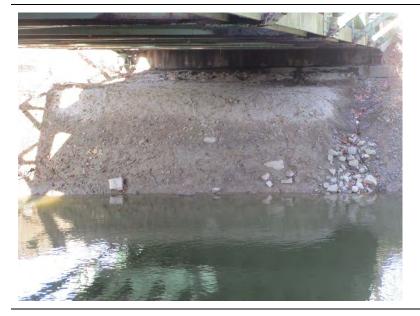
Deficiencies: There is leaking on abutments. Spalling with exposed steel in mud walls at each bridge corner with 3 to 6 inches of section loss. Large spall with loss of bearing at South Abutment.

PHOTO 16: SOUTH ABUTMENT

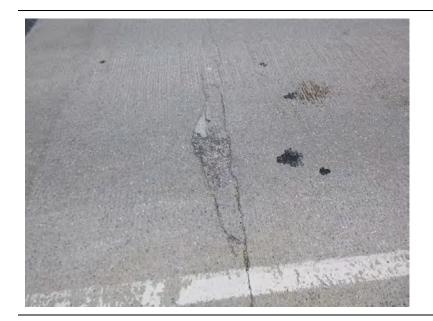
PHOTO 22: OVERLAY SPALL NORTH END

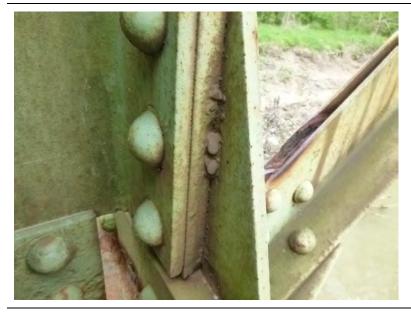
PHOTO 25: TACK WELD SOUTHWEST L3

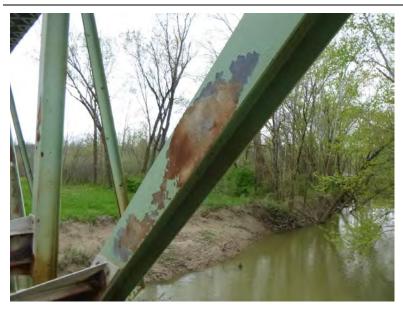
PHOTO 27: L4U3 NORTHWEST PAINT PEELING

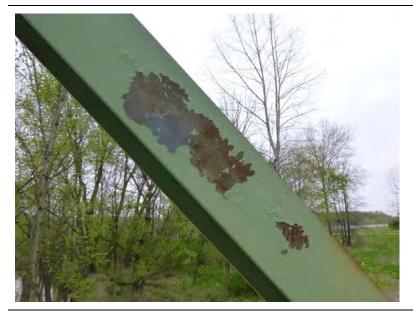
PHOTO 28: L2U3 NORTHWEST PAINT PEELING

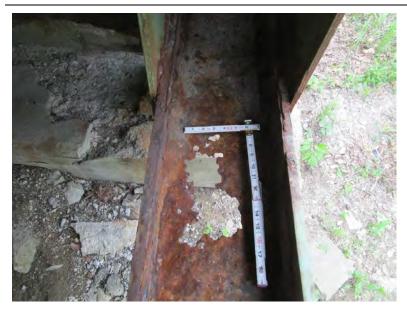
PHOTO 30: MODERATE SECTION LOSS IN WEB AT NELO

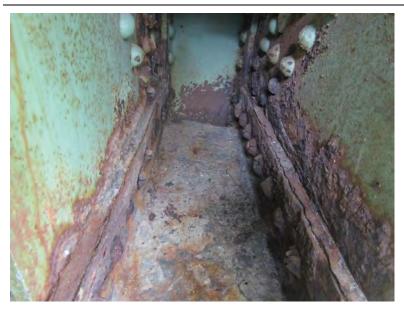
PHOTO 33: EXPANSION RUST AND SECTION LOSS AT NELO

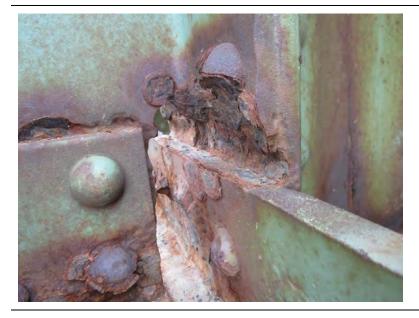
PHOTO 34: SEL1 INTERIOR ANGLE SECTION LOSS

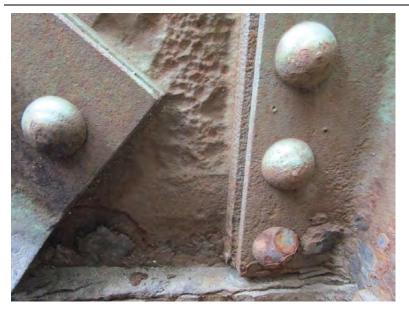
PHOTO 36: SEL2L1 INTERIOR GUSSET PLATE SECTION LOSS AT DIAGONAL END

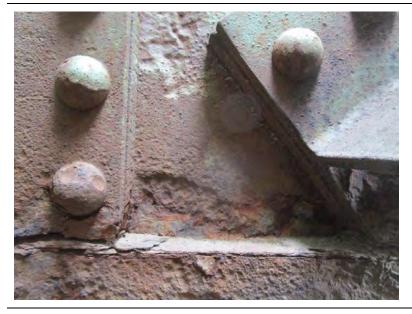
PHOTO 37: SEL2L1 EXTERIOR GUSSET PLATE SECTION LOSS AT DIAGONAL END

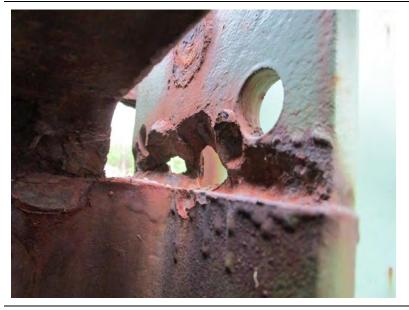
PHOTO 40: NEL1 60% SECTION LOSS ON INTERNAL FLANGE OF VERTICAL

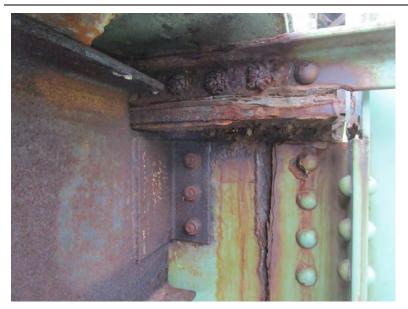
PHOTO 42: TYPICAL FLOOR BEAM DETERIORATION AT TOP FLANGE

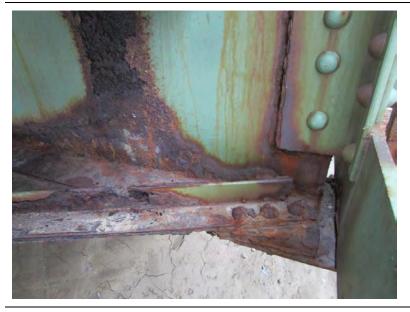
PHOTO 43: TYPICAL FLOOR BEAM DETERIORATION AT BOTTOM FLANGE
