## BRIDGE INSPECTION REPORT

**Bridge Number:** I64-103-04691 C

**Facility Carried:** I-64

**Inspection Date:** 10/01/2009

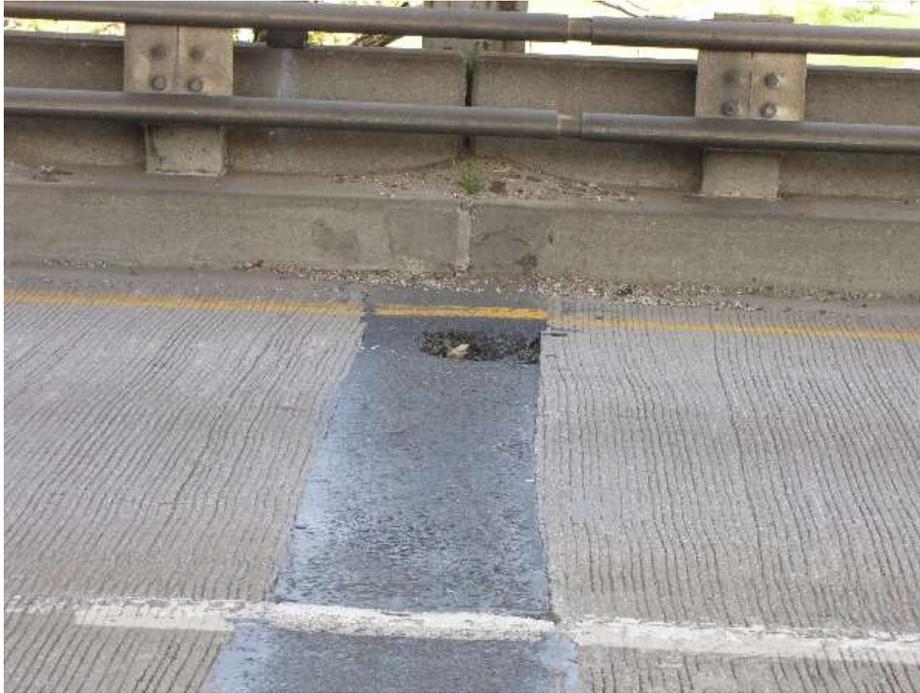
Photo 3  
Bad Joint

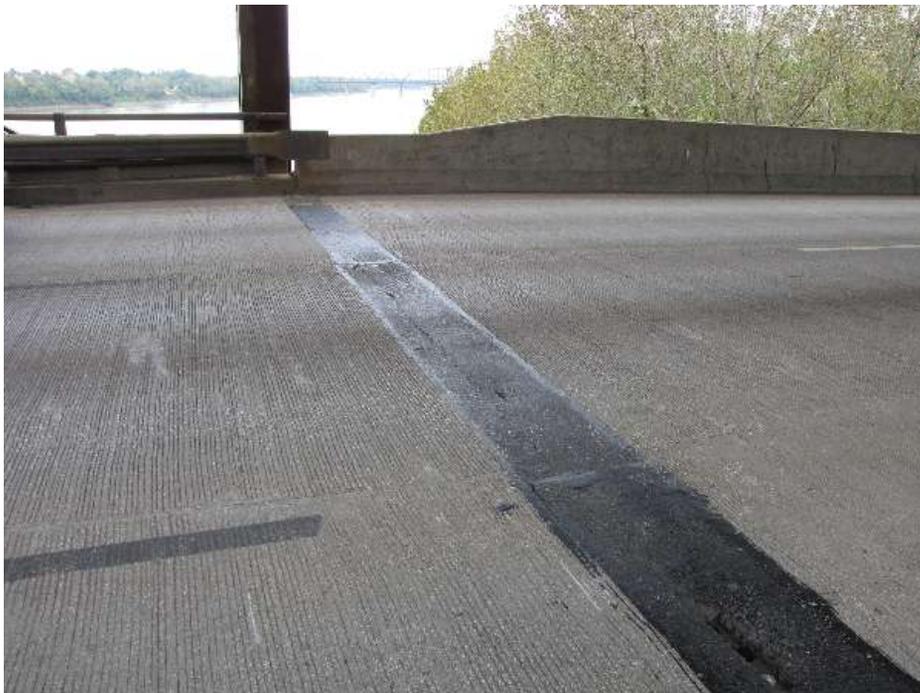
Photo 4  
Bad Joint

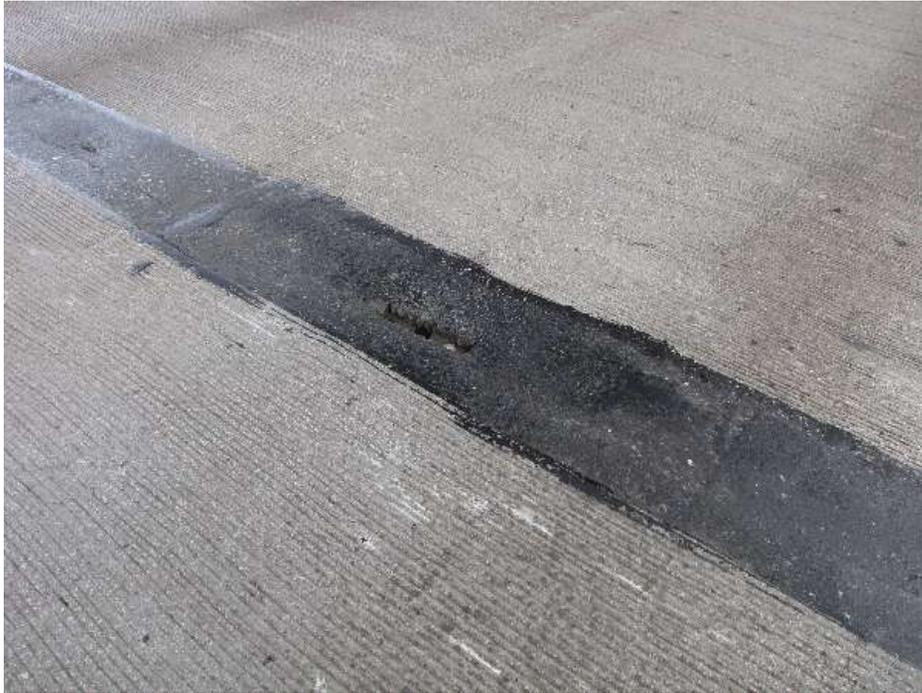
Photo 5

Bad Joint

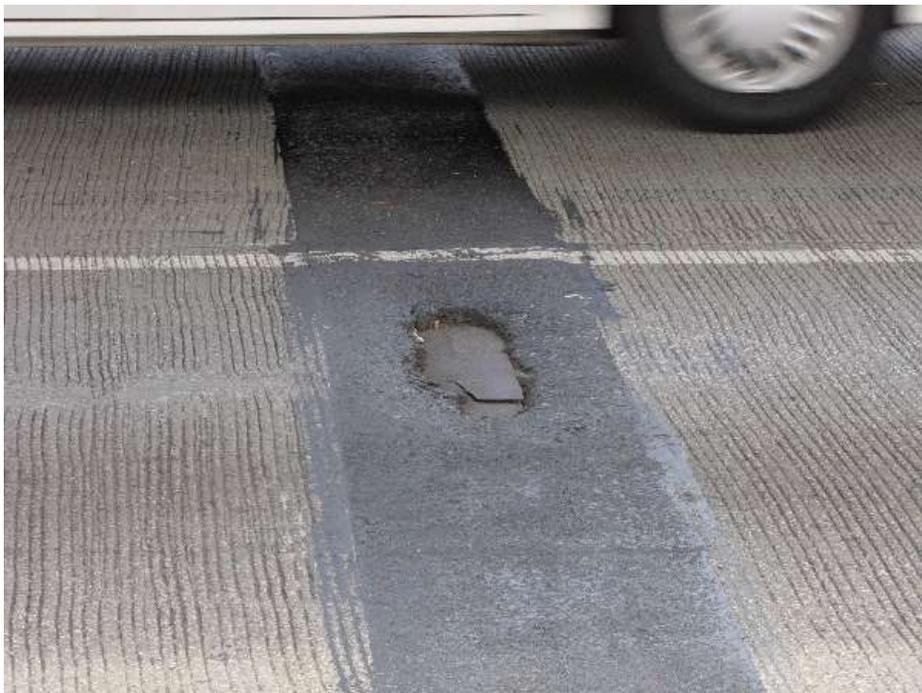
Photo 6

Bad Joint

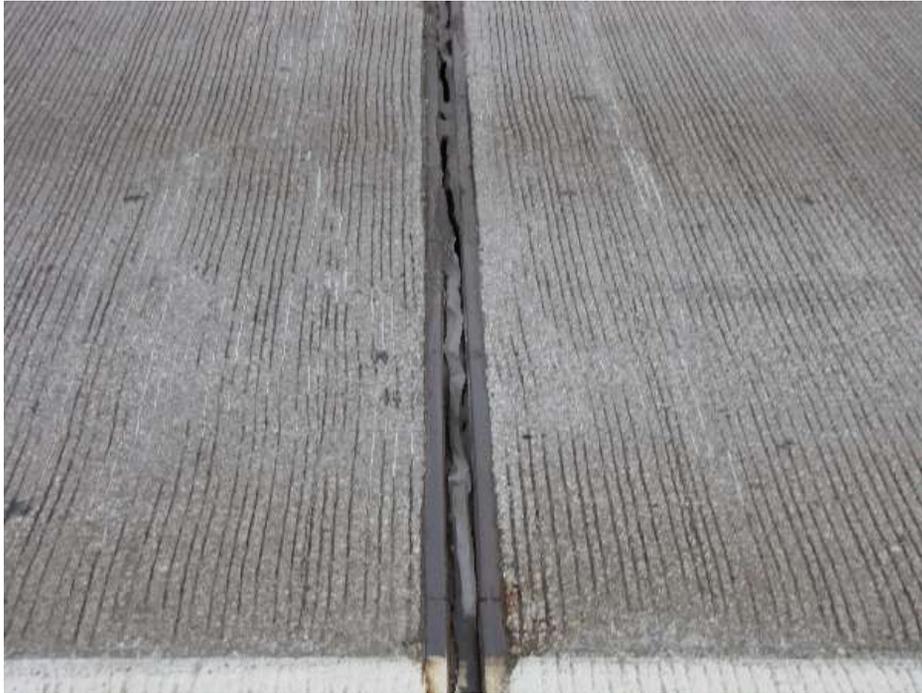
Photo 7

Bad Joint

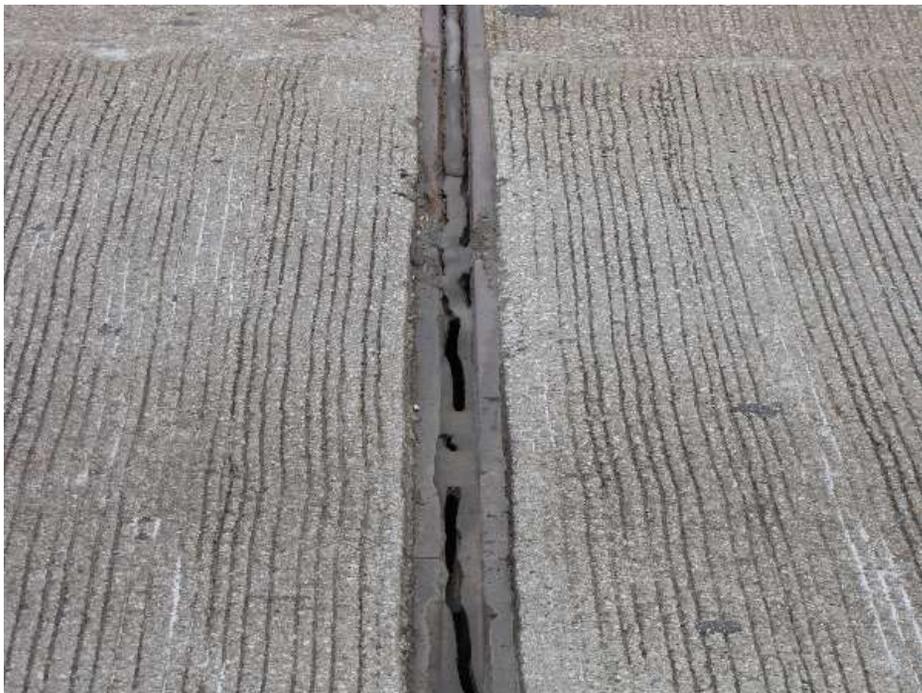
Photo 8

Bad Joint

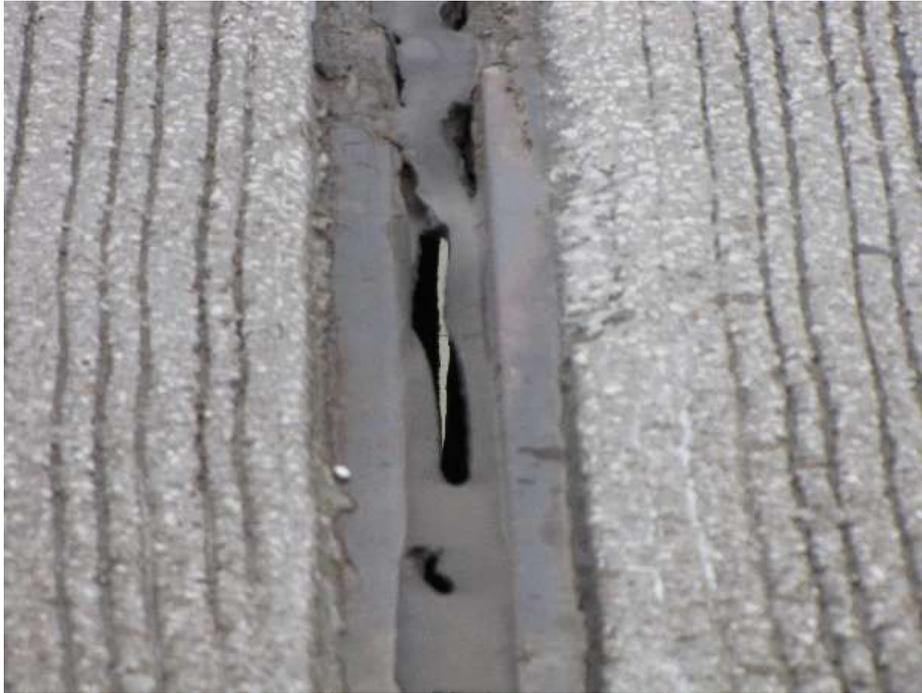
Photo 9

Bad Joint

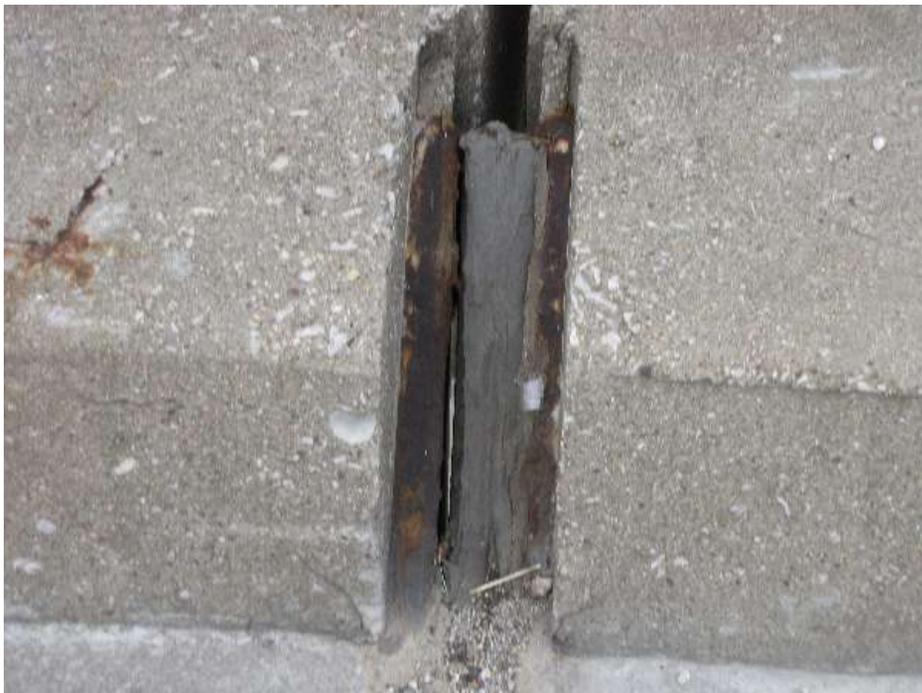
Photo 10

Bad Joint

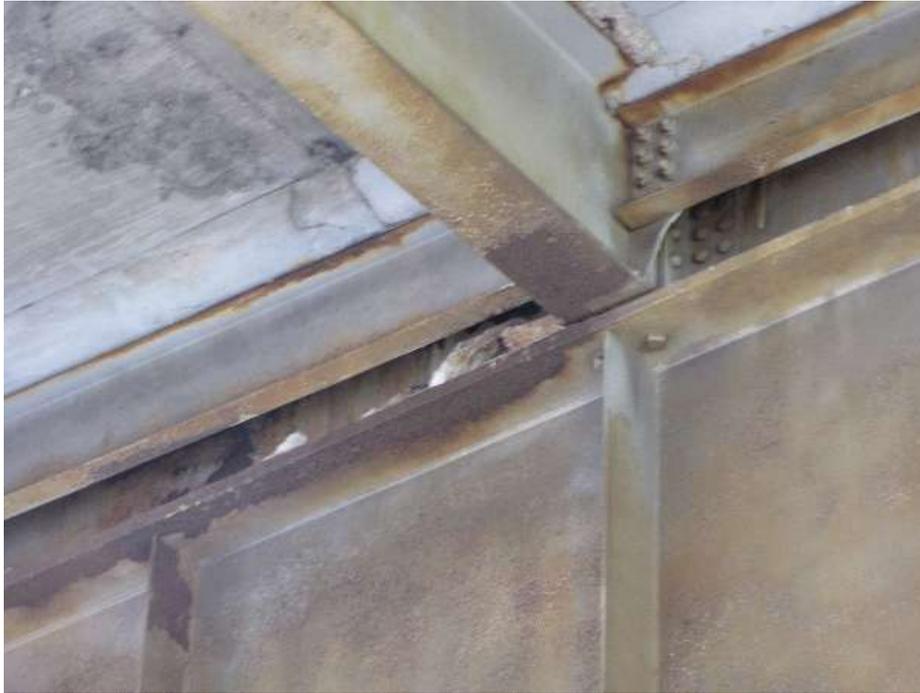
Photo 11

Debris on the Floor Beam

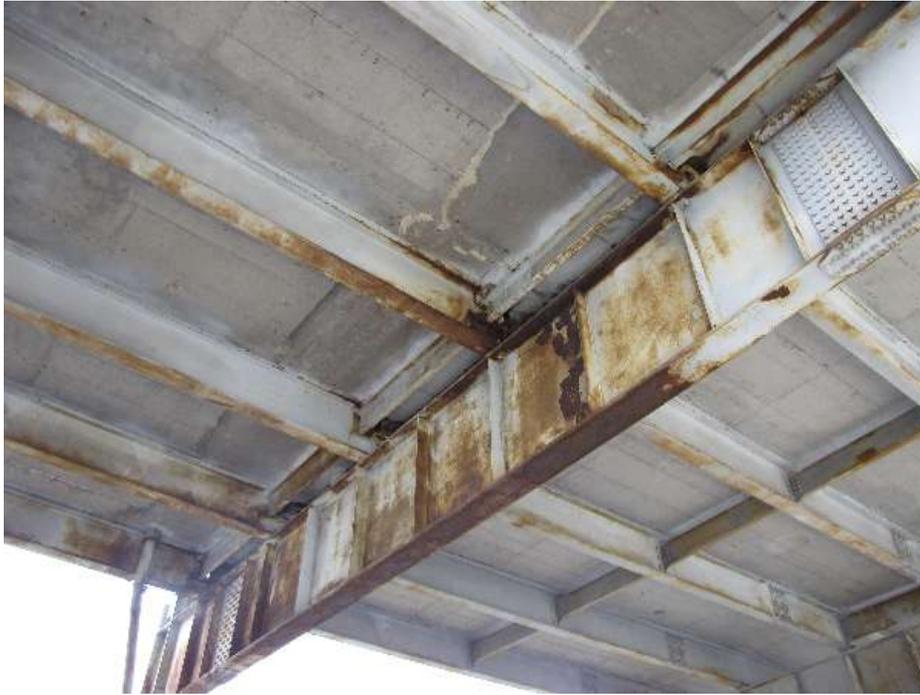
Photo 13

Debris on the Floor Beam

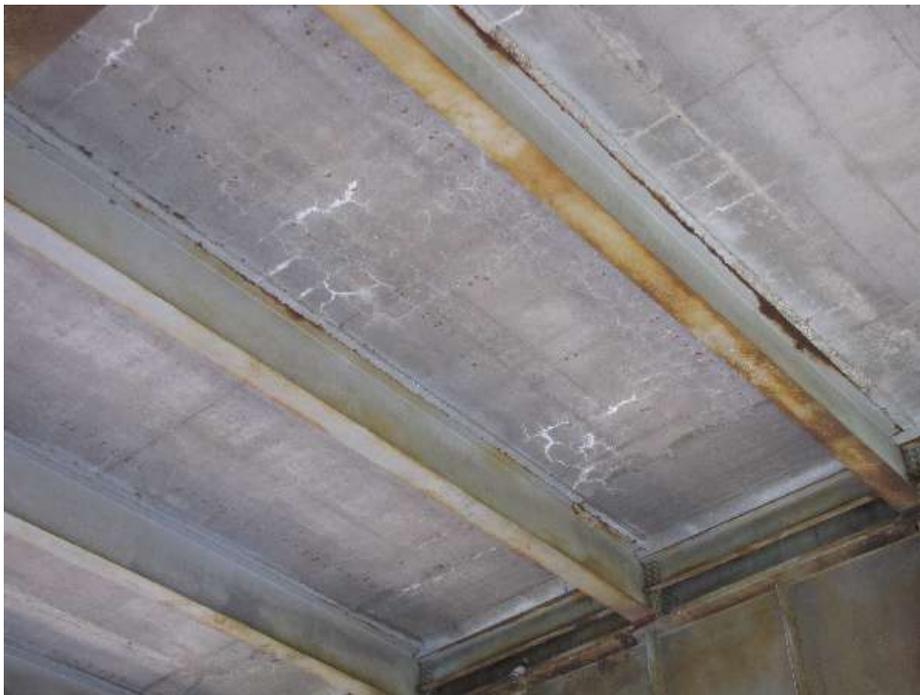
Photo 14

Sound/Chip off Loose Concrete

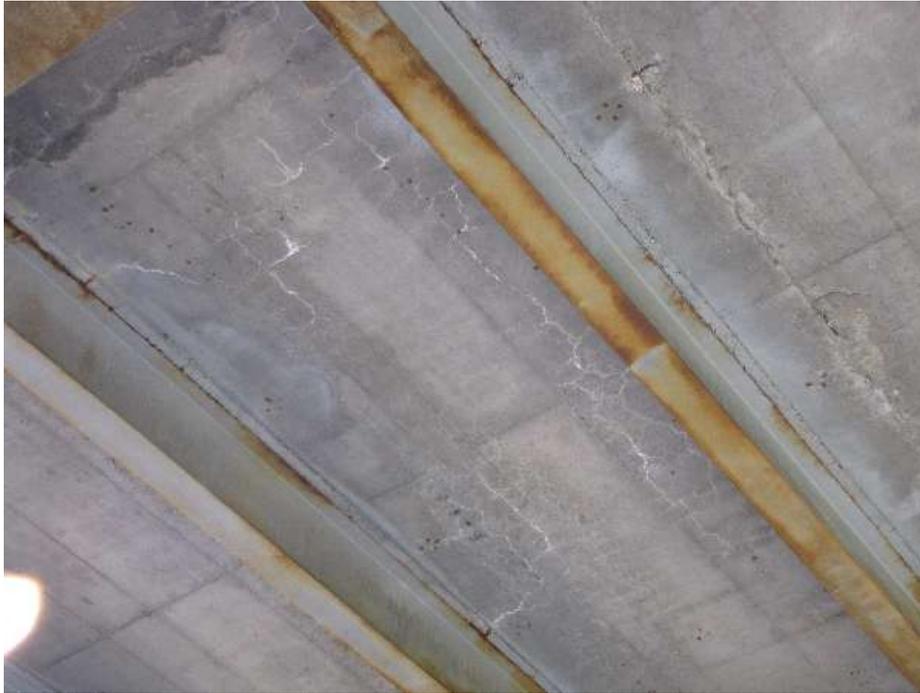
Photo 15

Sound/Chip off Loose Concrete

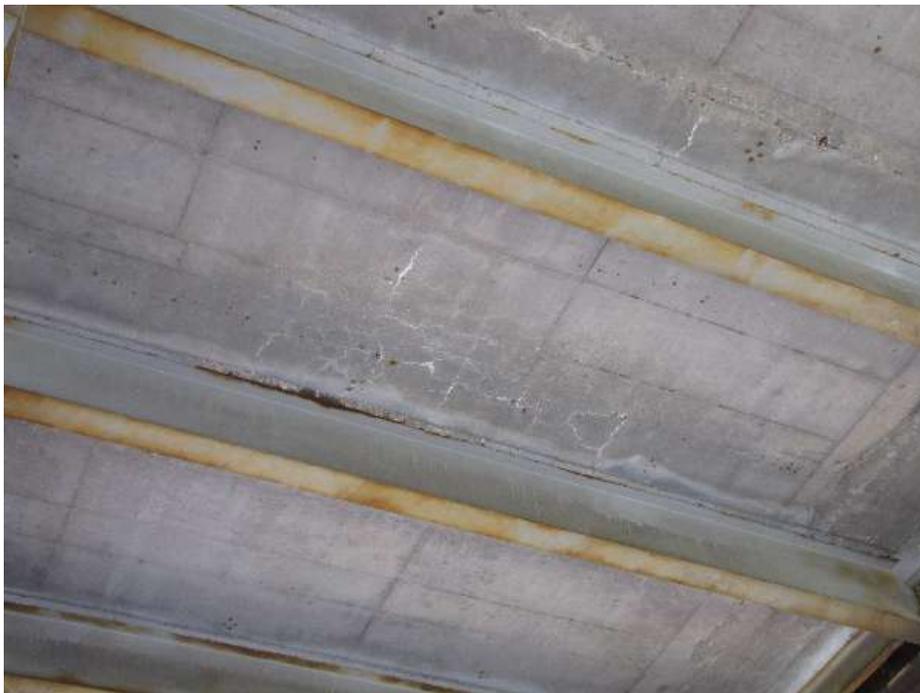
Photo 16

Sound/Chip off Loose Concrete

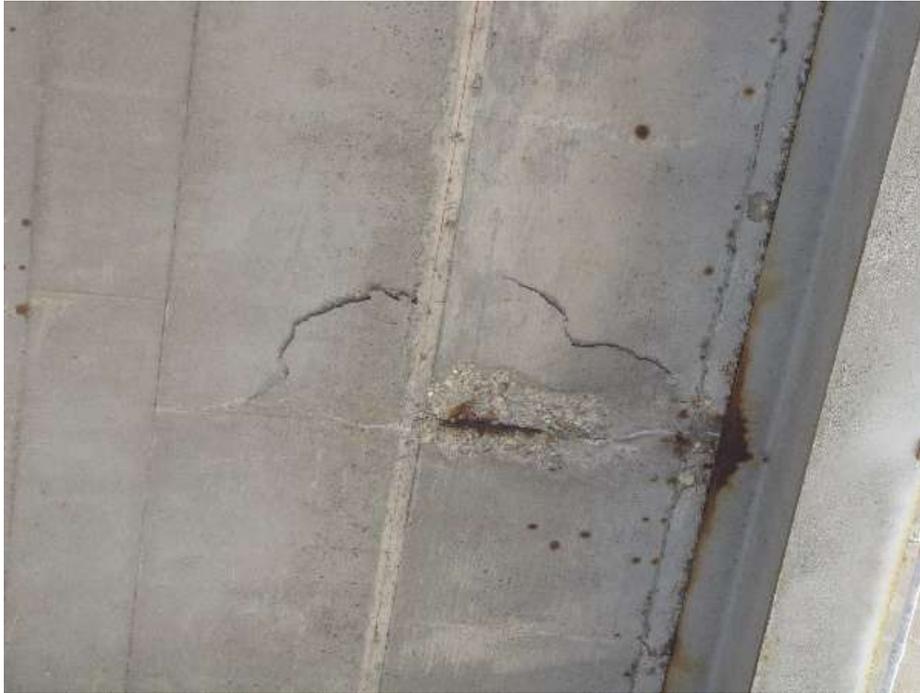
Photo 17

Sound/Chip off Loose Concrete
