ABBREVIATED ENGINEER'S REPORT
Bridge Project-Scope Undetermined
Wilson Road over Dukes Creek, Dunes State Park, Porter County

Date: 2/23/2022 Work Type: Bridge Project-Scope Undetermined
 Project FY: TBD Work Category: Institutional Road Project
 Des: TBD STR #: P000-64-07069 NBI#: **060160**

Structure P000-64-07069

P000-64-07069
WILSON ROAD
over
DUNES CREEK

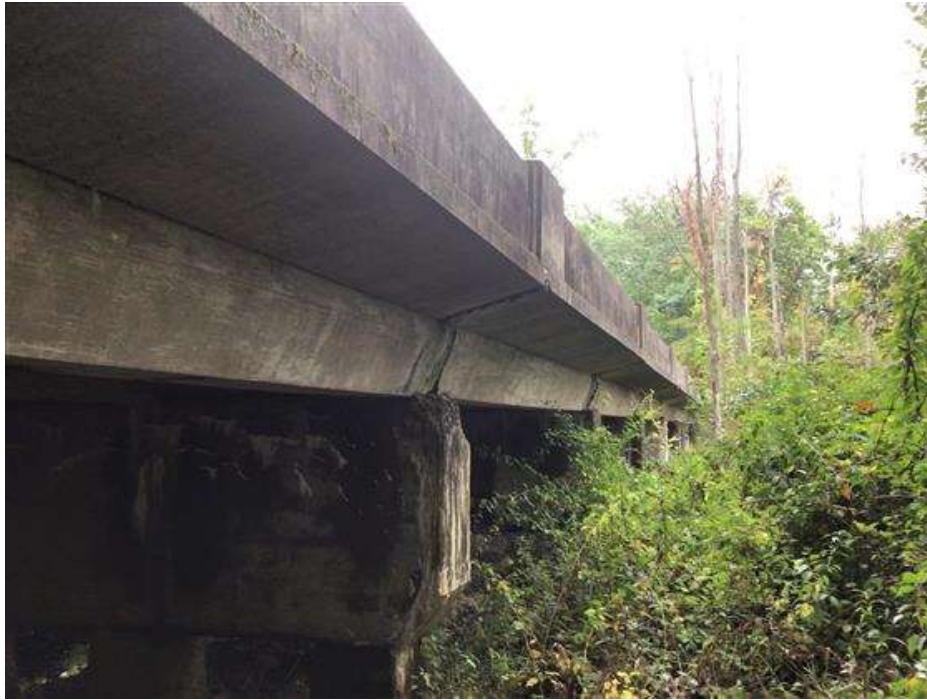
PHOTO 1 Condition
Description South profile

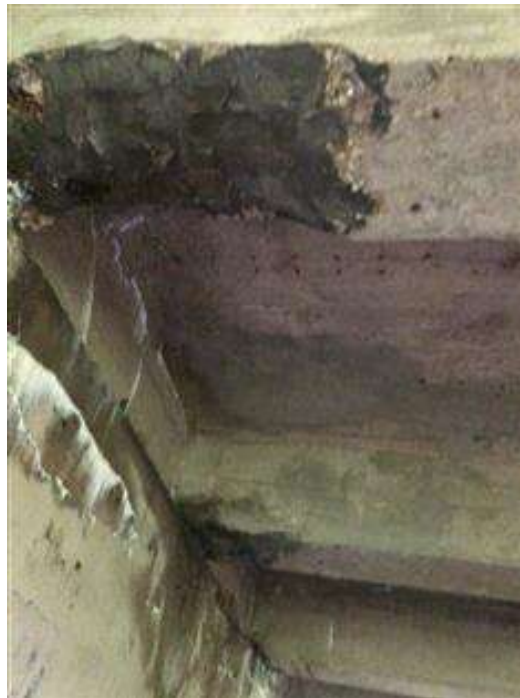
There is beam end cracking on the majority of the beams with efflorescence. Beam one and two in span B have spalling with exposed reinforcement. Some of the exposed reinforcement has been patched with grout. Note that the patching did not restore the original cross section. Span F all beams are map cracked, longitudinal cracking in the bottom of the beams and vertical cracking in the beams. Cracking has heavy efflorescence.

PHOTO 2 Condition
Description Span b, beam patching

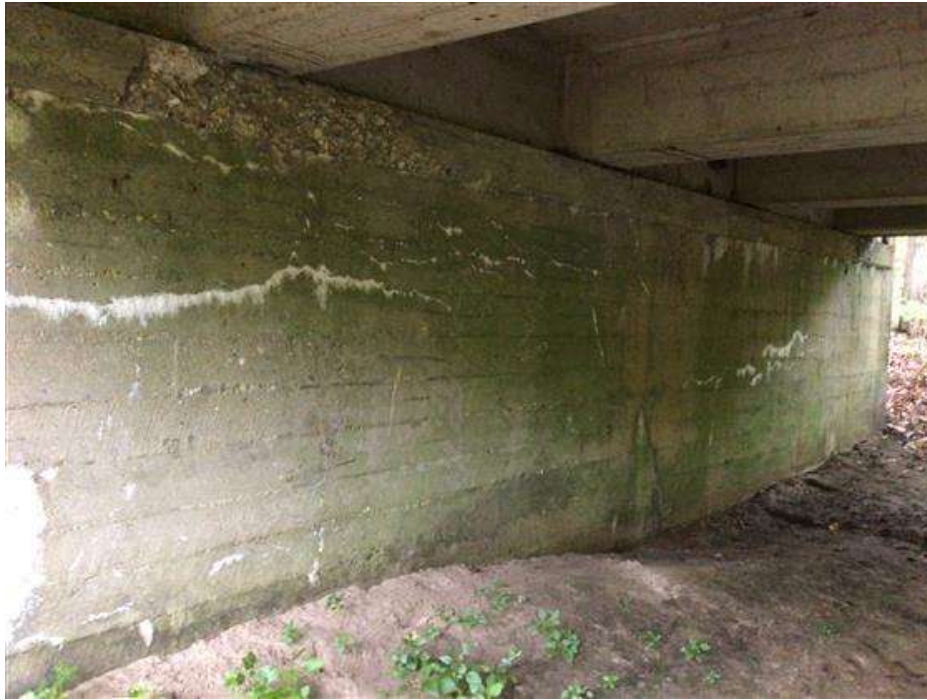
Minor concrete pillar and pier cap cracking. Minor vertical cracks in abutment walls. There is spalling with exposed reinforcement on abutment 9 the south wing wall. Abutment 1 has a spall with exposed rebar near its base. East outside ends of caps at top of piers 2,3,4, 5,6,7,8 have efflorescence and spalling. West outside ends of caps at top of piers 2 and 6 have heavy efflorescence and spalling. Pier #3, Column #5, is spalled and cracked at base of column. Pier #6 Column # 5 has spalling at its base as well.

PHOTO 3 Condition
Description Abutment 1 looking north

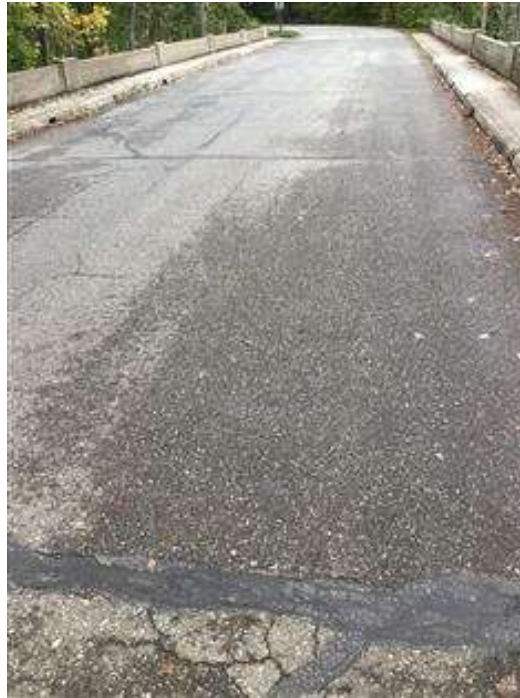
The HMA wearing surface has a large amount of cracking throughout the entire surface. Some of the cracking have been sealed with crumb rubber.

PHOTO 7 Condition
Description Wearing surface

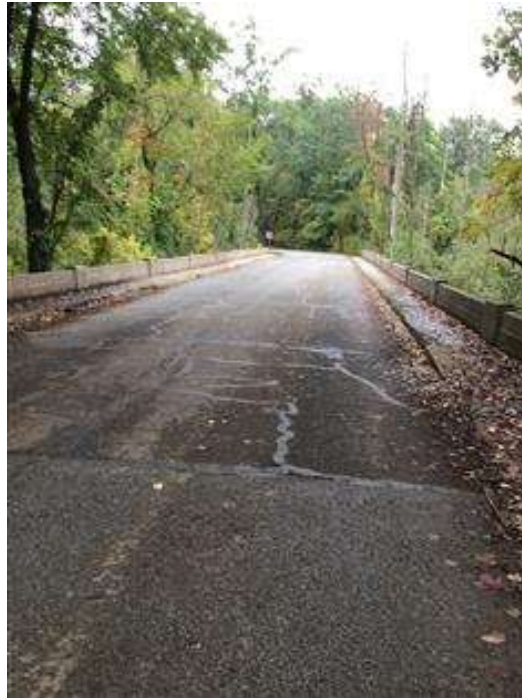
PHOTO 9 Condition
Description East road alignment

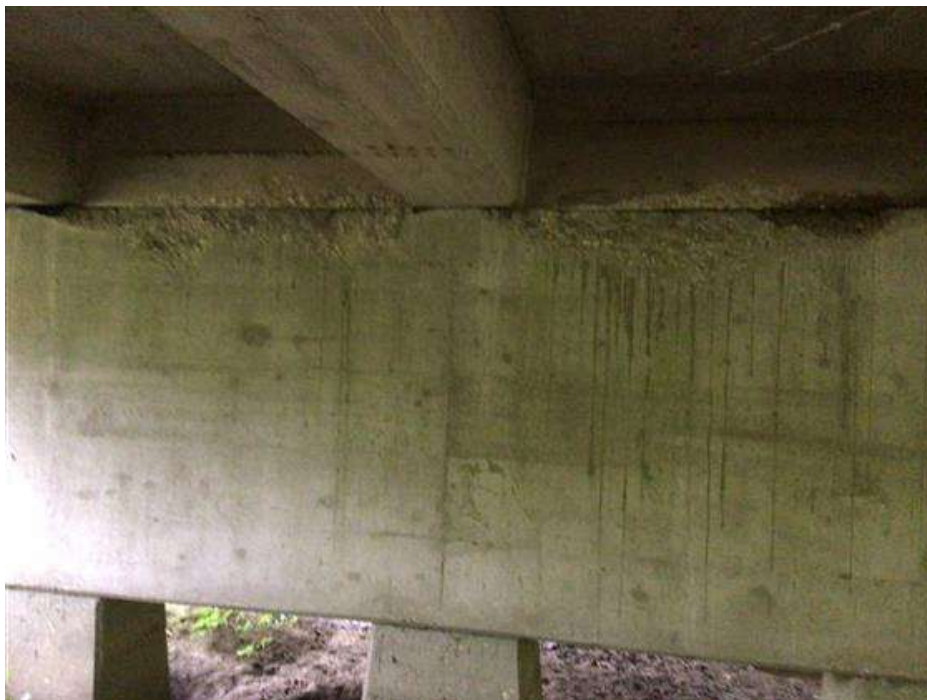
PHOTO 14 Condition
Description Spalling on pier 4

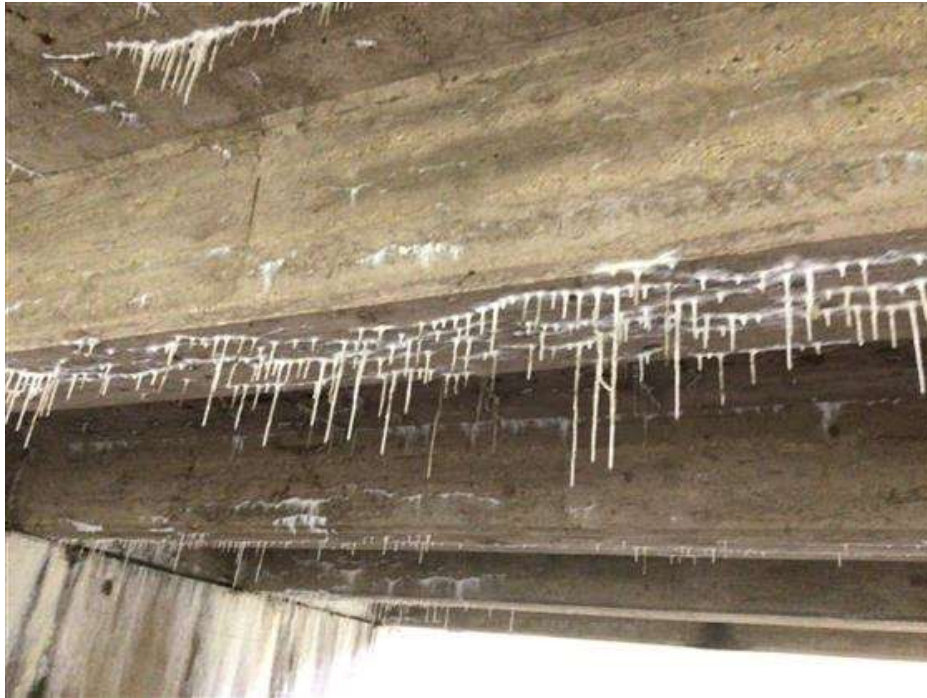
PHOTO 17 Condition
Description Span f

There is cracking with heavy efflorescence in all spans of the deck. Span F is heavily map cracked worse than the other spans and contains significant leaking efflorescence. The Span F beams and deck were sounded, finding significant delamination. Exact amount not know in paved deck. It is also unknown if there is a deck membrane between the wearing surface and deck.

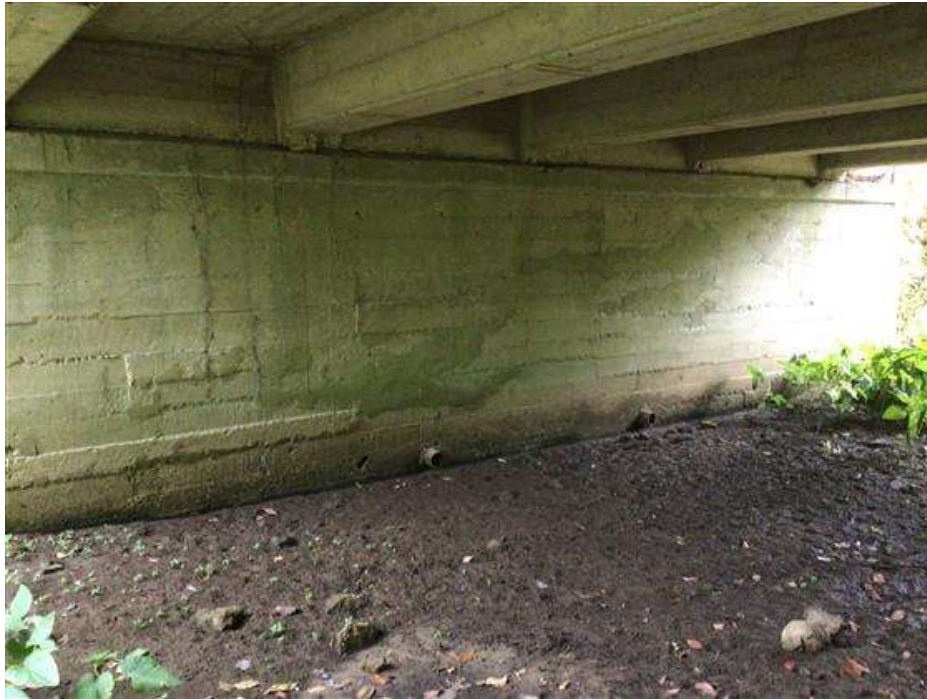
PHOTO 19 Condition
Description Abutment 9

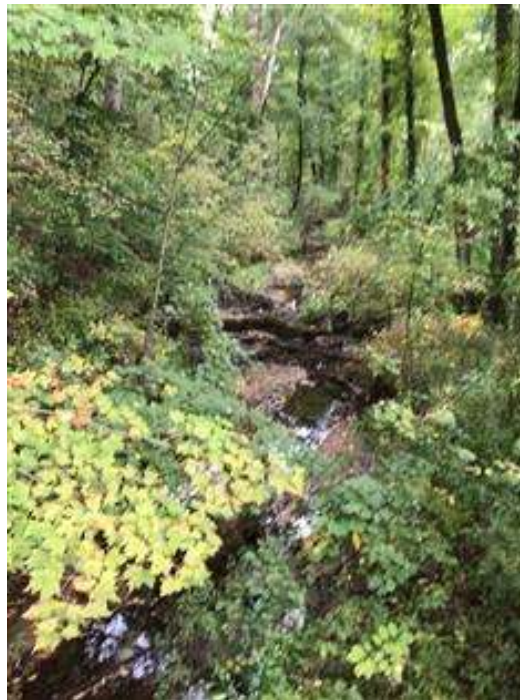
There are two channels that flow under the structure. The main channel flows under the majority of Span A. The north channel has debris in sediment build up that should be cleared out. The area around is swamp like conditions.

PHOTO 20 Condition
Description North channel alignment

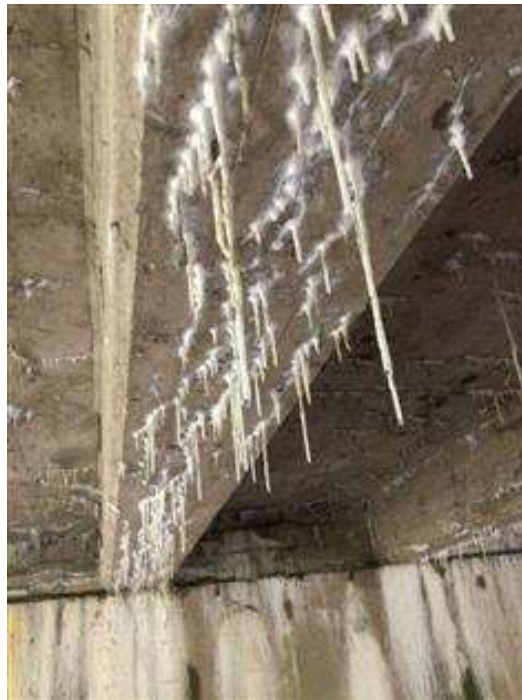
PHOTO 22 Condition
Description Activity growing efflorescence on beams in span f
