# Pavement Condition Report

## Angola-Steuben County Airport

Project 15805741

**February 2015**

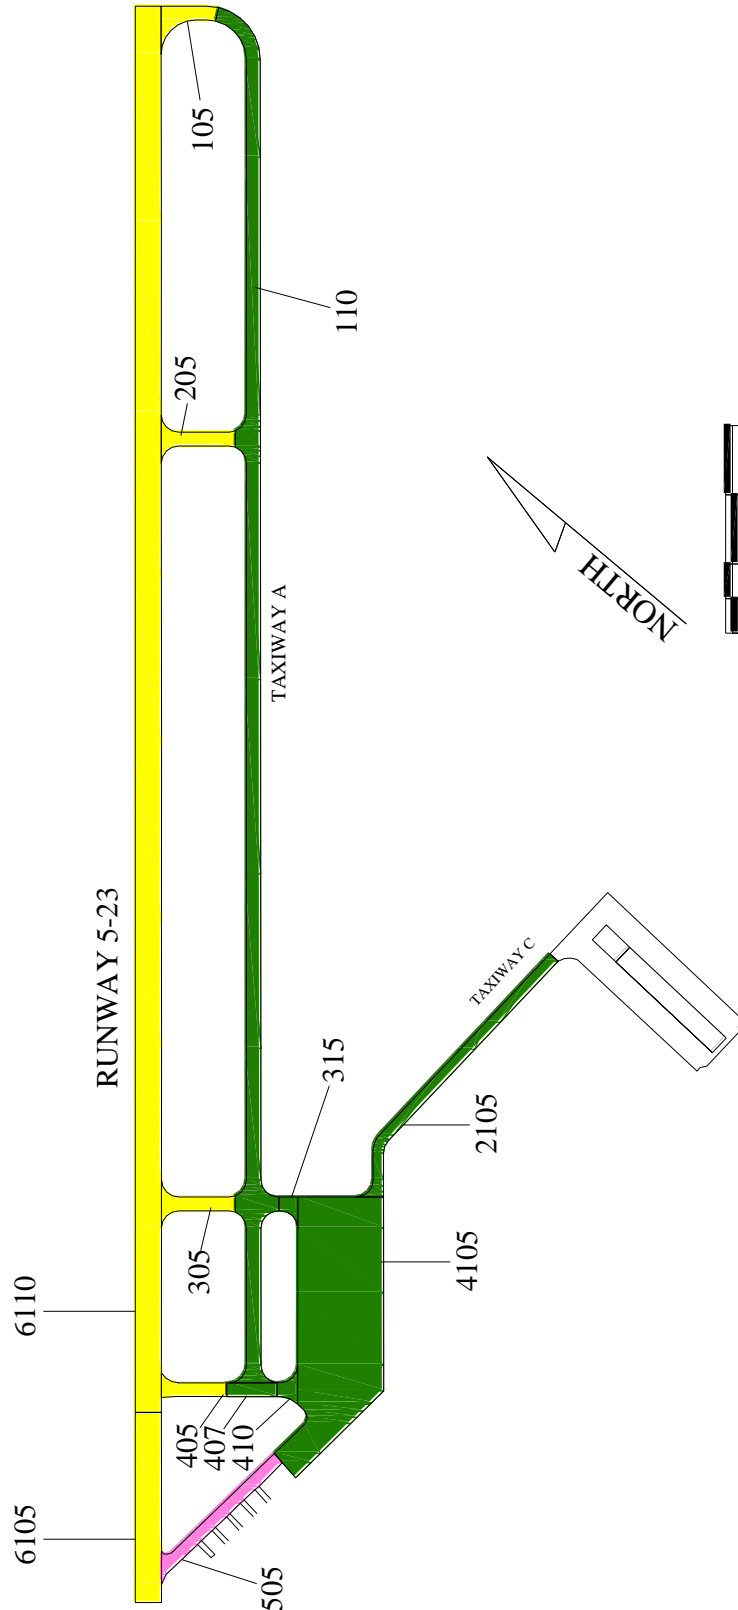
Figure 2-1. Inspected Pavement Condition

The pavement within each of the PCI condition categories is shown in Figure 2-1. The inspected PCI is summarized by branch use in Figure 2-2, and the photographs in Figure 2-3 through Figure 2-6 provide examples of the condition categories.

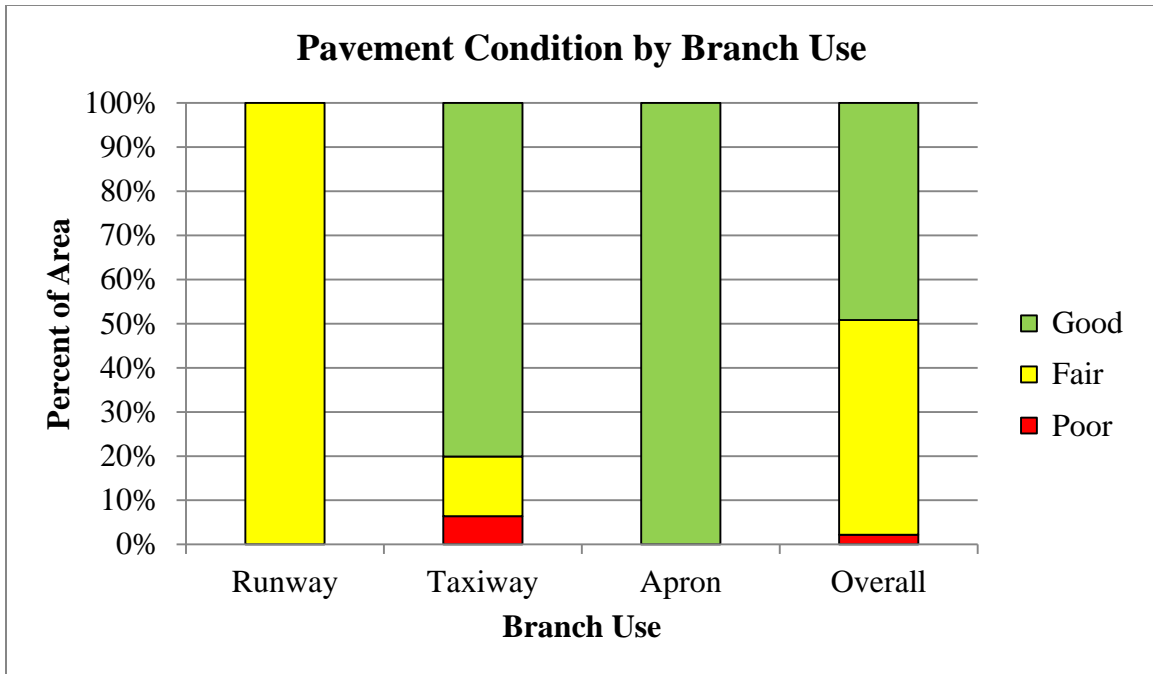
Figure 2-2. Pavement Condition by Branch Use

The average inspected Pavement Condition Index (PCI) for all the airfield pavements was 80. Runways had an average inspected PCI of 67 and were above the desired MSL of 60. Taxiways had an average inspected PCI of 86, and ramps had an average inspected PCI of 98.

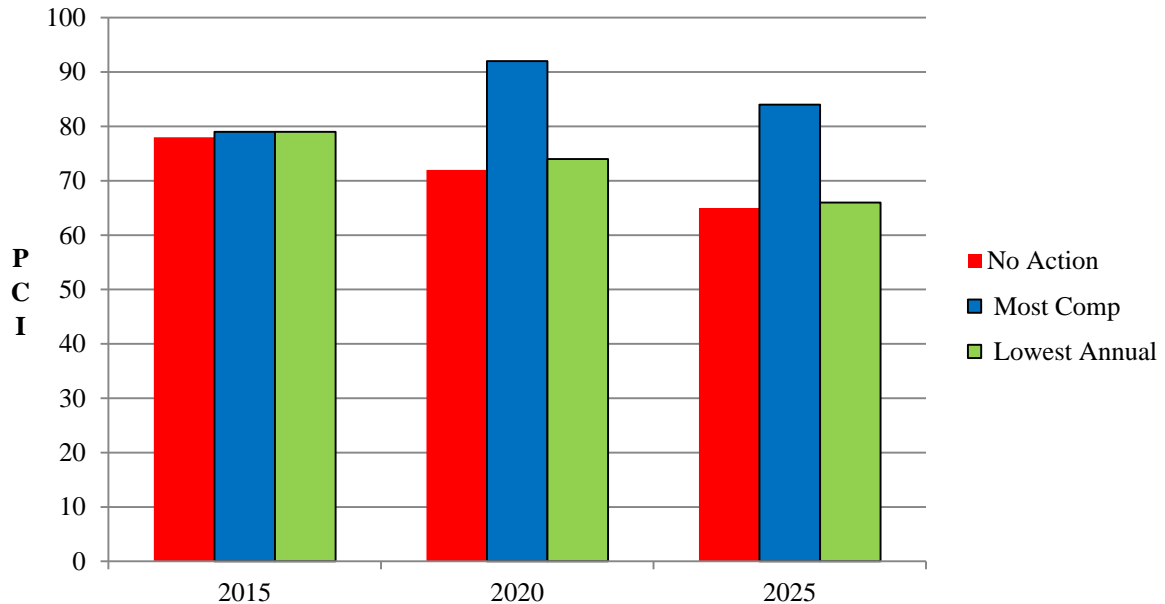
Figure 3-1. Programmed CIP

Figure 3-1 shows a projection of the overall airport pavement condition for the next 10 years based on implementing one of three capital improvement strategies:

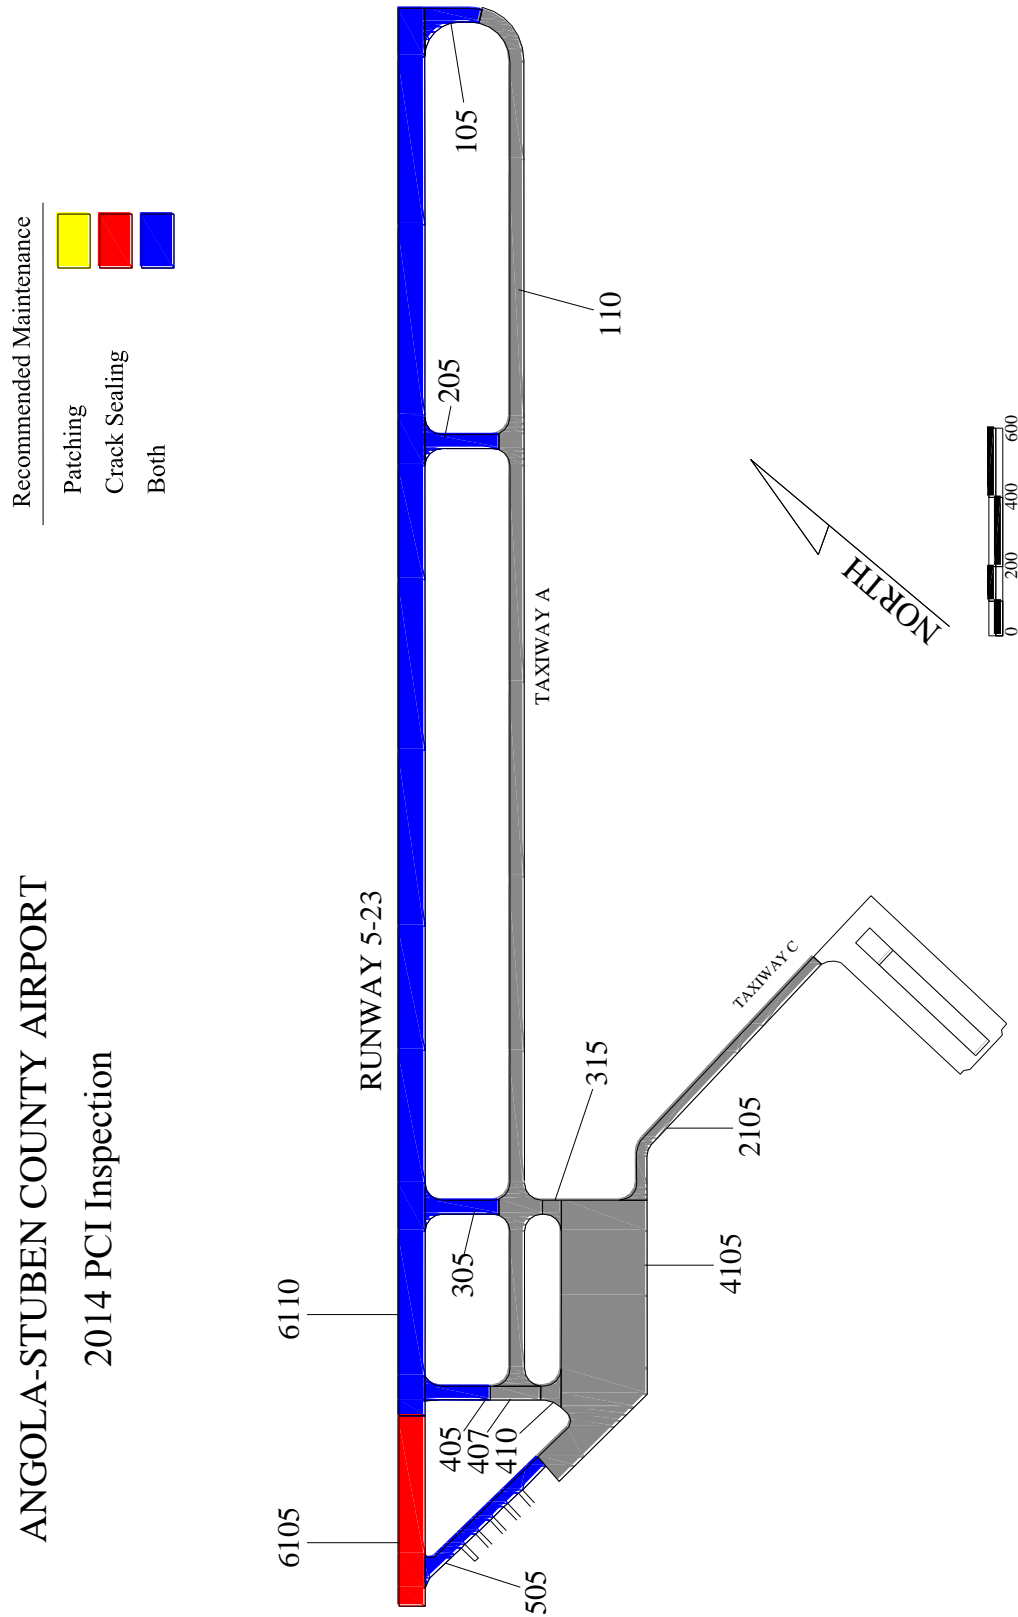
Figure 4-1. Recommended Maintenance

Analysis of potential maintenance projects identified approximately 1,000 square feet of patching needs and approximately 12,000 linear feet of crack sealing and crack repair needs, at an estimated total cost of approximately \$25,000.

Work Item	Quantity	Unit	Cost
AC PATCH	1,029	S.F.	\$ 8,931
AC RESTORATIVE CRACK REPAIR	5,061	L.F.	\$ 9,359
AC SUSTAINING CRACK REPAIR	7,299	L.F.	\$ 6,316
<b>Total:</b>			<b>\$24,606</b>
