Pavement Condition Report

Jeffersonville-Clark Regional Airport

Project 1480370

January 2014

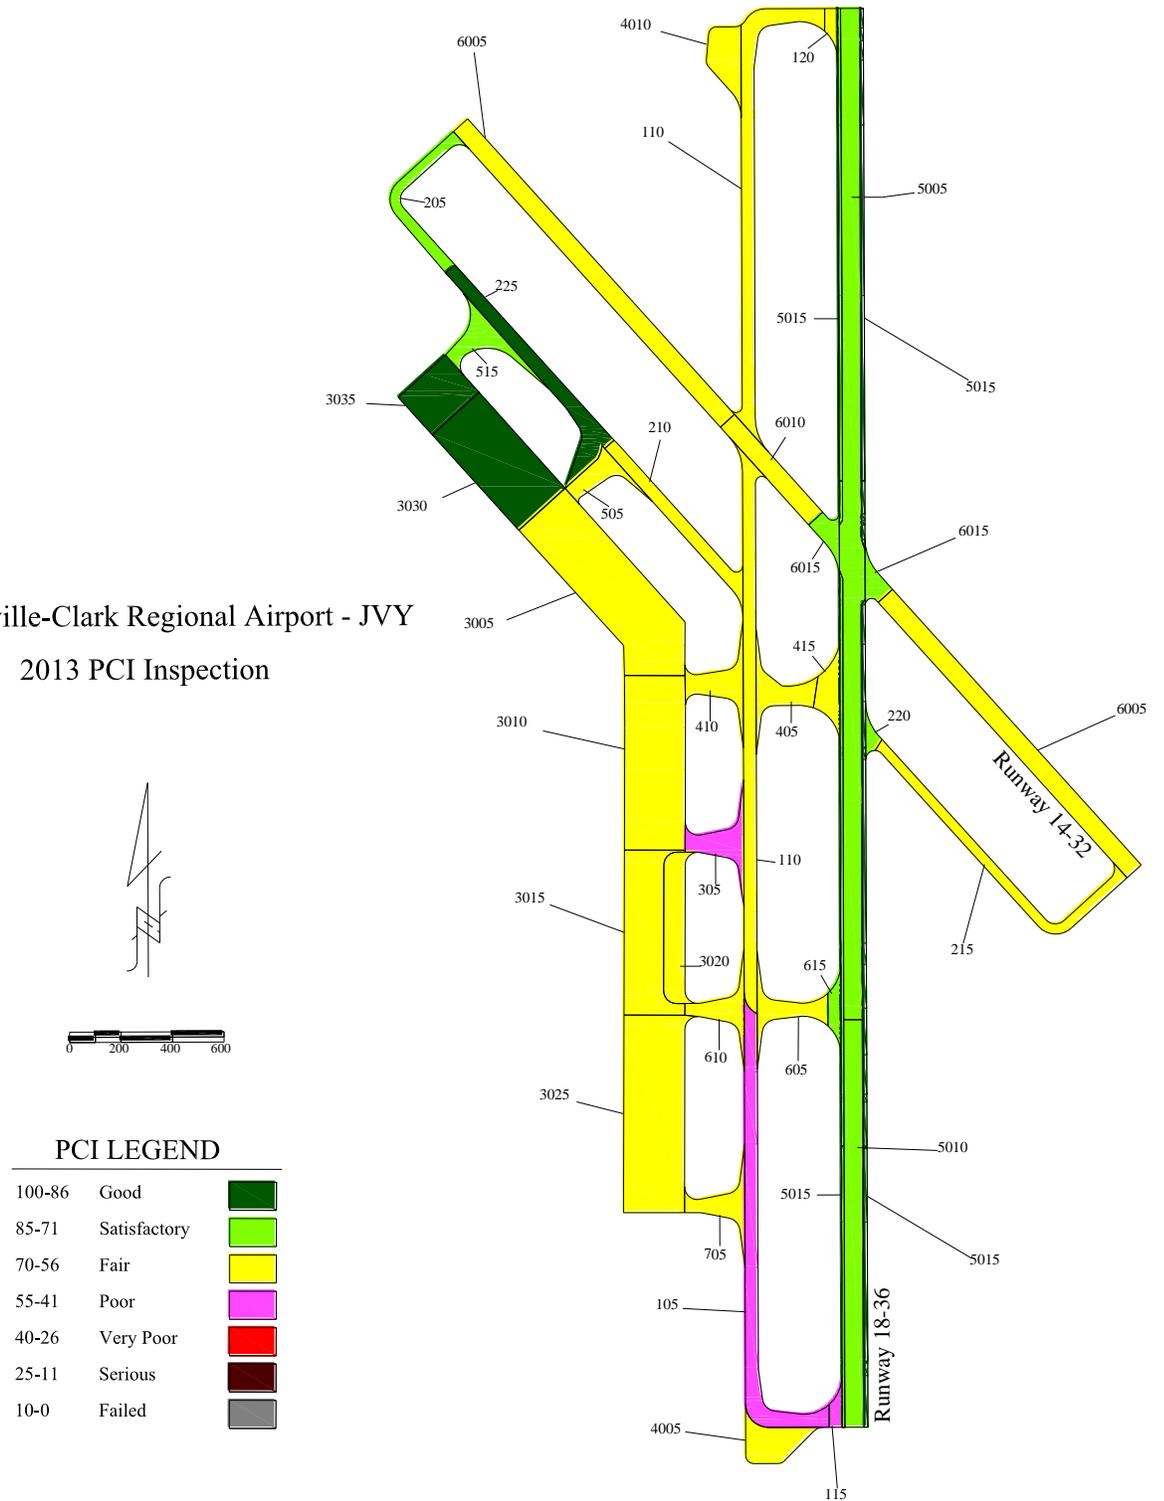
Figure 2-1. Inspected Pavement Condition

The pavement within each of the PCI condition categories is shown in Figure 2-1. The inspected PCI is summarized by branch use in Figure 2-2, and the photographs in Figure 2-3 through Figure 2-5 provide examples of the condition categories.

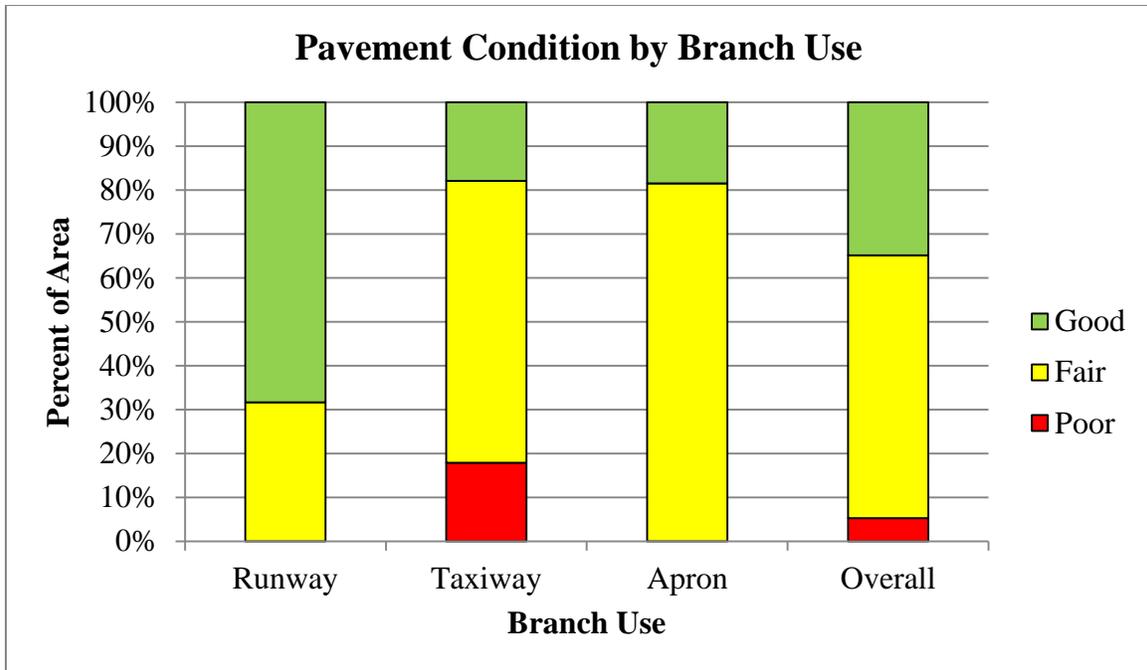
Figure 2-2. Pavement Condition by Branch Use

The overall Pavement Condition Index (PCI) for the airfield was 69. Runways had an average inspected PCI of 76 and are above the desired MSL of 65. Taxiways had an average inspected PCI of 64, and ramps had an average inspected PCI of 67.

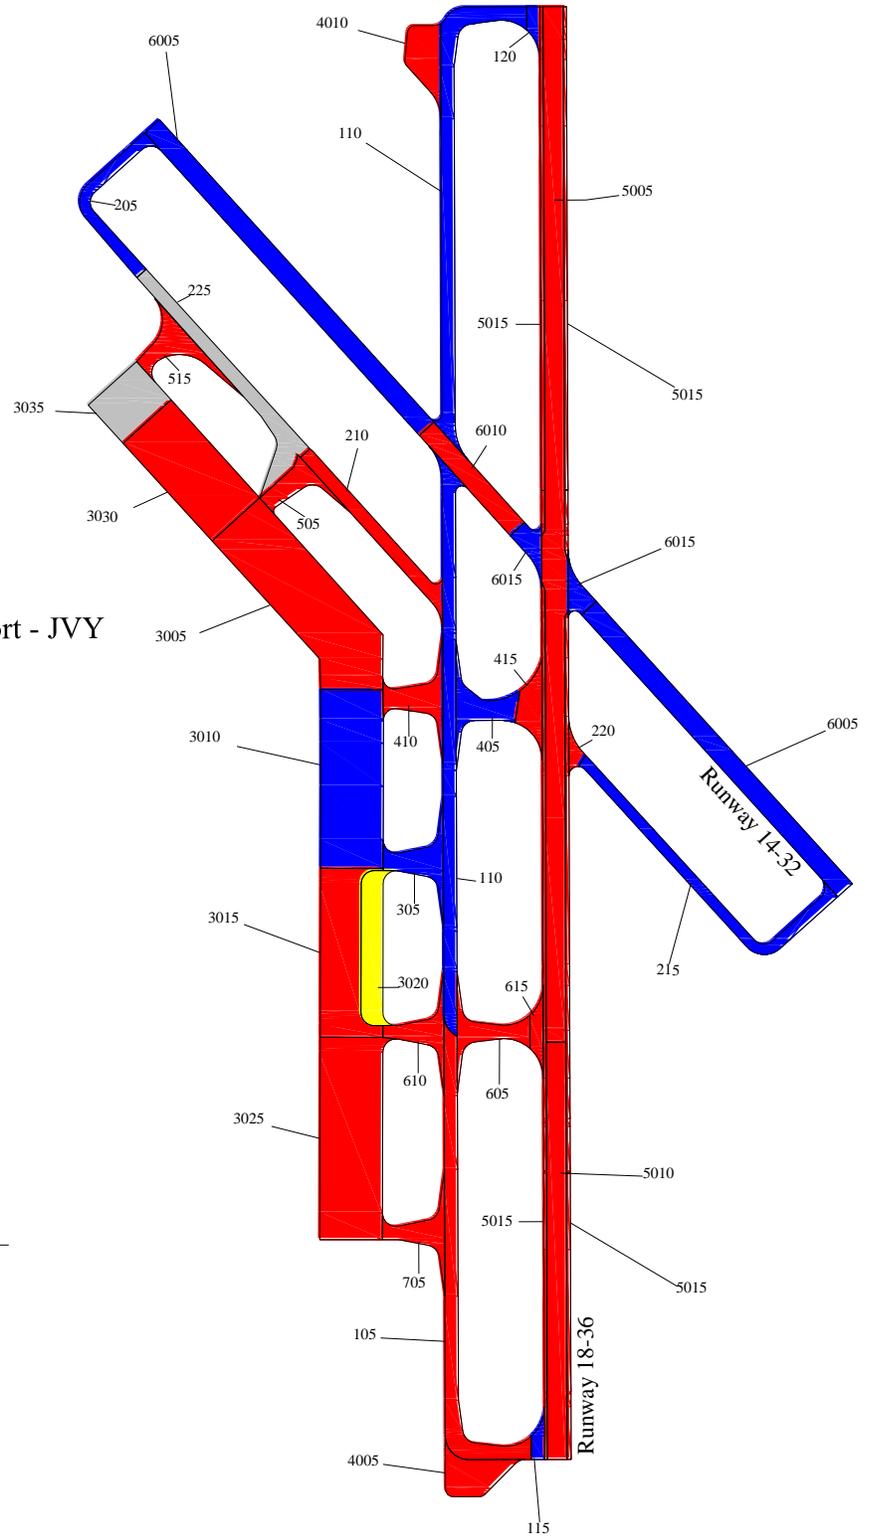
Figure 4-1. Recommended Maintenance

Analysis of potential maintenance projects identified approximately 1,300 square feet of patching needs and approximately 180,000 linear feet of crack sealing and crack repair needs, at an estimated total cost of approximately \$230,000.

Work Item	Quantity	Unit	Cost
AC RESTORATIVE CRACK REPAIR	173,640	LF	215,314
AC SUSTAINING CRACK REPAIR	8,163	LF	7,063
AC PATCH	1296	SF	11,243
Total:			\$ 233,620
