Pavement Condition Report

Clinton Airport

Project 15805741

February 2015

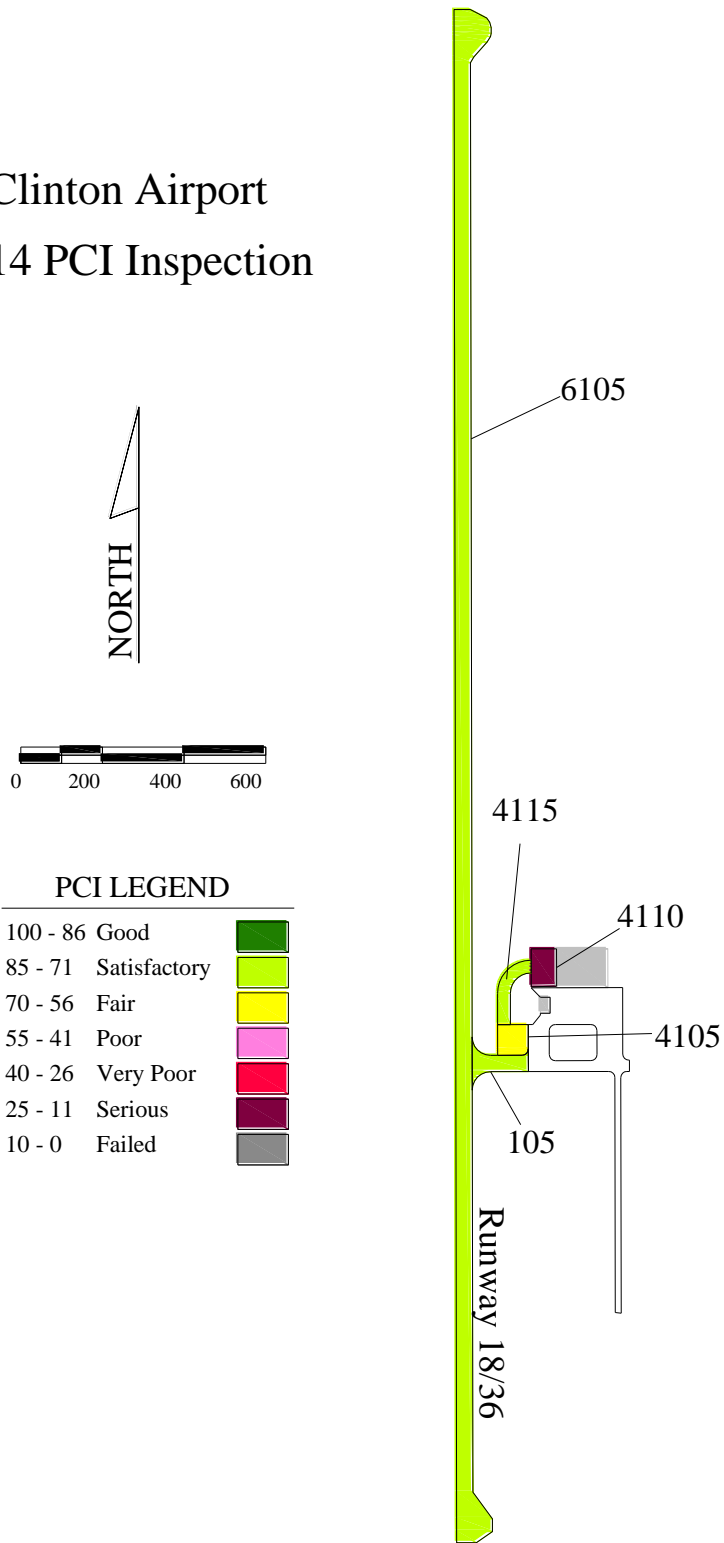
Figure 2-1. Inspected Pavement Condition

The pavement within each of the PCI condition categories is shown in Figure 2-1. The inspected PCI is summarized by branch use in Figure 2-2, and the photographs in Figure 2-3 through Figure 2-5 provide examples of the condition categories.

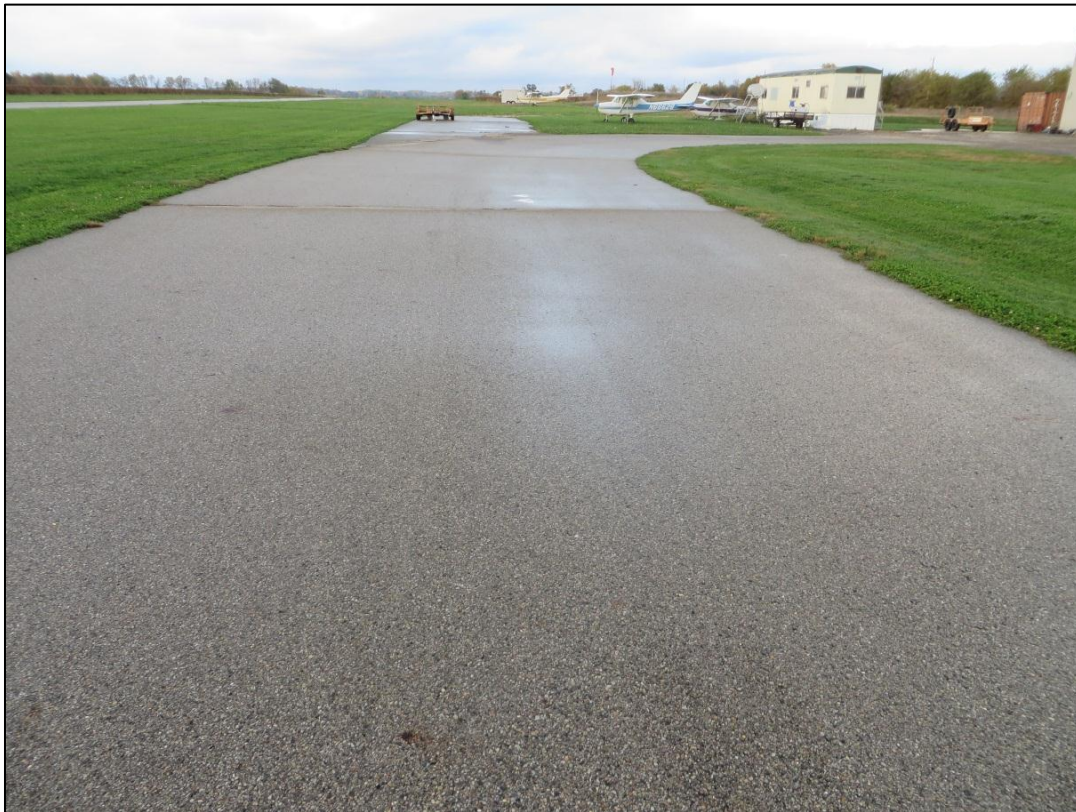
Figure 2-3. Typical Satisfactory AC Pavement (Feature 4115)

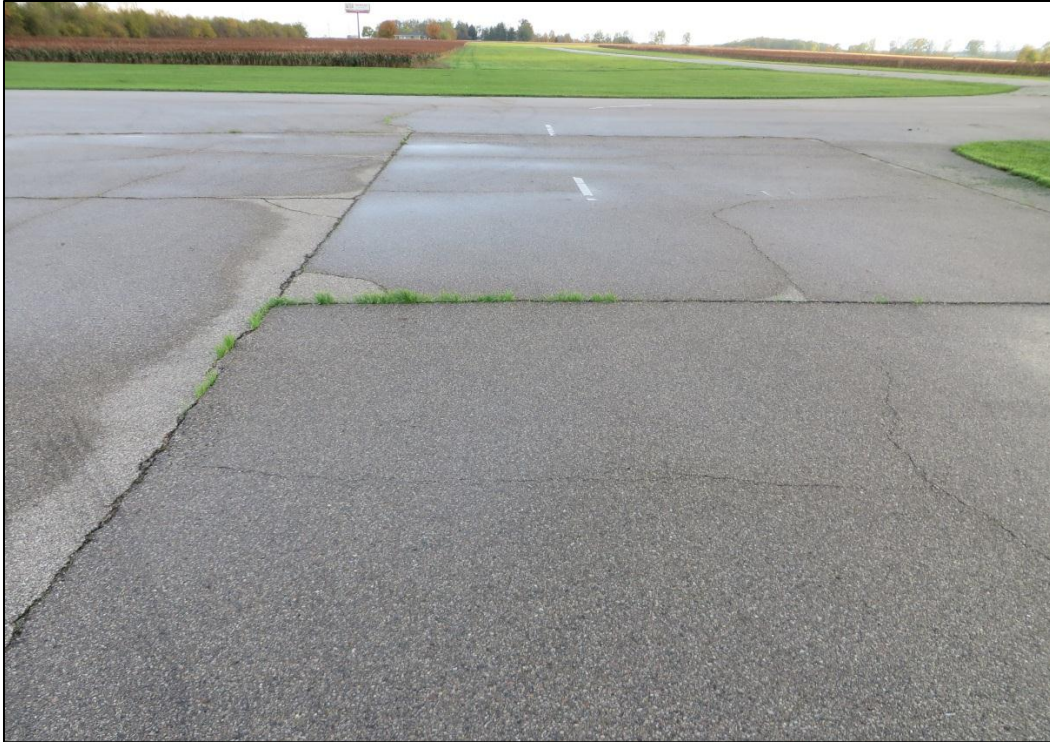
Figure 2-4. Typical Fair AC Pavement (Feature 4105)

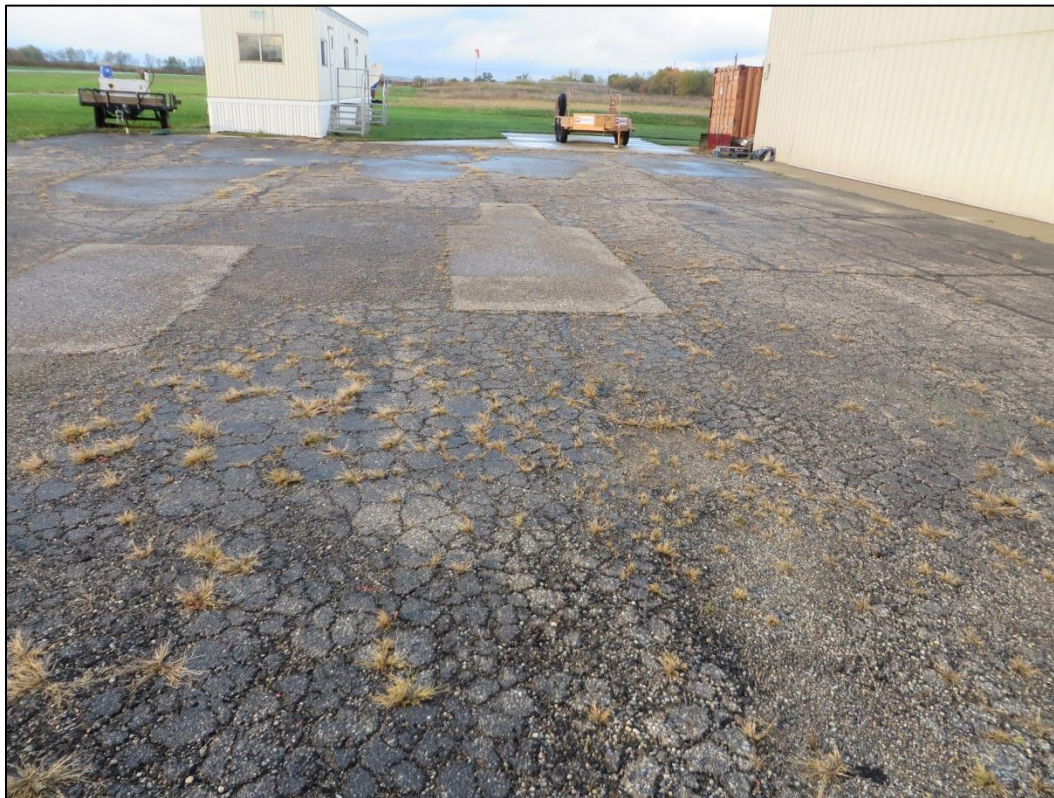
Figure 2-5. Typical Serious AC Pavement (Feature 4110)
