# Pavement Condition Report

## Indianapolis - Eagle Creek Airpark

Project 1480370

**January 2014**

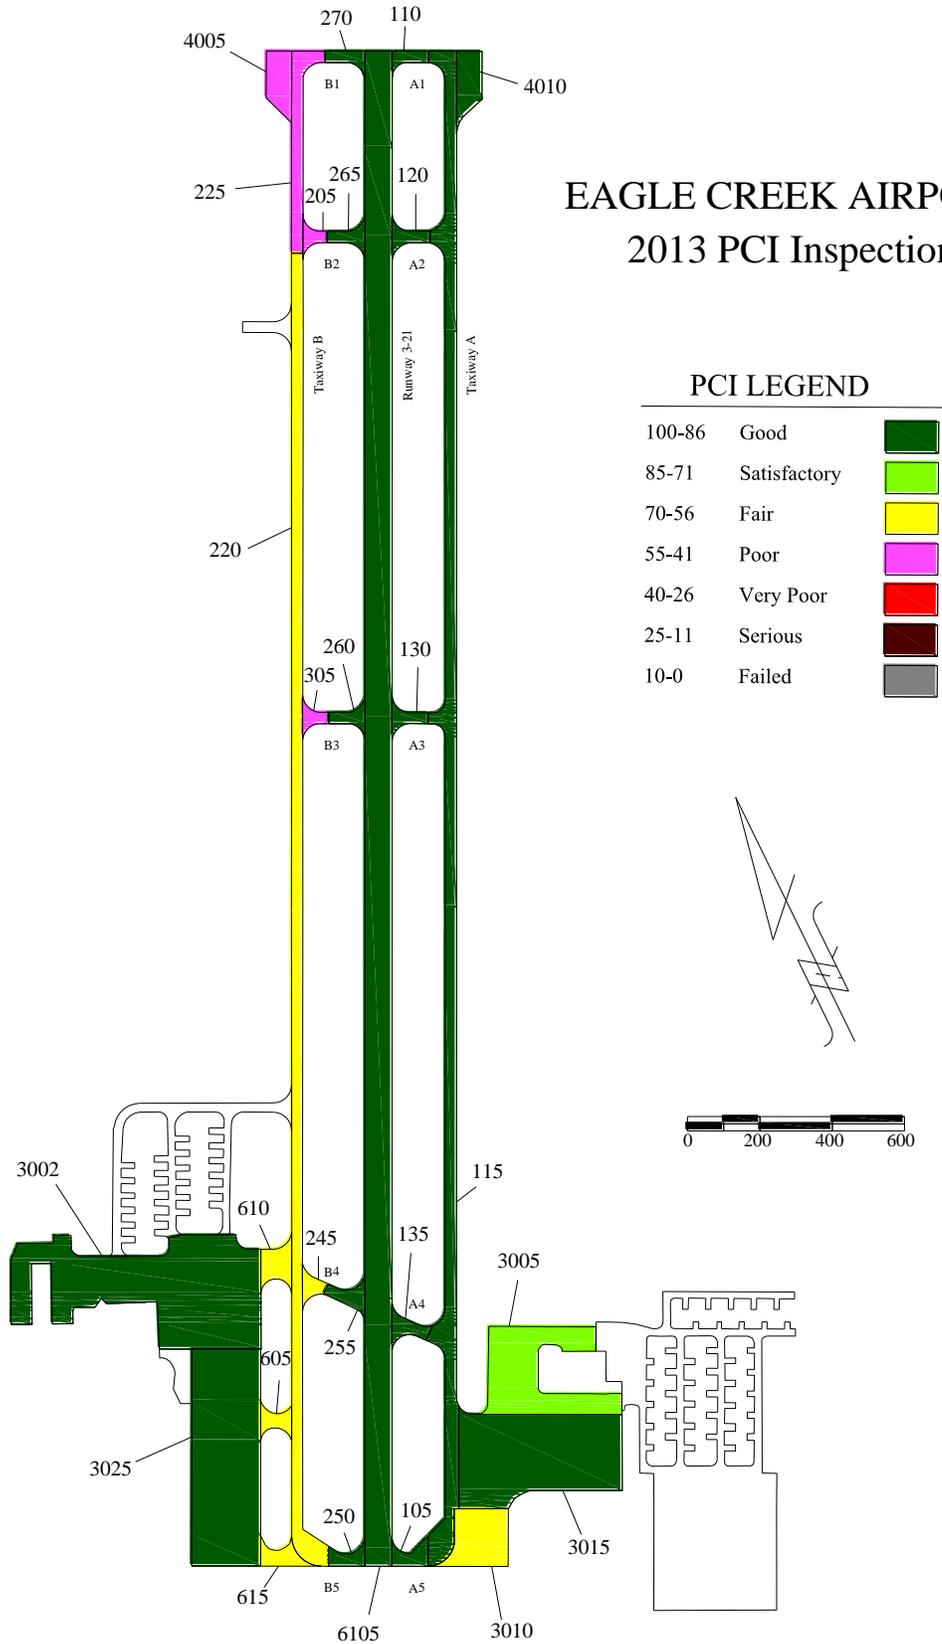
Figure 2-1. Inspected Pavement Condition

The pavement within each of the PCI condition categories is shown in Figure 2-1. The inspected PCI is summarized by branch use in Figure 2-2, and the photographs in Figure 2-3 through Figure 2-7 provide examples of the condition categories.
