Pavement Condition Report

Goshen Municipal Airport

Project 15805741

February 2015

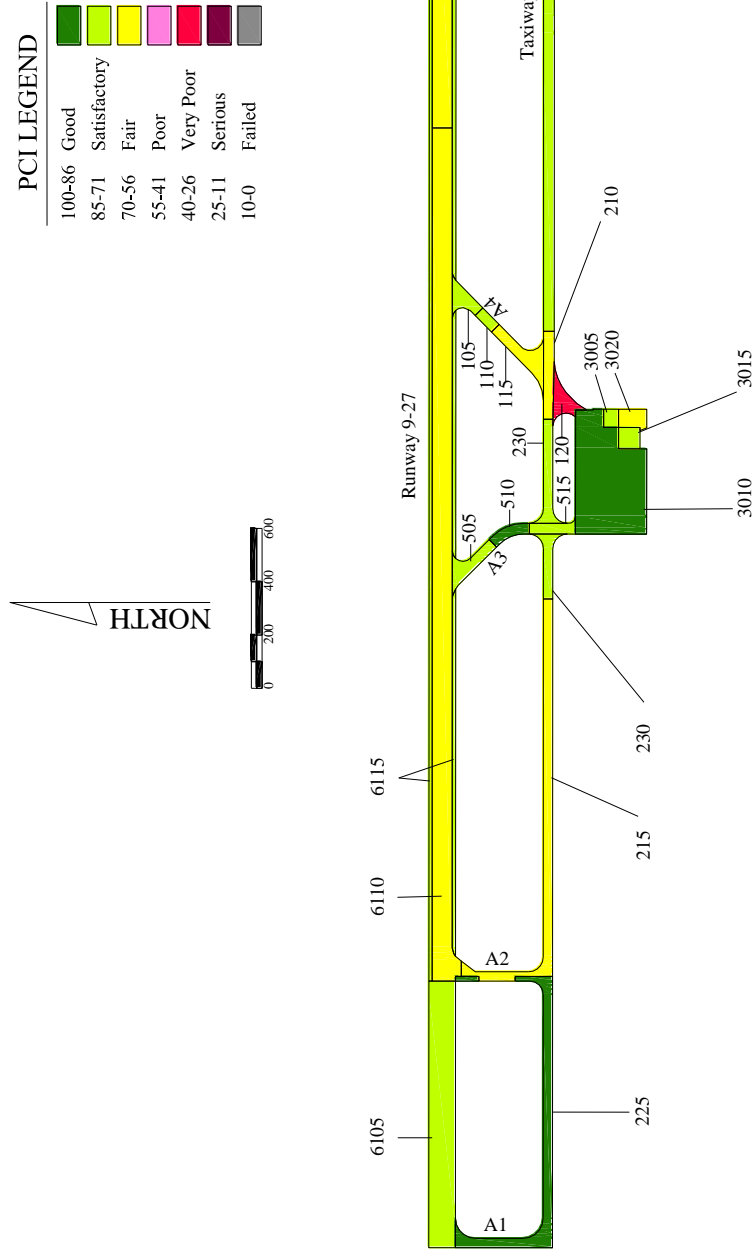
Figure 2-1. Inspected Pavement Condition

The pavement within each of the PCI condition categories is shown in Figure 2-1. The inspected PCI is summarized by branch use in Figure 2-2, and the photographs in Figure 2-3 through Figure 2-7 provide examples of the condition categories.

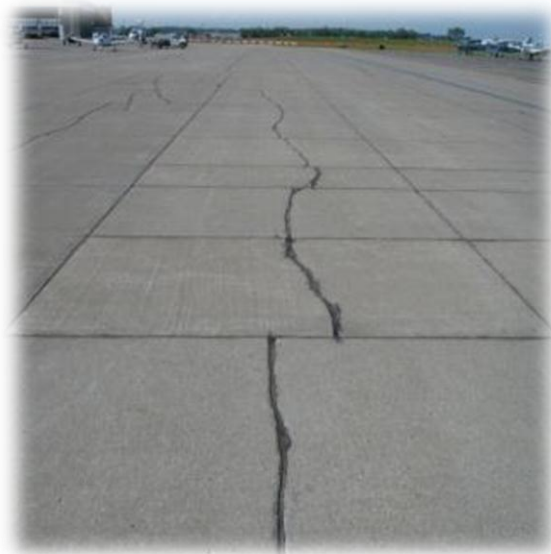
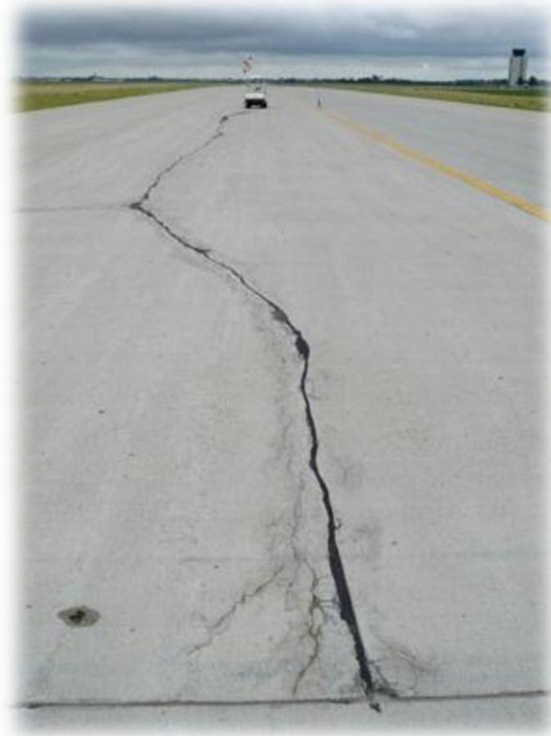
A slab divided into four or more pieces is said to be “divided” or “shattered.” Shattered slab is a separate distress category and indicates a significant structural failure. A shattered slab has lost its ability to distribute loads. Shattered slabs are rated in three severities, but the recommended action in any case is slab replacement.

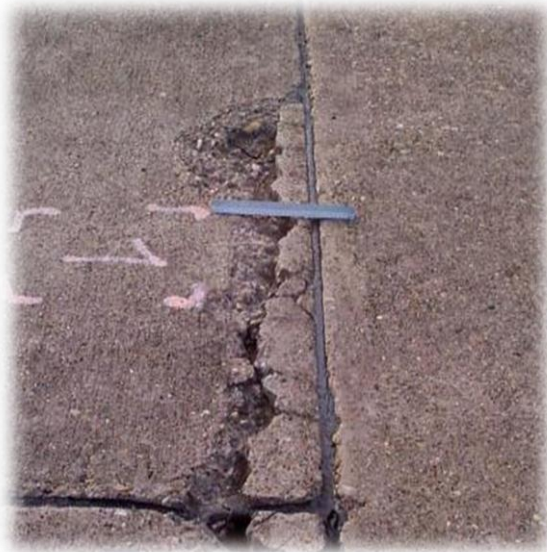
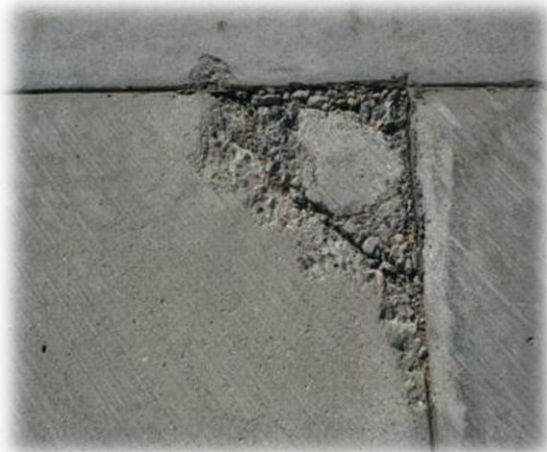
Spall repair requires patching. The extent and severity of spalling suggests the appropriate action. At low severity, spalled concrete remains securely in place in the slab. A low-severity spall should be monitored closely for further deterioration and should be patched when spalled particles become loose, or during the next scheduled patching activity. Medium- and high-severity spalls should be repaired immediately to prevent FOD. If the pavement can be restored to serviceable condition, spalls should be patched for long-term service. If the pavement is beyond repair, temporary patching should be considered to control FOD.

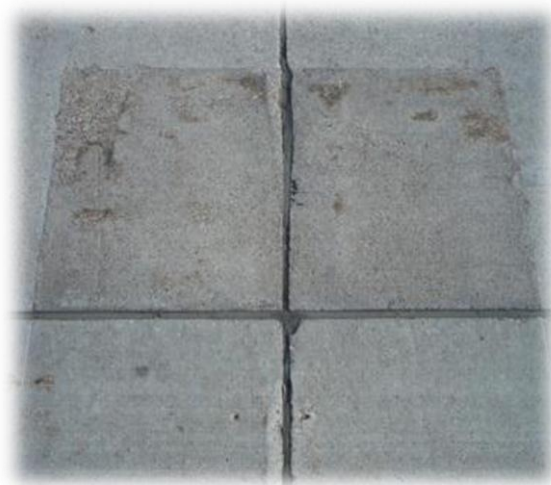
Large patches also may be the result of spall repair, but they often indicate more serious deficiencies, such as corner breaks or other full-depth failure smaller than panel size.

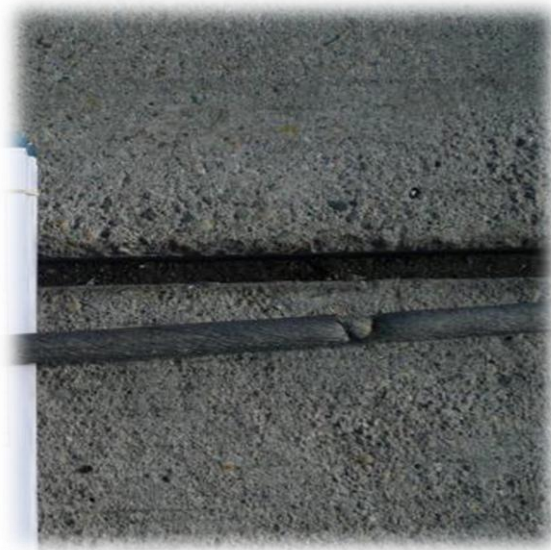
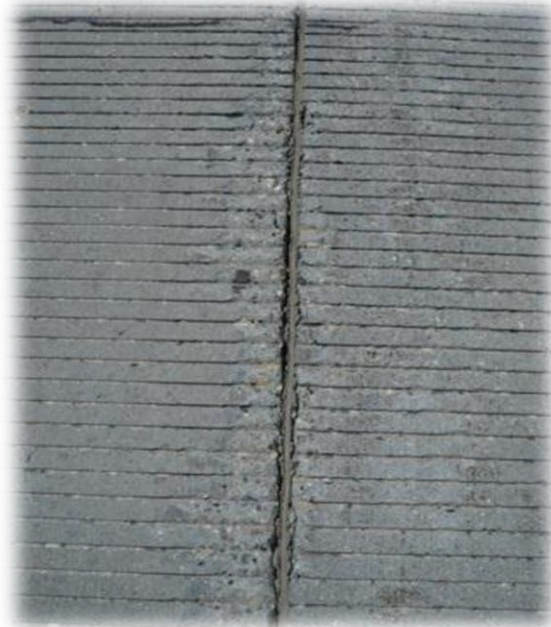
On serviceable pavement, deteriorated joint sealant should be repaired or replaced to preserve pavement and subgrade integrity and prolong service life. The issue is not so clear-cut with unserviceable pavement. Pavement that can be restored to serviceable condition by maintenance activities such as patching and joint seal repair, or by slab replacement, should be so maintained as long as the process is cost-effective. However, when age and condition preclude economical return to serviceable condition by such means, joint seal repair would no longer be cost-effective and should be suspended except for an interim maintenance program to control FOD potential.

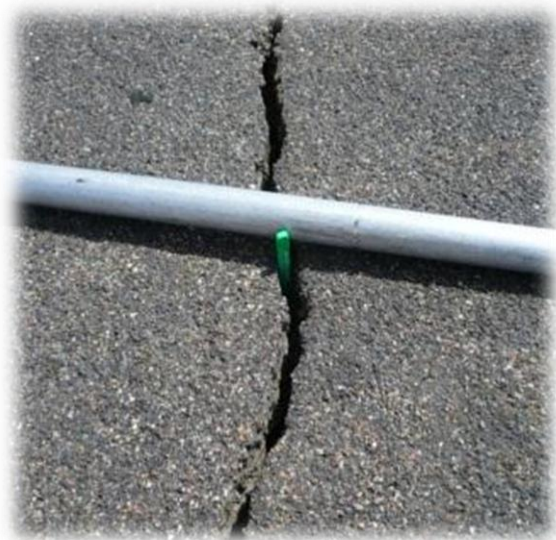
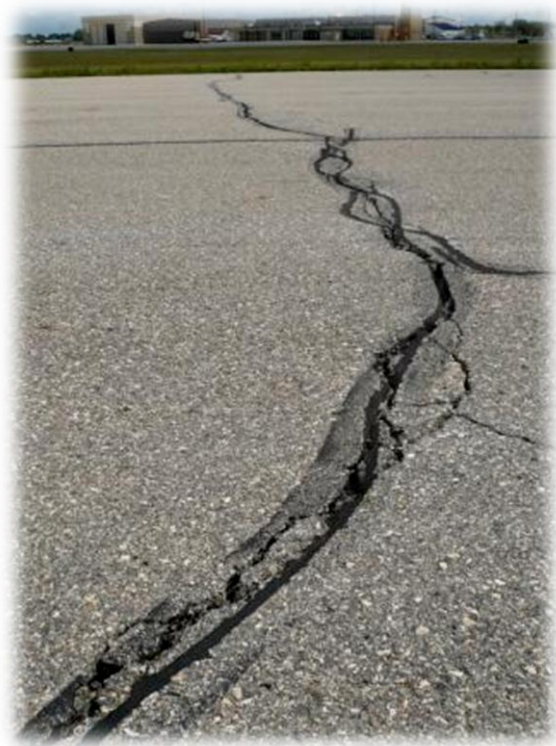
Low-severity L&T cracks are less than ¼ inch wide, or if sealed with suitable filler material in satisfactory condition can be any width less than 3 inches, if they are not spalled. Maintenance usually is not indicated for low-severity cracking. Moderately spalled cracks and cracks wider than ¼ inch which are not satisfactorily sealed are at medium severity. Medium-severity cracks should be sealed with a high-quality crack filling material. Severely spalled cracks and cracks wider than 3 inches are at high severity. High-severity L&T cracks normally require patching.

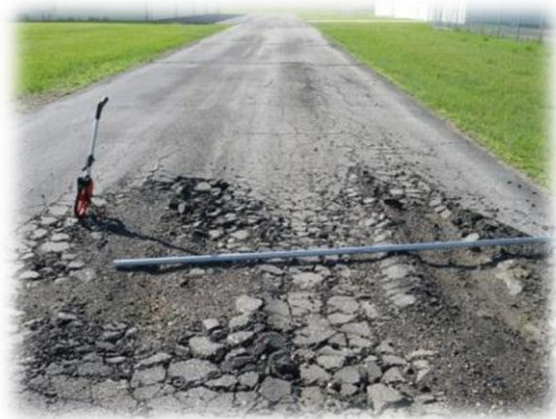
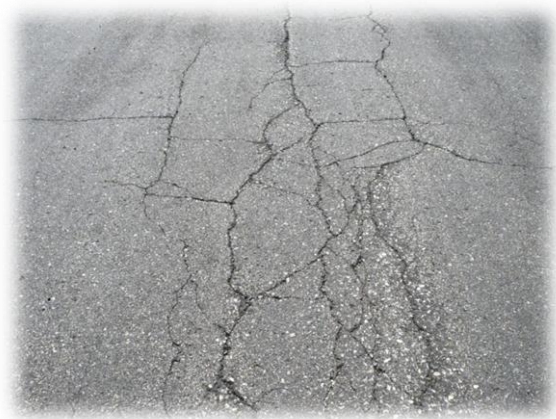
Alligator cracking is a serious structural failure that cannot be repaired with sealant. The proper repair is patching.

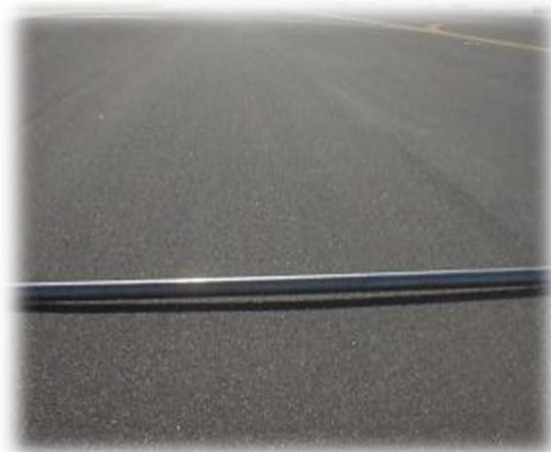
At low severity, ruts have an average depth of ¼ to ½ inches. At medium severity, ruts have an average depth of ½ to 1 inch. At high severity, ruts have an average depth greater than 1 inch. Patching is the appropriate repair for ruts.
