# Pavement Condition Report

## Griffith-Merrillville Airport

Project 15805741

**February 2015**

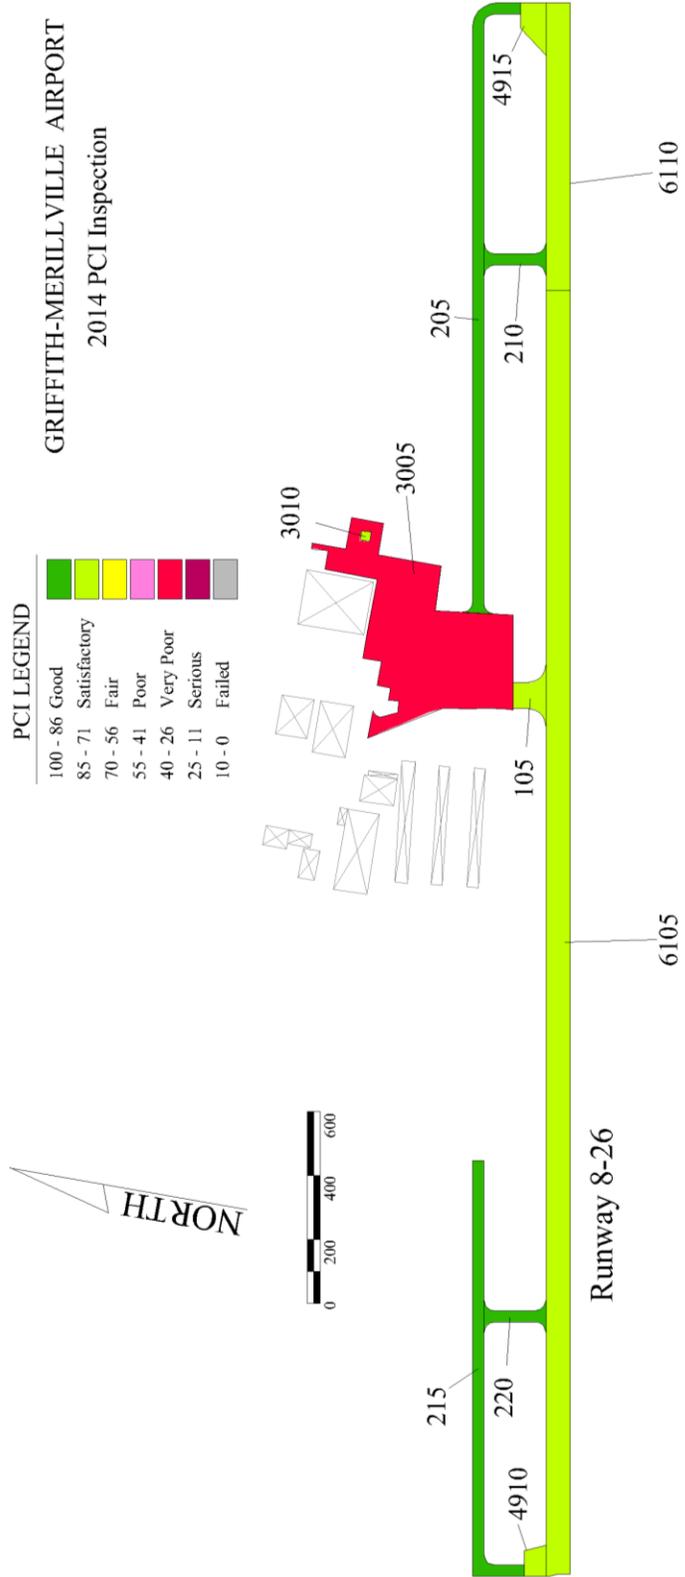
Figure 2-1. Inspected Pavement Condition

The pavement within each of the PCI condition categories is shown in Figure 2-1. The inspected PCI is summarized by branch use in Figure 2-2, and the photographs in Figure 2-3 through Figure 2-5 provide examples of the condition categories.

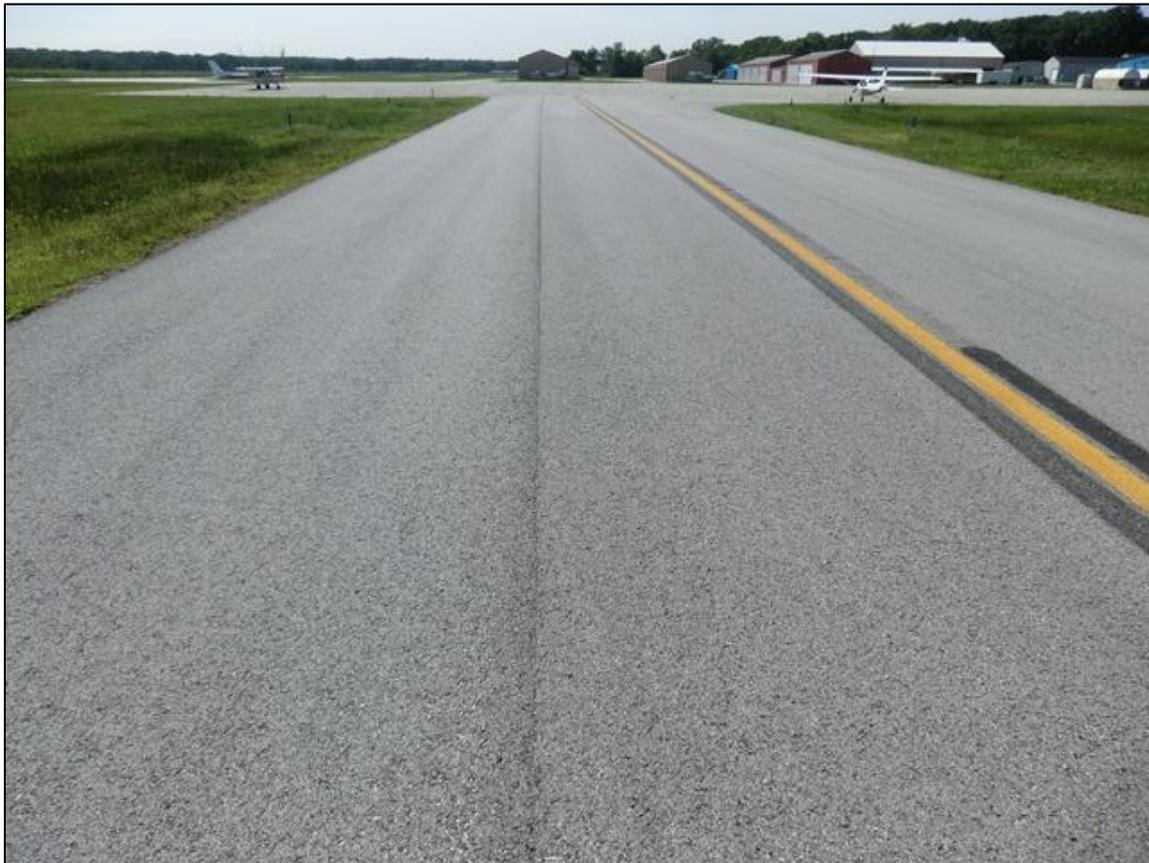
Figure 2-3. Typical Good AC Pavement (Feature 3268)

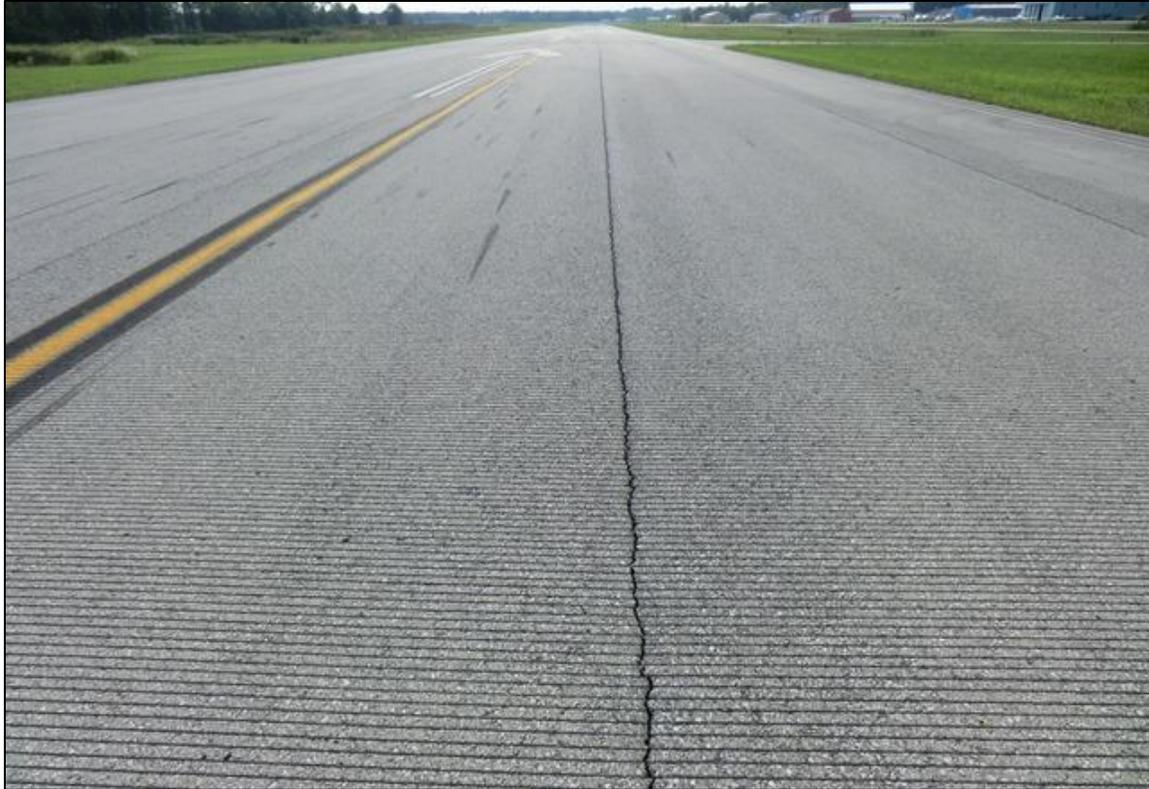
Figure 2-4. Typical Satisfactory AC Pavement (Feature 6110)

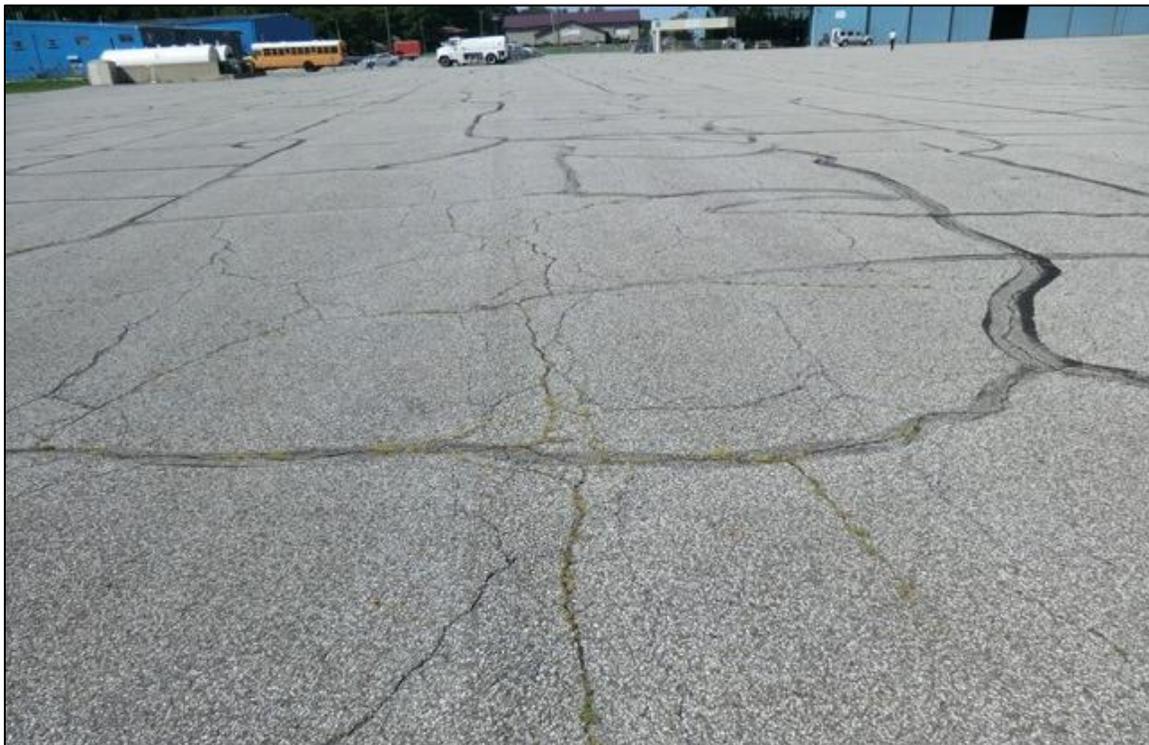
Figure 2-5. Typical Very Poor AC Pavement (Feature 3005)

Feature	Built	Description	Action Yr	Work Item	Cost, \$
215	2012	PARALLEL TAXIWAY	2023	Resurfacing	72,417
3005	1991	RAMP	2015	Structural Overlay	355,753
3010	1991	HELIPAD	2023	Patching / Joint Repair	335
				<b>Total</b>	<b>428,505</b>

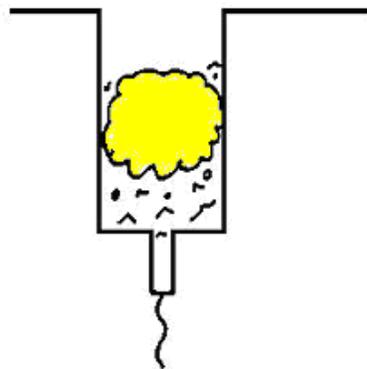
Typical failed joint sealant, w/  
debris and incompressibles.
