Pavement Condition Report

Huntingburg Airport

Project 15805741

February 2015

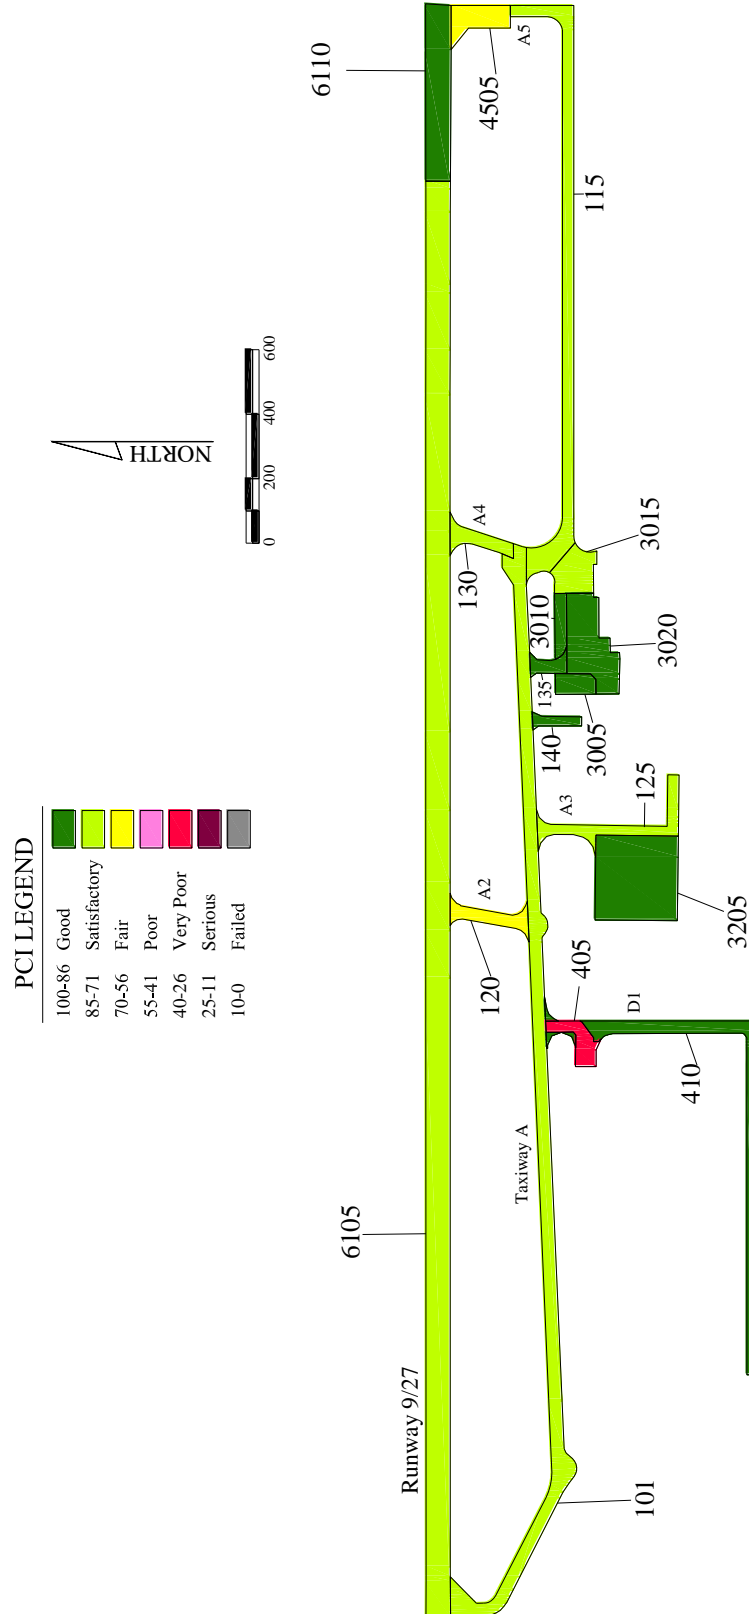
Figure 2-1. Inspected Pavement Condition

The pavement within each of the PCI condition categories is shown in Figure 2-1. The inspected PCI is summarized by branch use in Figure 2-2, and the photographs in Figure 2-3 through Figure 2-5 provide examples of the condition categories.

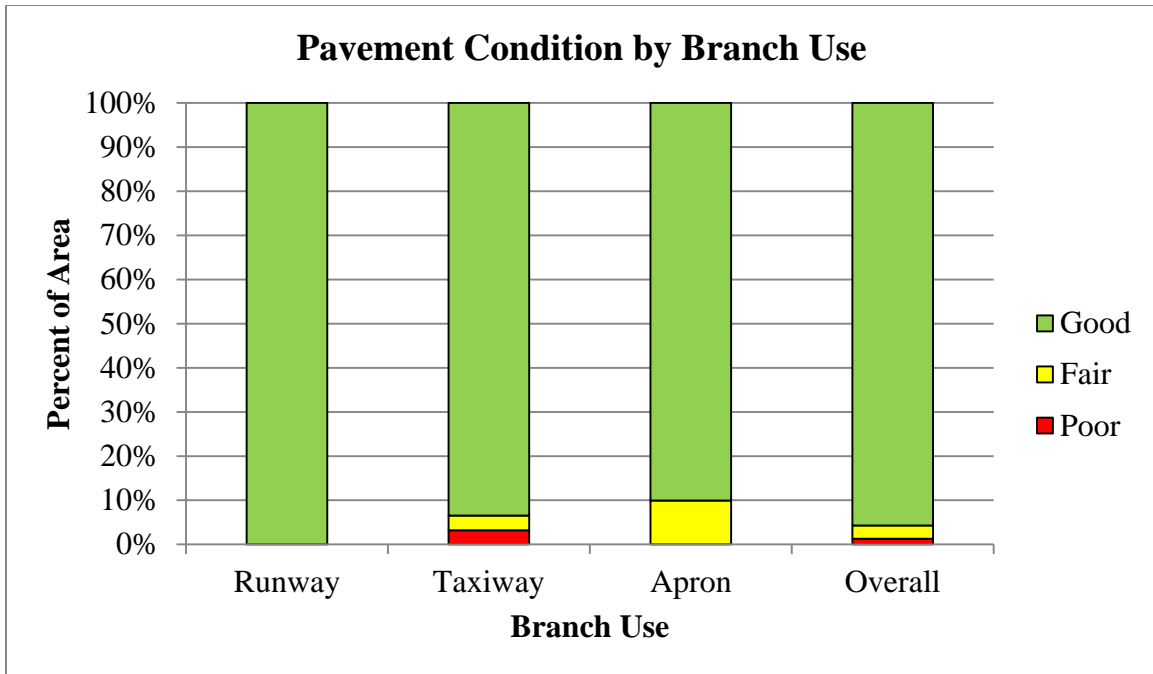
Figure 2-2. Pavement Condition by Branch Use

The average inspected Pavement Condition Index (PCI) for all the airfield pavements was 85. Runways had an average inspected PCI of 84 and were above the desired MSL of 60. Taxiways had an average inspected PCI of 83, and ramps had an average inspected PCI of 92.
