Pavement Condition Report

Indianapolis Executive Airport

Project 13801869

January 2013

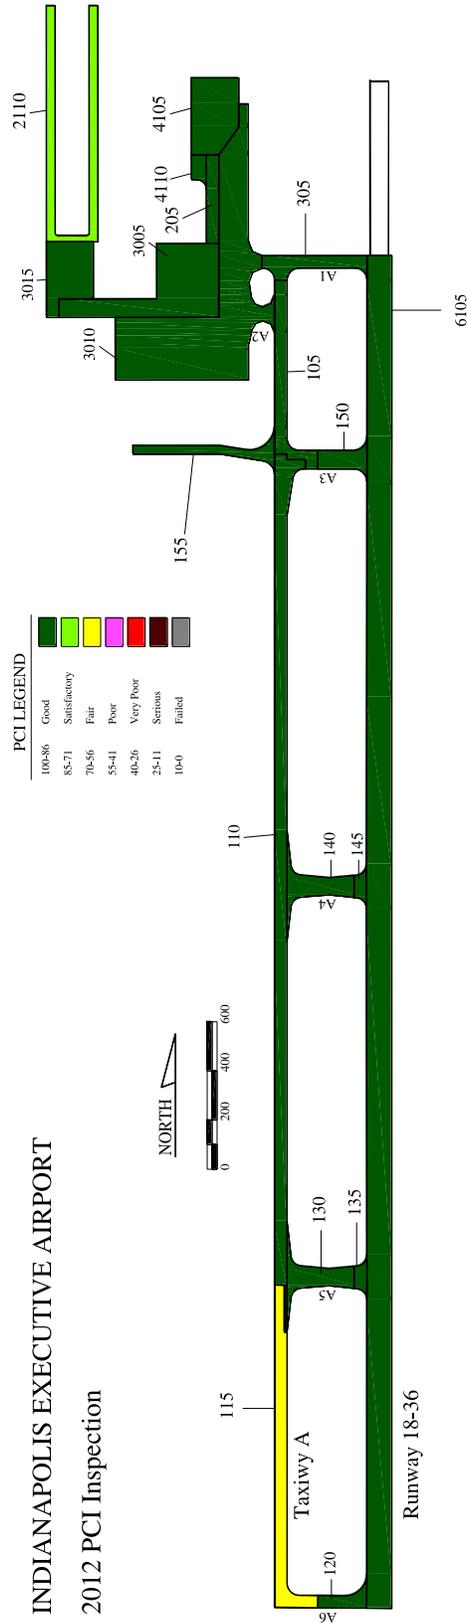
Figure 2-1. Inspected Pavement Condition

The pavement within each of the PCI condition categories is shown in Figure 2-1. The inspected PCI is summarized by branch use in Figure 2-2, and the photographs that follow provide examples of the condition categories.

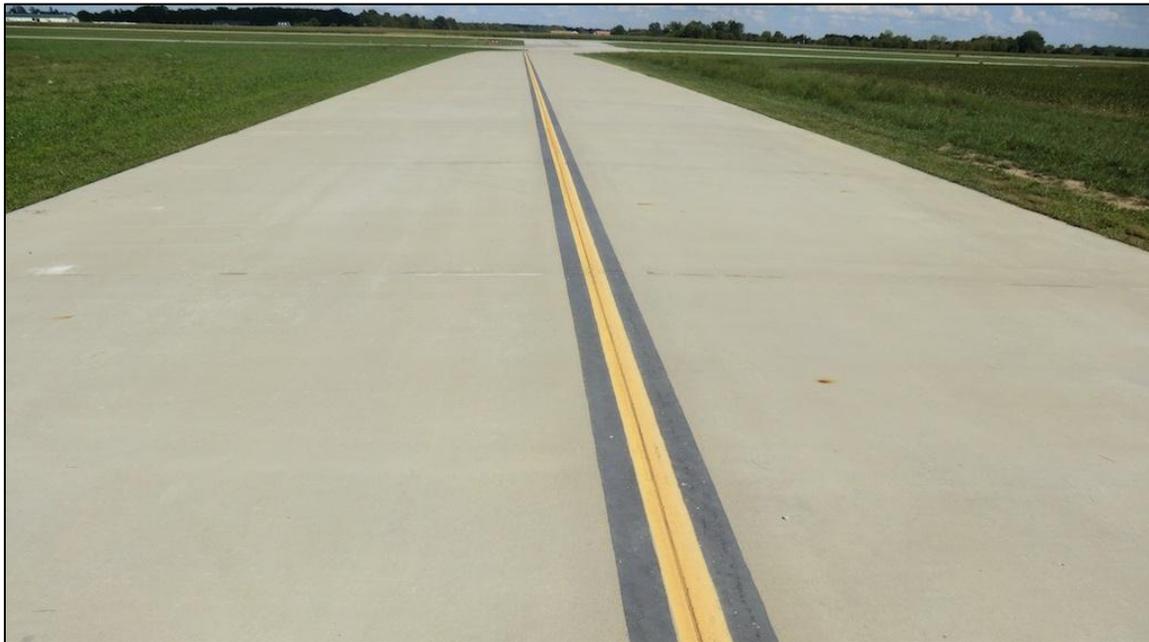
Figure 2-3. Typical Good PCC Pavement (Feature 155)
