Pavement Condition Report

Indianapolis-Hendricks County Airport

Project 15805741

February 2015

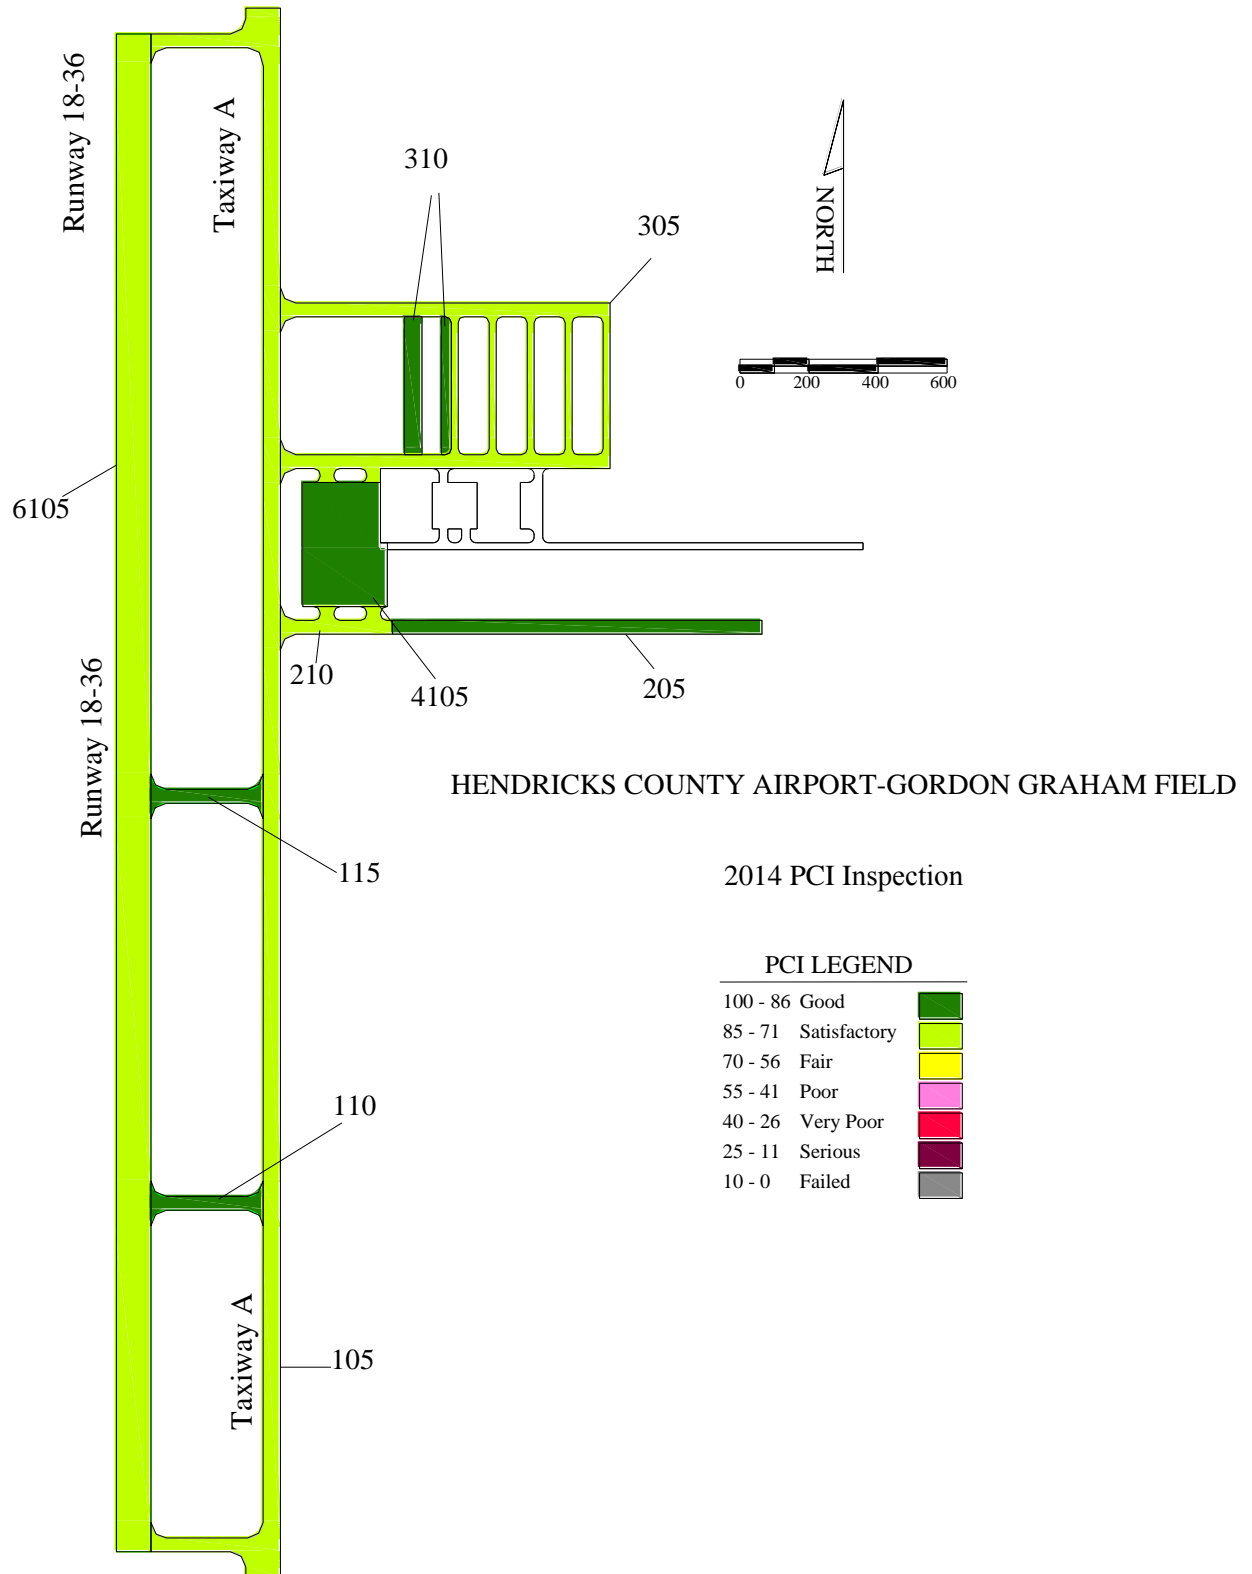
Figure 2-1. Inspected Pavement Condition

The pavement within each of the PCI condition categories is shown in Figure 2-1. The inspected PCI is summarized by branch use in Figure 2-2, and the photographs in Figure 2-3 through Figure 2-5 provide examples of the condition categories.
