Pavement Condition Report

Indianapolis Regional Airport

Project 15805741

February 2015

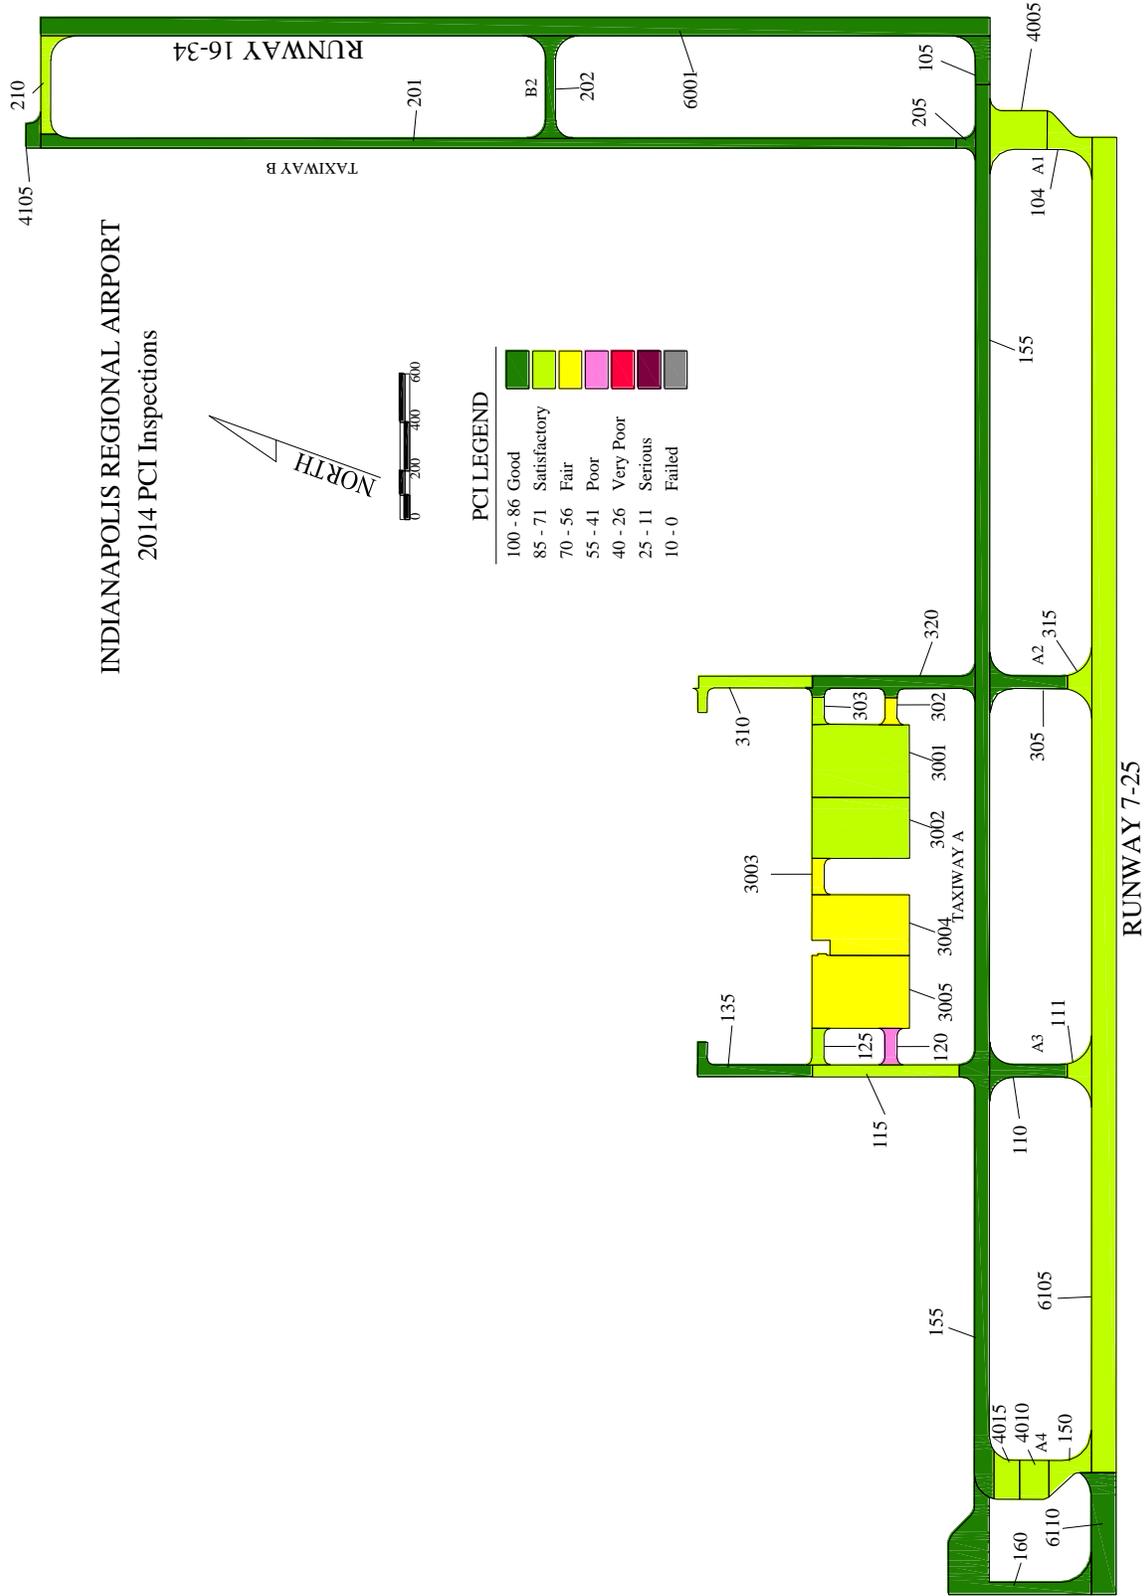
Figure 2-1. Inspected Pavement Condition

The pavement within each of the PCI condition categories is shown in Figure 2-1. The inspected PCI is summarized by branch use in Figure 2-2, and the photographs in Figure 2-3 through Figure 2-7 provide examples of the condition categories.

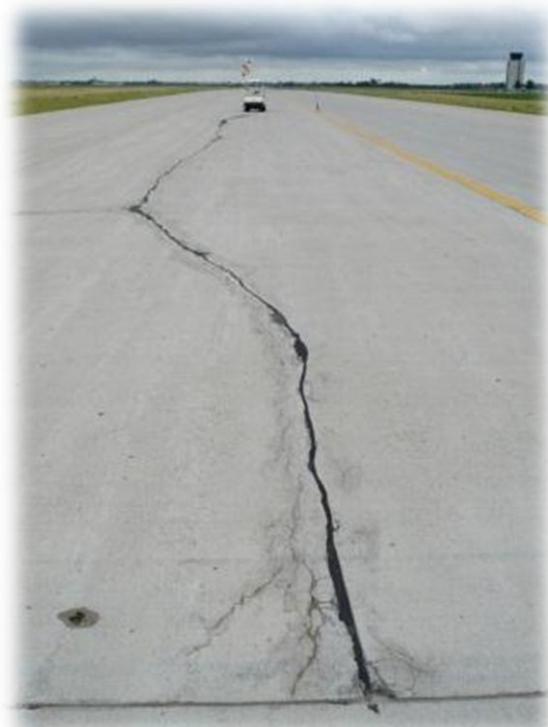
A slab divided into four or more pieces is said to be “divided” or “shattered.” Shattered slab is a separate distress category and indicates a significant structural failure. A shattered slab has lost its ability to distribute loads. Shattered slabs are rated in three severities, but the recommended action in any case is slab replacement.

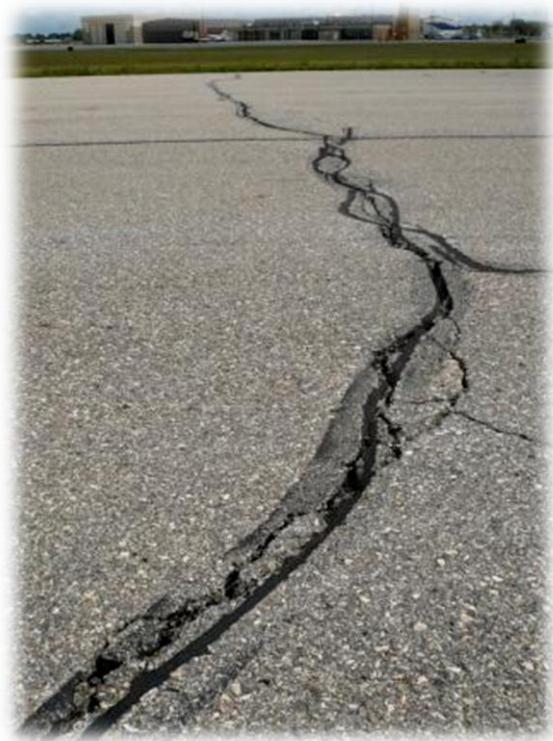
Low-severity L&T cracks are less than ¼ inch wide, or if sealed with suitable filler material in satisfactory condition can be any width less than 3 inches, if they are not spalled. Maintenance usually is not indicated for low-severity cracking. Moderately spalled cracks and cracks wider than ¼ inch which are not satisfactorily sealed are at medium severity. Medium-severity cracks should be sealed with a high-quality crack filling material. Severely spalled cracks and cracks wider than 3 inches are at high severity. High-severity L&T cracks normally require patching.
