# Pavement Condition Report

## Rensselaer-Jasper County Airport

Project 15805741

**February 2015**

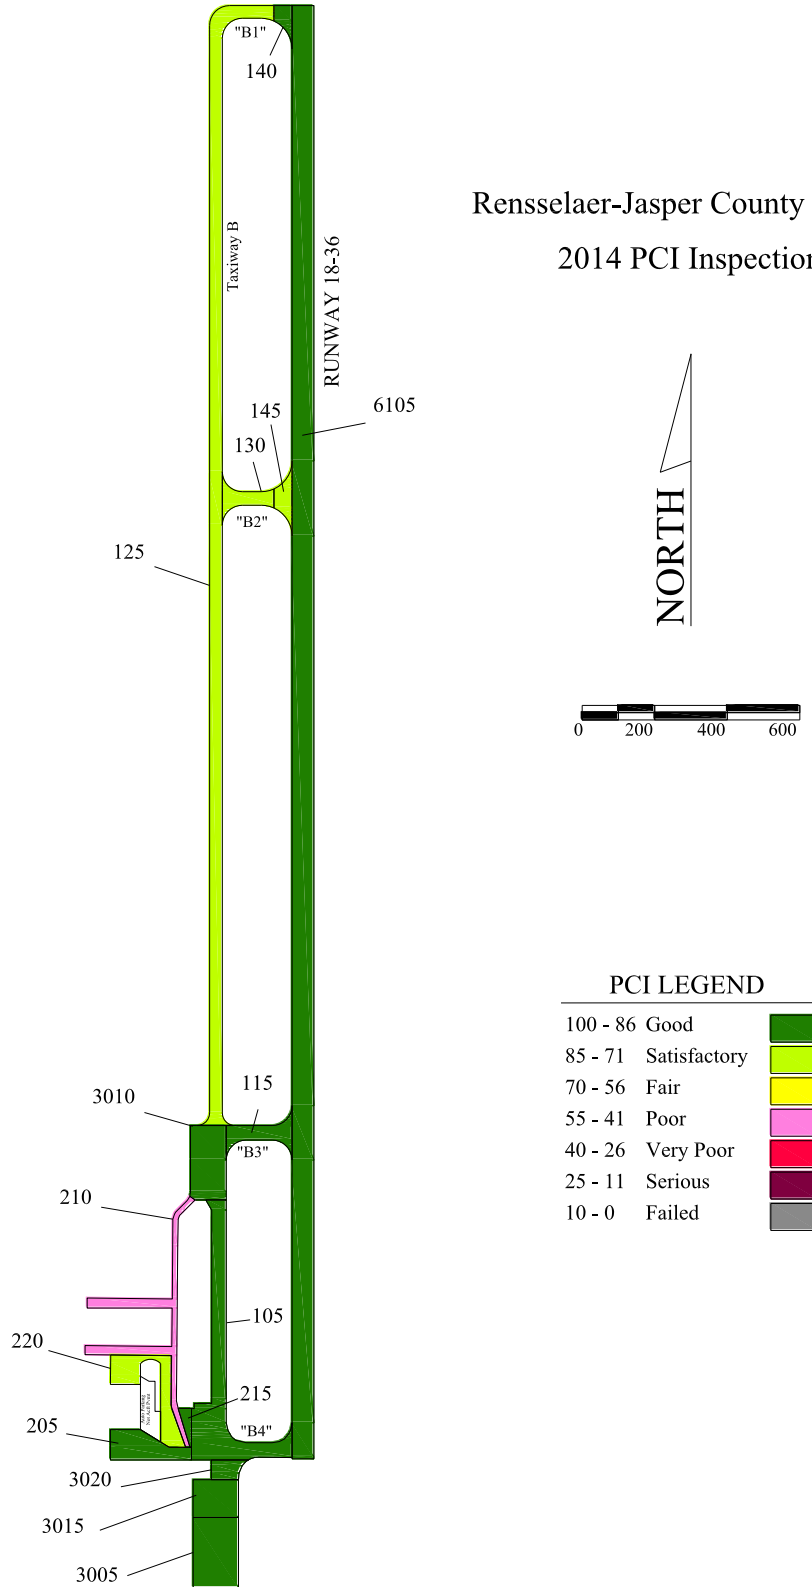
Figure 2-1. Inspected Pavement Condition

The pavement within each of the PCI condition categories is shown in Figure 2-1. The inspected PCI is summarized by branch use in Figure 2-2, and the photographs in Figure 2-3 through Figure 2-5 provide examples of the condition categories.

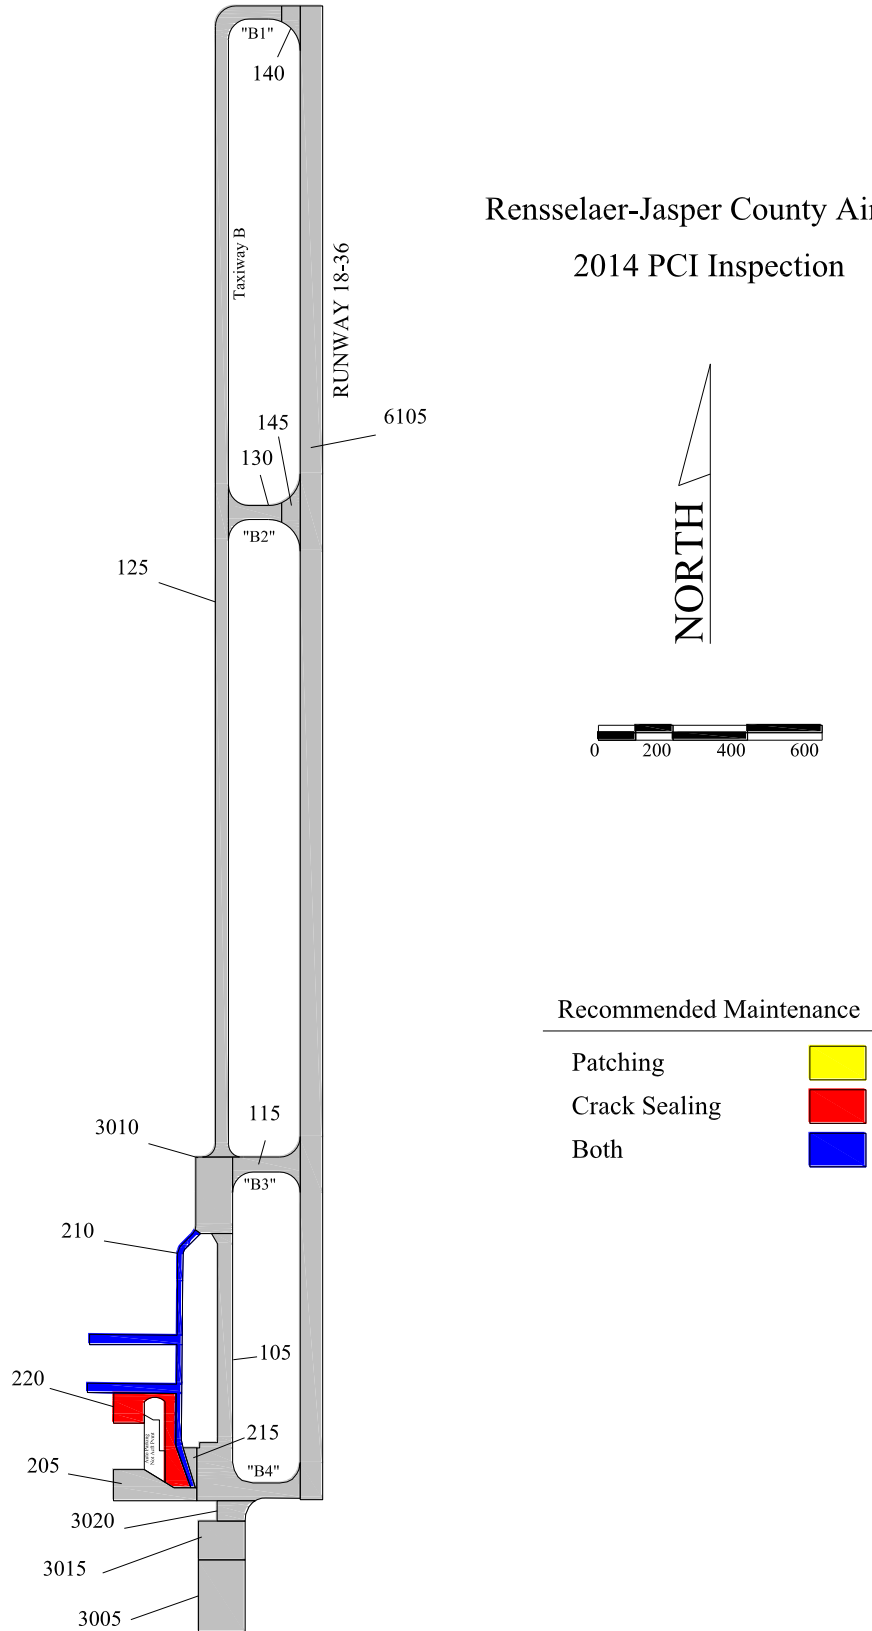
Figure 4-1. Recommended Maintenance

Analysis of potential maintenance projects identified approximately 1,300 square feet of patching needs and approximately 300 linear feet of crack sealing and crack repair needs, at an estimated total cost of approximately \$12,000.
