Pavement Condition Report

Michigan City Municipal Airport

Project 13801869

January 2013

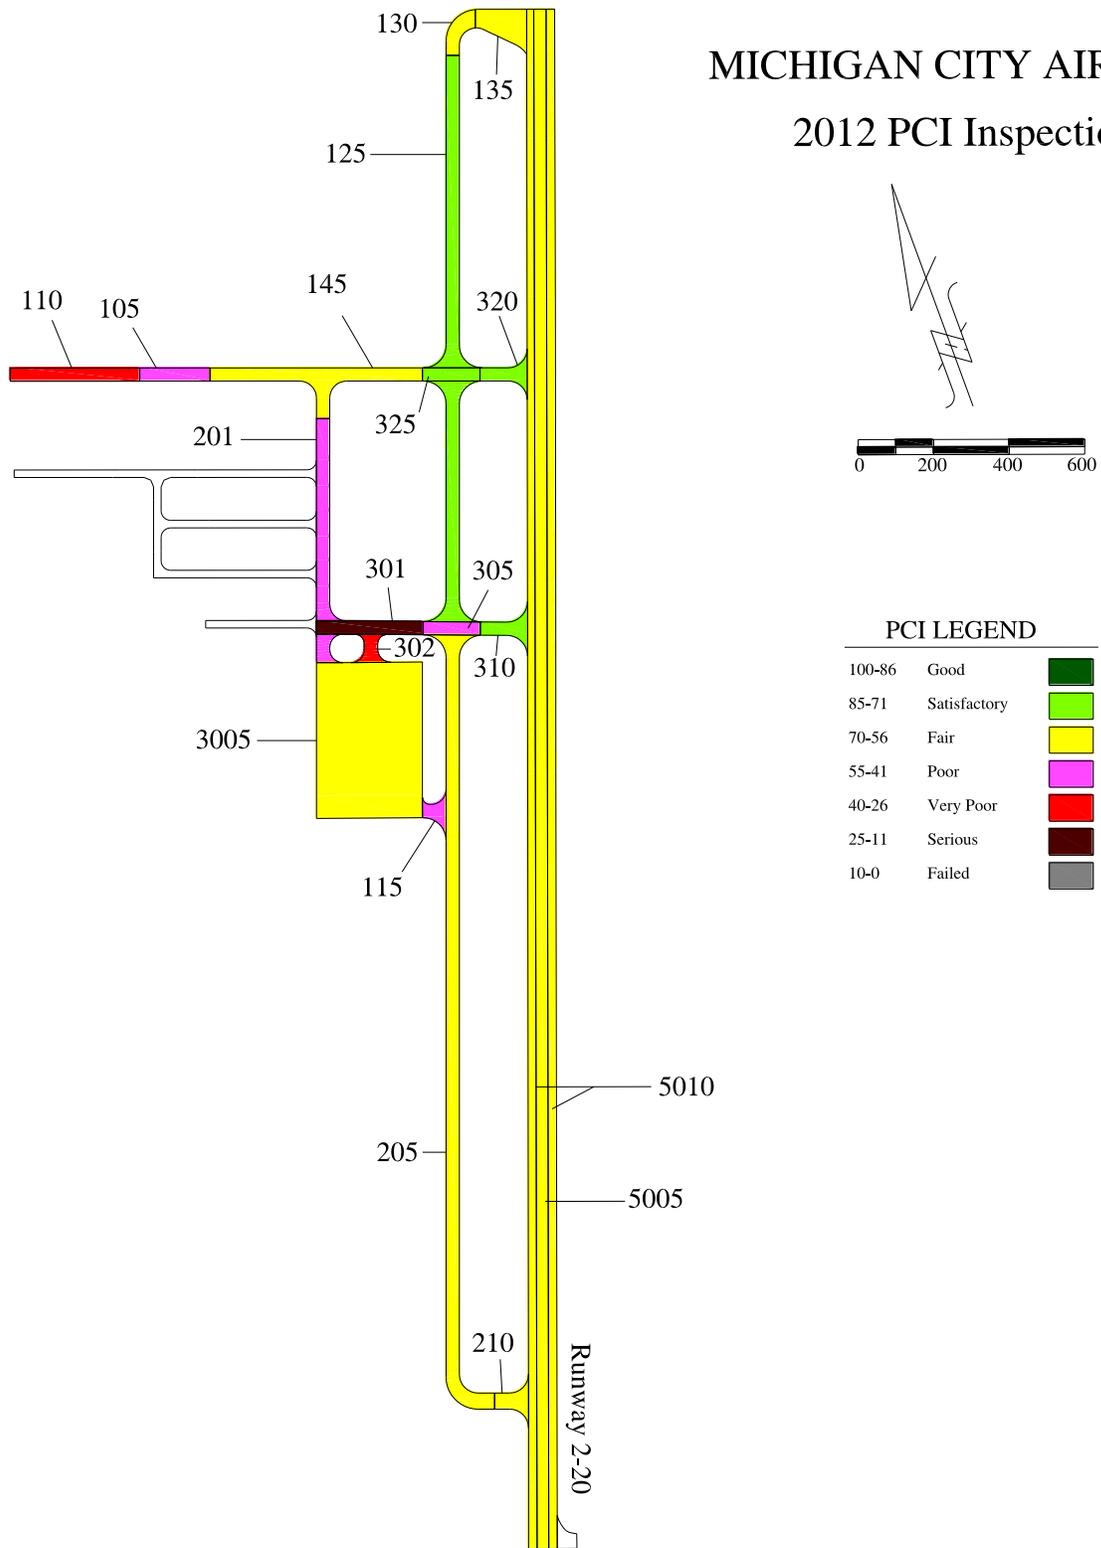
Figure 2-1. Inspected Pavement Condition

Seven pavement sections had a simplified PCI rating of Poor, indicating that near-term maintenance needs may range from routine up to a reconstruction to maintain serviceability. The pavement within each of the PCI condition categories is shown in Figure 2-1. The inspected PCI is summarized by branch use in Figure 2-2, and the photographs that follow provide examples of the condition categories.
