Pavement Condition Report

Monticello-White County Airport

Project 15805741

February 2015

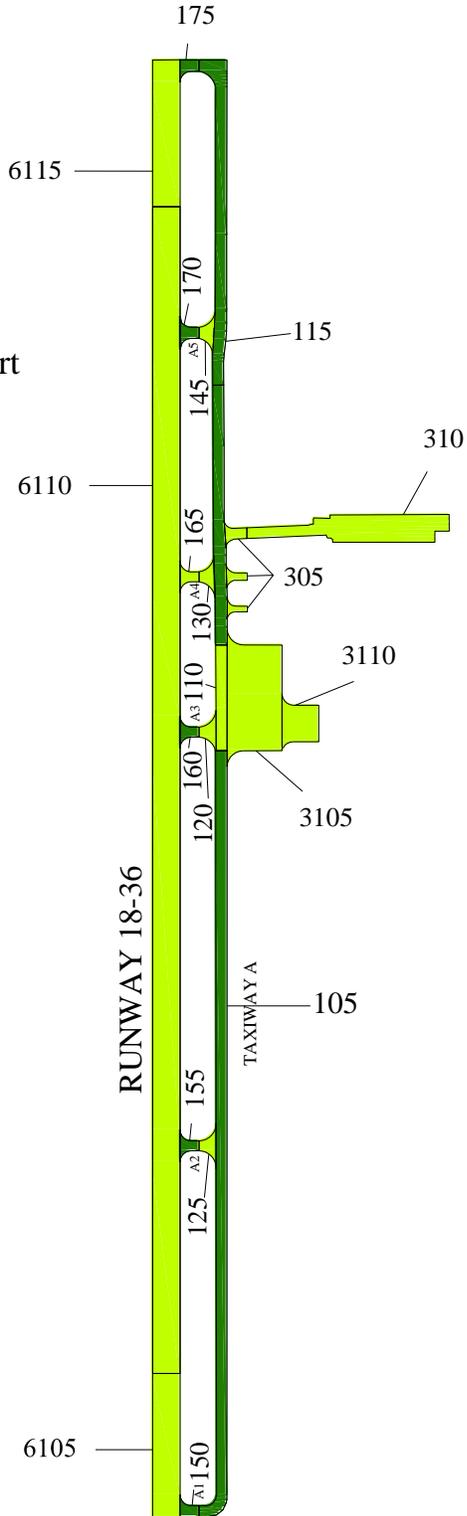
Figure 2-1. Inspected Pavement Condition

The pavement within each of the PCI condition categories is shown in Figure 2-1. The inspected PCI is summarized by branch use in Figure 2-2, and the photographs in Figure 2-3 through Figure 2-5 provide examples of the condition categories.

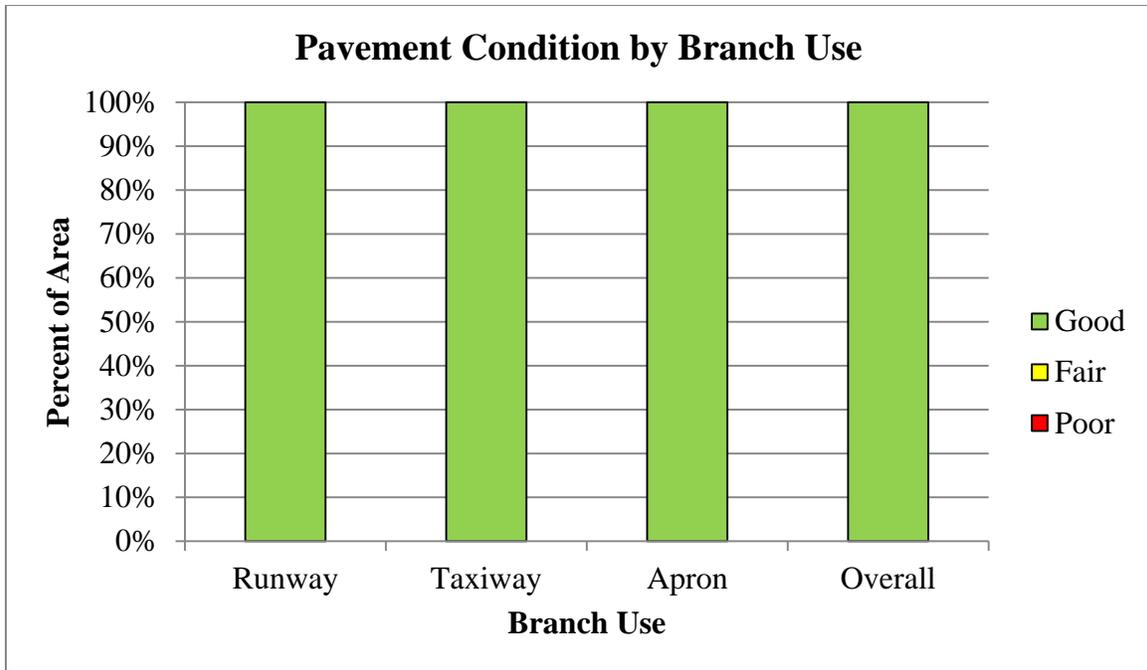
Figure 2-2. Pavement Condition by Branch Use

The average inspected Pavement Condition Index (PCI) for all the airfield pavements was 82. Runways had an average inspected PCI of 80 and were above the desired MSL of 60. Taxiways had an average inspected PCI of 88, and ramps had an average inspected PCI of 77.

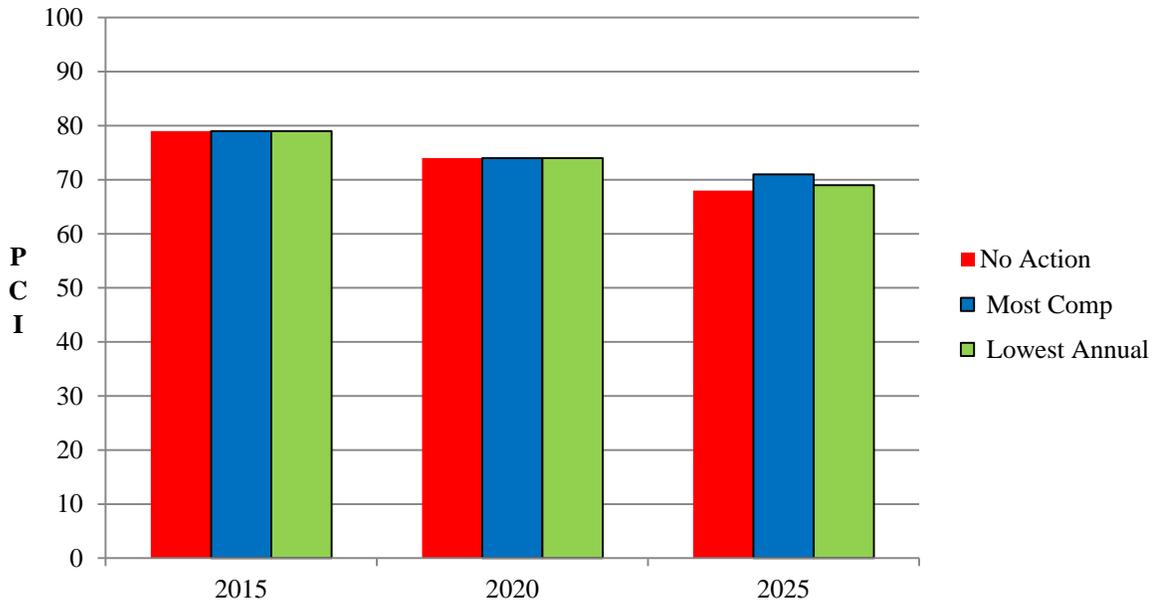
Figure 3-1. Programmed CIP

The table below provides a summary of the projected pavement rehabilitation needs for the next 5 years of the capital improvement program, starting in 2015. The PCI is not expected to fall below MSL within the next five years and no airfield pavement rehabilitation actions are identified. If no action is taken, the overall PCI is projected to drop from 80 to 74 by 2020.

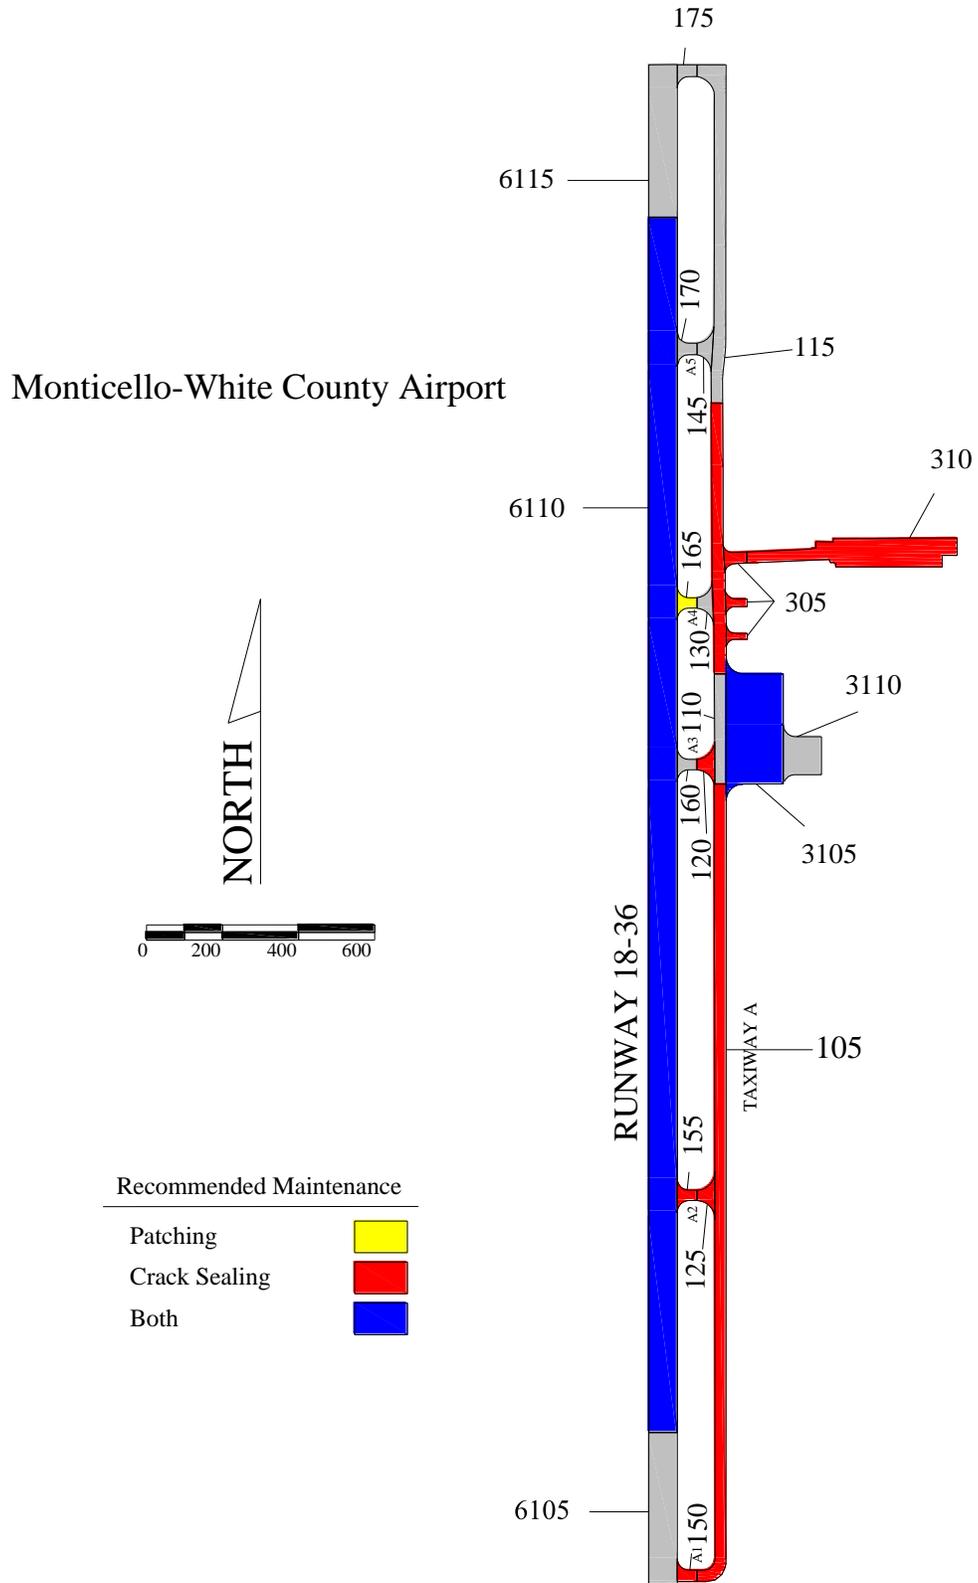
Figure 4-1. Recommended Maintenance

Analysis of potential maintenance projects identified approximately 100 square feet of patching needs and approximately 6,000 linear feet of crack sealing and crack repair needs, at an estimated total cost of approximately \$7,000.

Work Item	Quantity	Unit	Cost
AC PATCH	103	S.F.	897
AC RESTORATIVE CRACK REPAIR	3,110	L.F.	3,856
AC SUSTAINING CRACK REPAIR	2,579	L.F.	2,231
Total:			\$6,984
