Pavement Condition Report

Valparaiso-Porter County Regional Airport

Project 1480370

January 2014

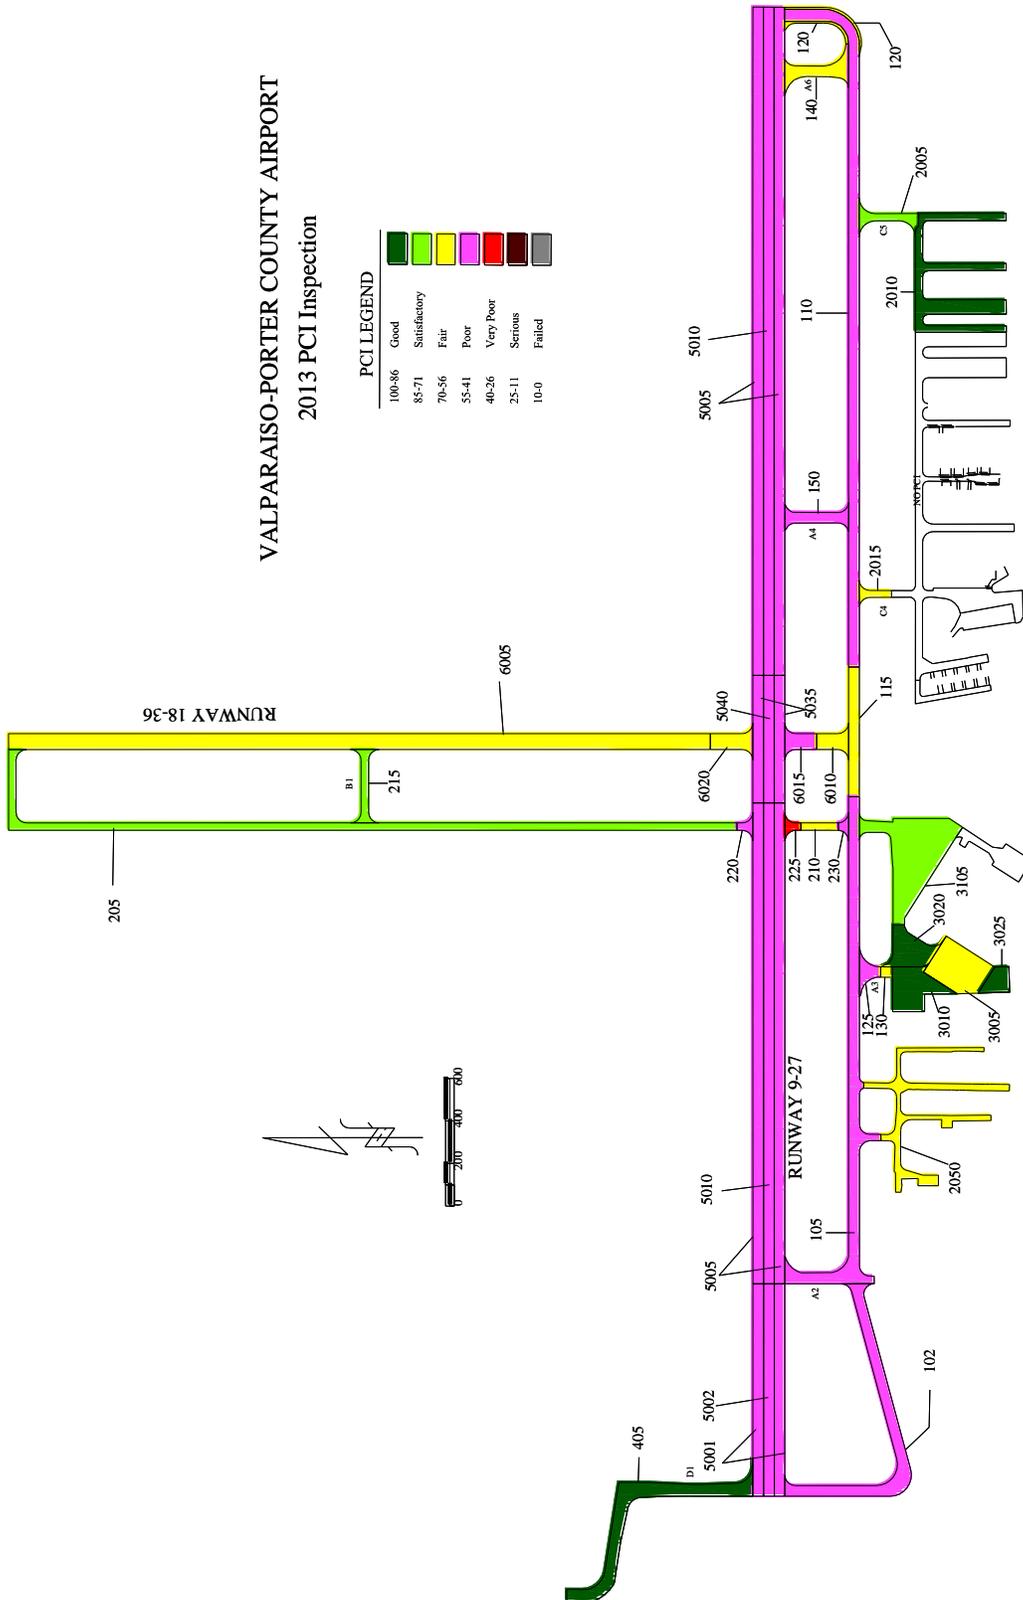
Figure 2-1. Inspected Pavement Condition

The pavement within each of the PCI condition categories is shown in Figure 2-1. The inspected PCI is summarized by branch use in Figure 2-2, and the photographs in Figure 2-3 through Figure 2-7 provide examples of the condition categories.

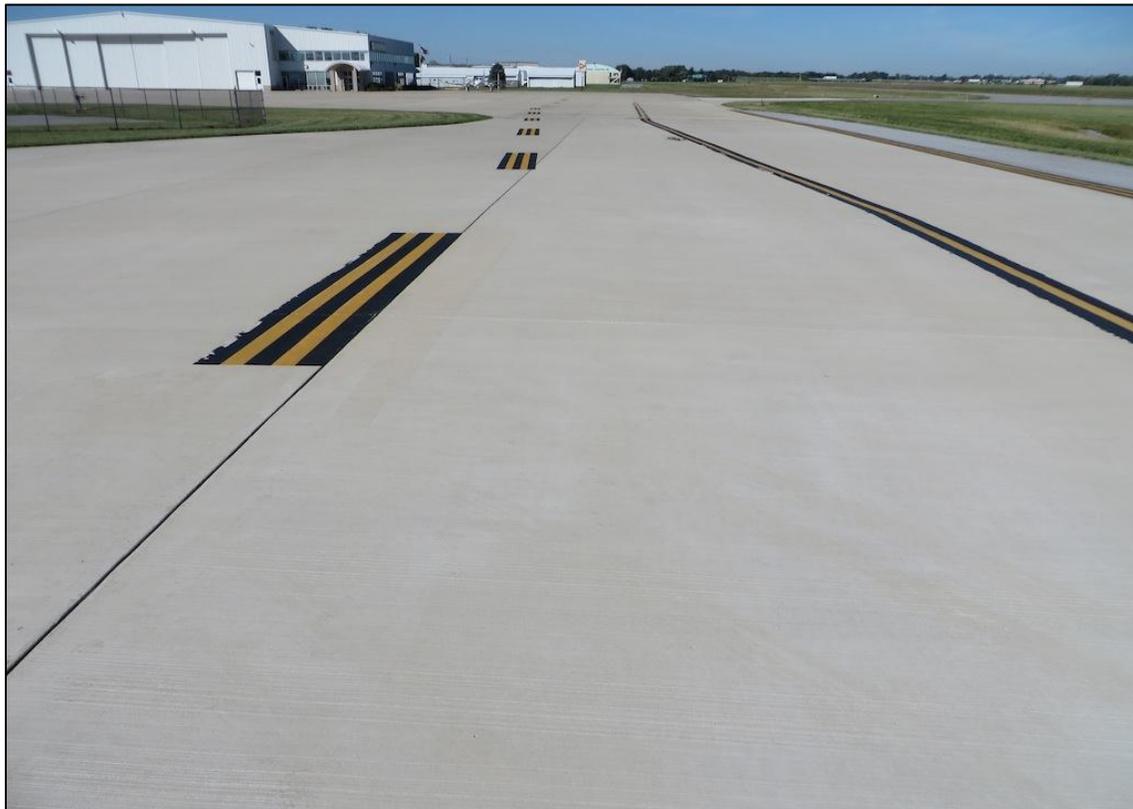
Figure 2-3. Typical Good PCC Pavement (Feature 3105)
