# Pavement Condition Report

## Portland Municipal Airport

Project 1480370

**January 2014**

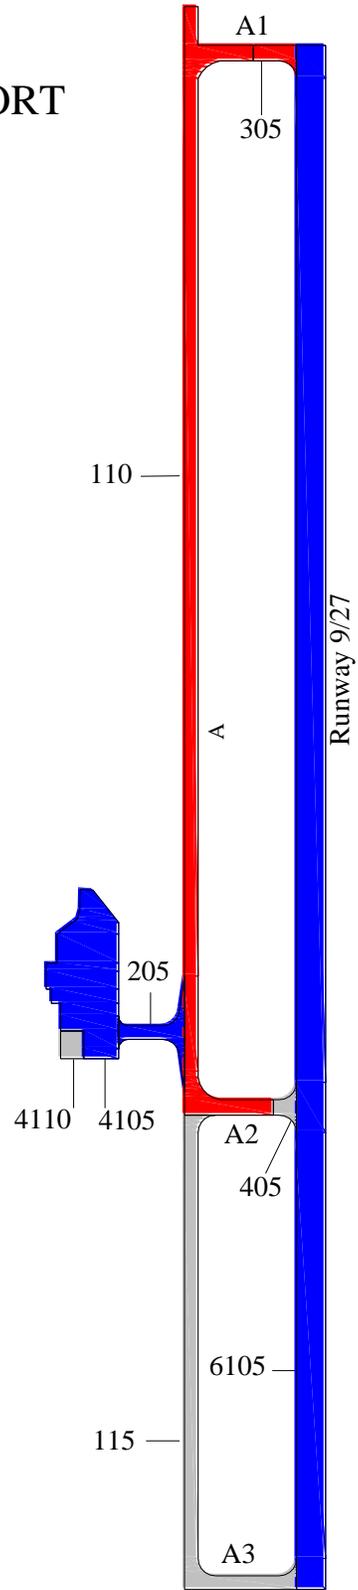
## 2013 PCI Inpsection

Analysis of potential maintenance projects identified 193 square feet of patching needs and approximately 19,500 linear feet of crack sealing and crack repair needs, at an estimated total cost of approximately \$25,000.

Specific recommendations to help prioritize airfield maintenance are found in chapter 4 of this report. A summary of all identified maintenance needs is shown in the table below and in the figure on the following page.

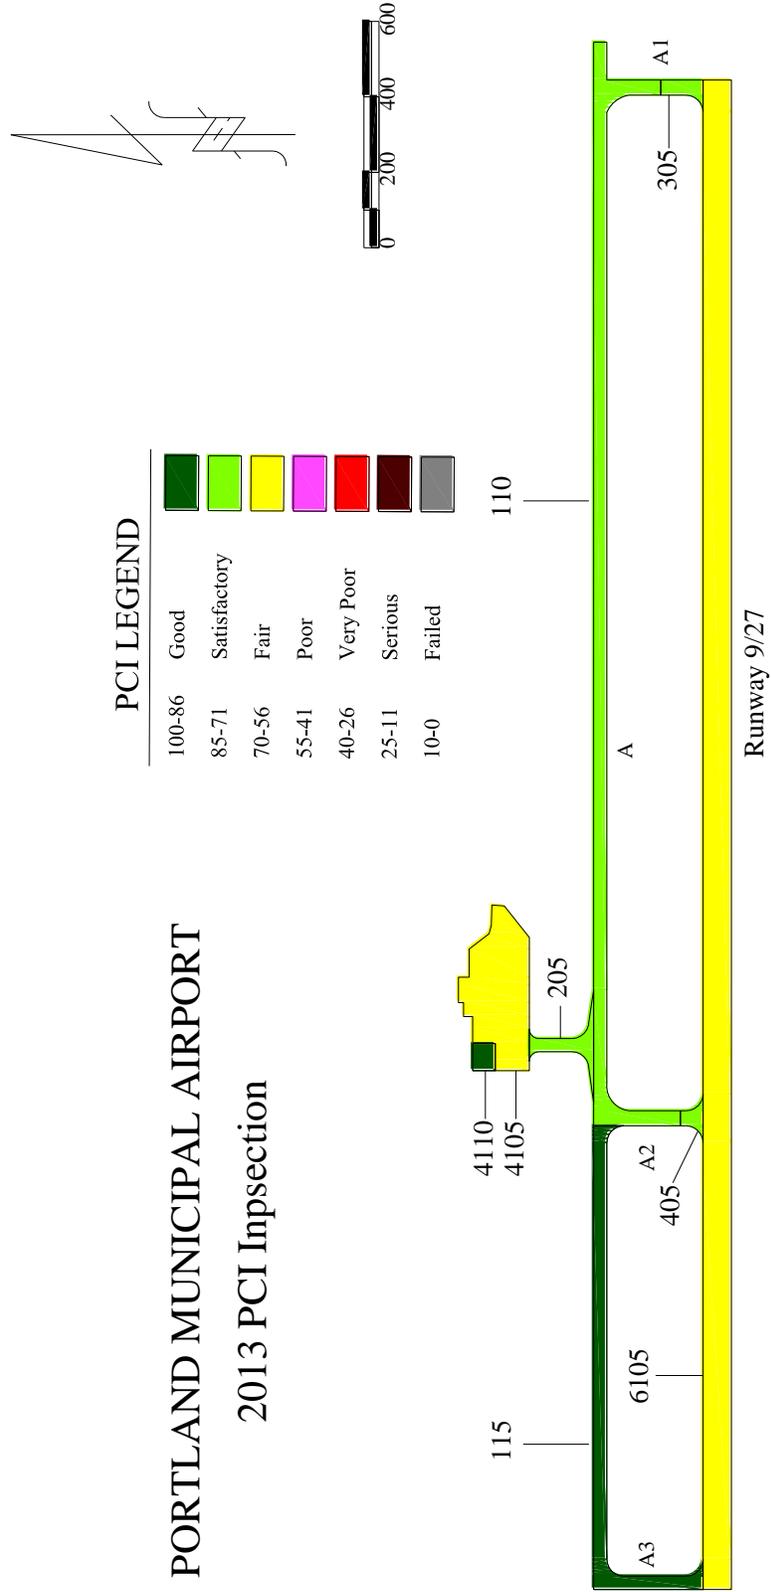
Figure 2-1. Inspected Pavement Condition

The pavement within each of the PCI condition categories is shown in Figure 2-1. The inspected PCI is summarized by branch use in Figure 2-2, and the photographs in Figure 2-3 through **Error! Reference source not found.** provide examples of the condition categories.

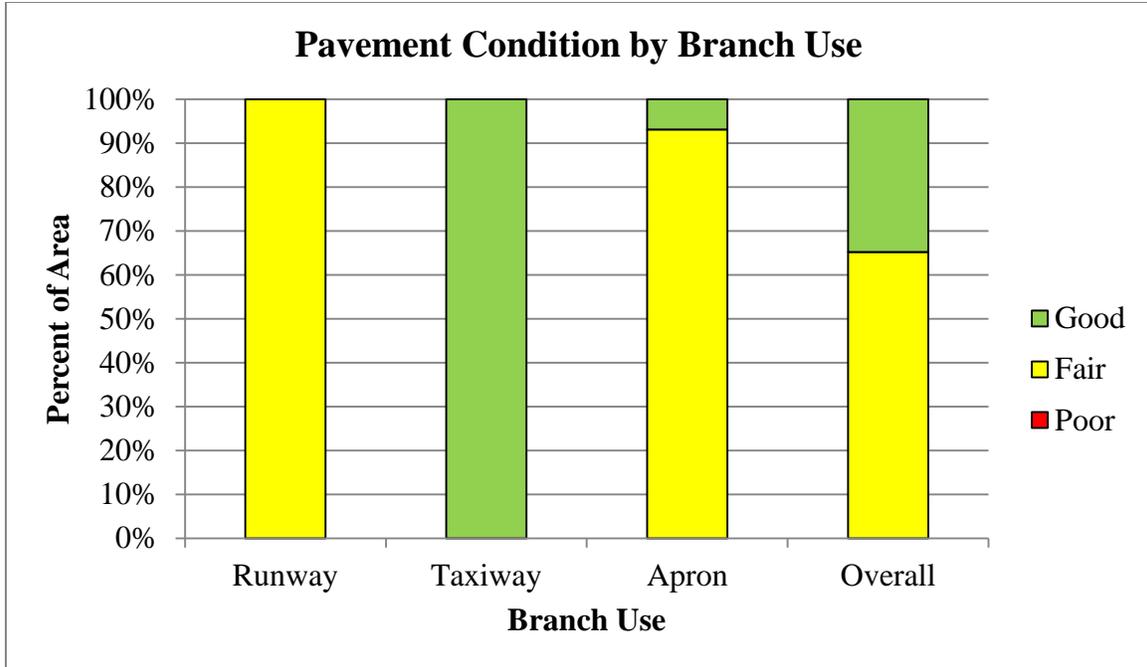
Figure 2-2. Pavement Condition by Branch Use

The overall Pavement Condition Index (PCI) for the airfield pavements was 73. Runways had an average inspected PCI of 67 and were above the desired MSL of 60. Taxiways had an average inspected PCI of 83, and ramps had an average inspected PCI of 68.
