Pavement Condition Report

Richmond Municipal Airport

Project 15805741

February 2015

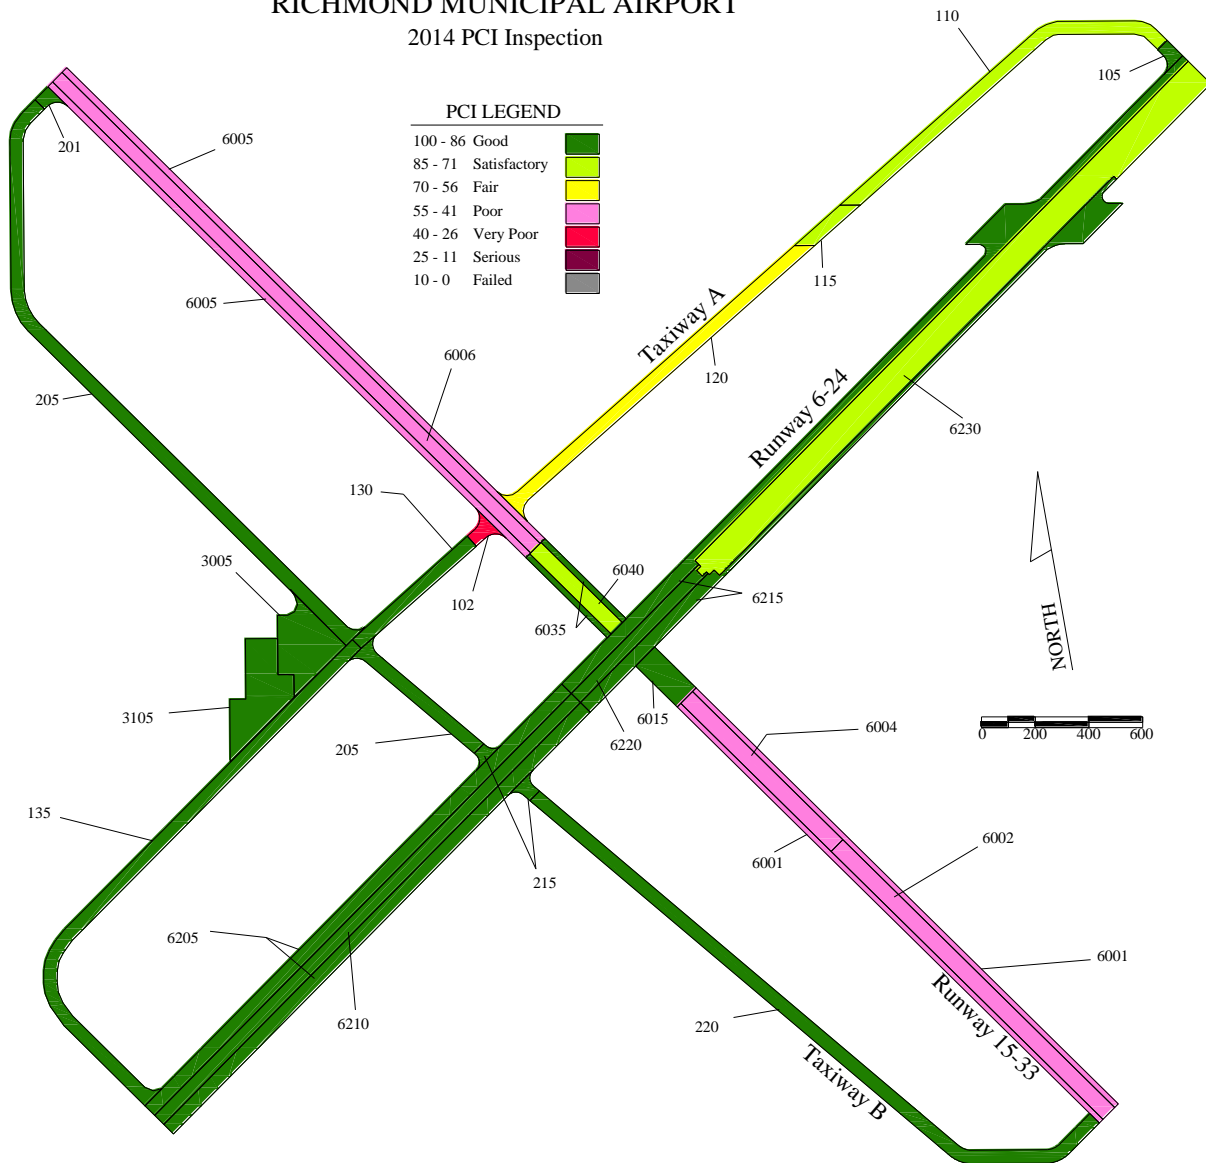
Figure 2-1. Inspected Pavement Condition

The average inspected Pavement Condition Index (PCI) for all the airfield pavements was 79. Runways had an average inspected PCI of 74. Runway 6-24 was below the MSL of 60 with an average PCI of 52. Runway 15-33 was well above the MSL with an average PCI of 89. The taxiways had an average inspected PCI of 89, and the ramps had an average inspected PCI of 90.

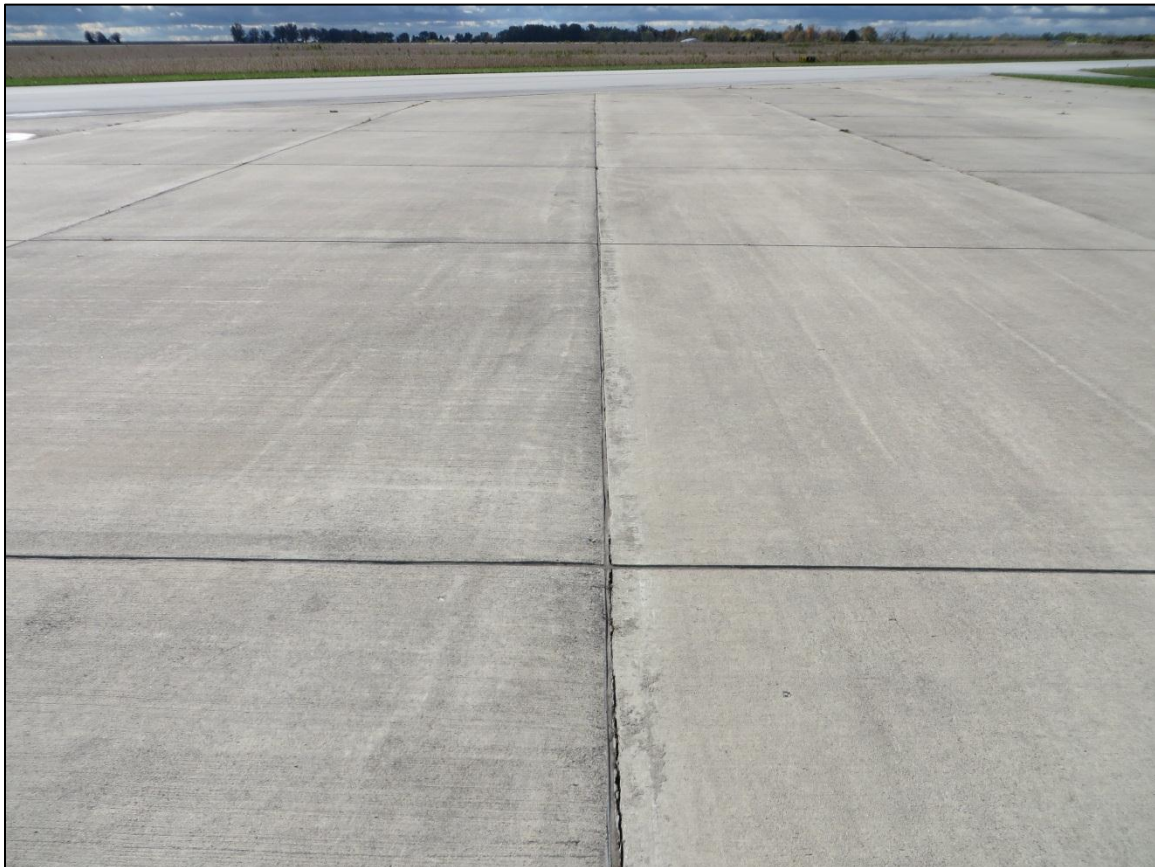
Figure 2-3. Typical Good PCC Pavement (Feature 3105)

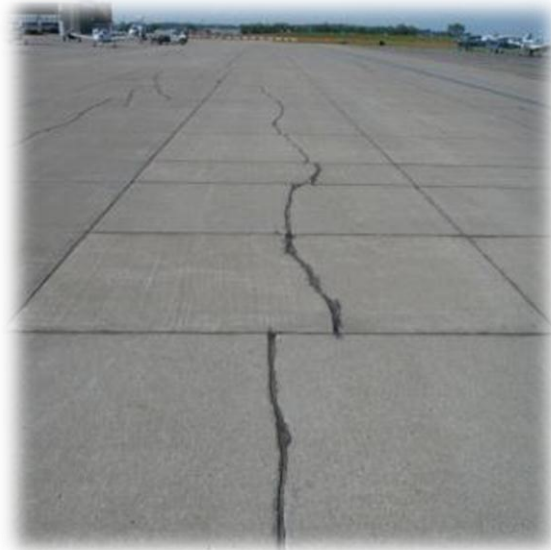
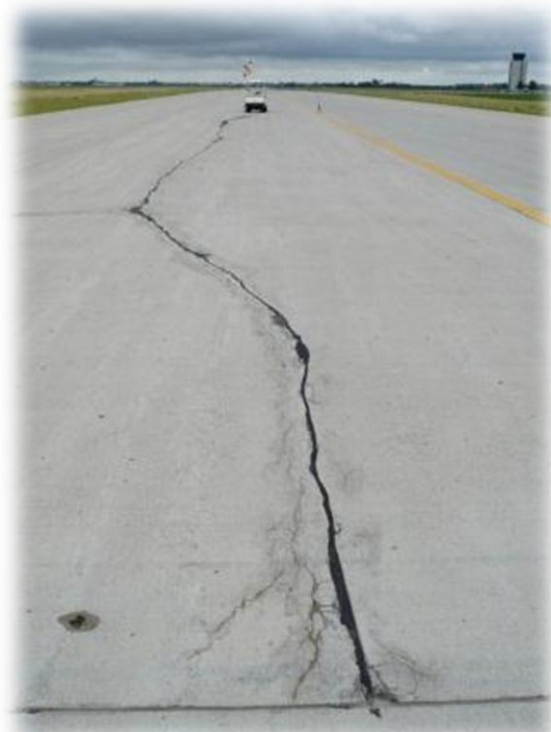
A slab divided into four or more pieces is said to be “divided” or “shattered.” Shattered slab is a separate distress category and indicates a significant structural failure. A shattered slab has lost its ability to distribute loads. Shattered slabs are rated in three severities, but the recommended action in any case is slab replacement.

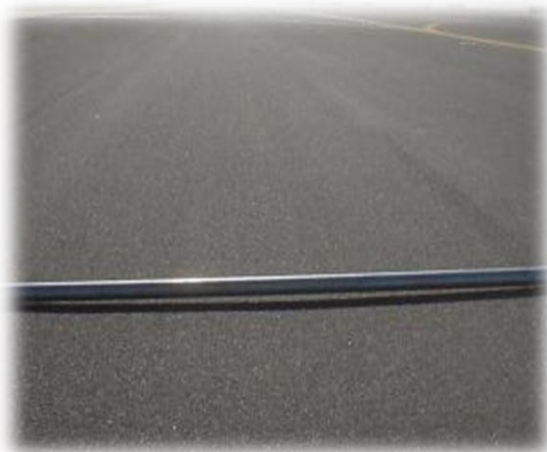
At low severity, ruts have an average depth of ¼ to ½ inches. At medium severity, ruts have an average depth of ½ to 1 inch. At high severity, ruts have an average depth greater than 1 inch. Patching is the appropriate repair for ruts.
