# Pavement Condition Report

## Sheridan Airport

Project 15805741

**February 2015**

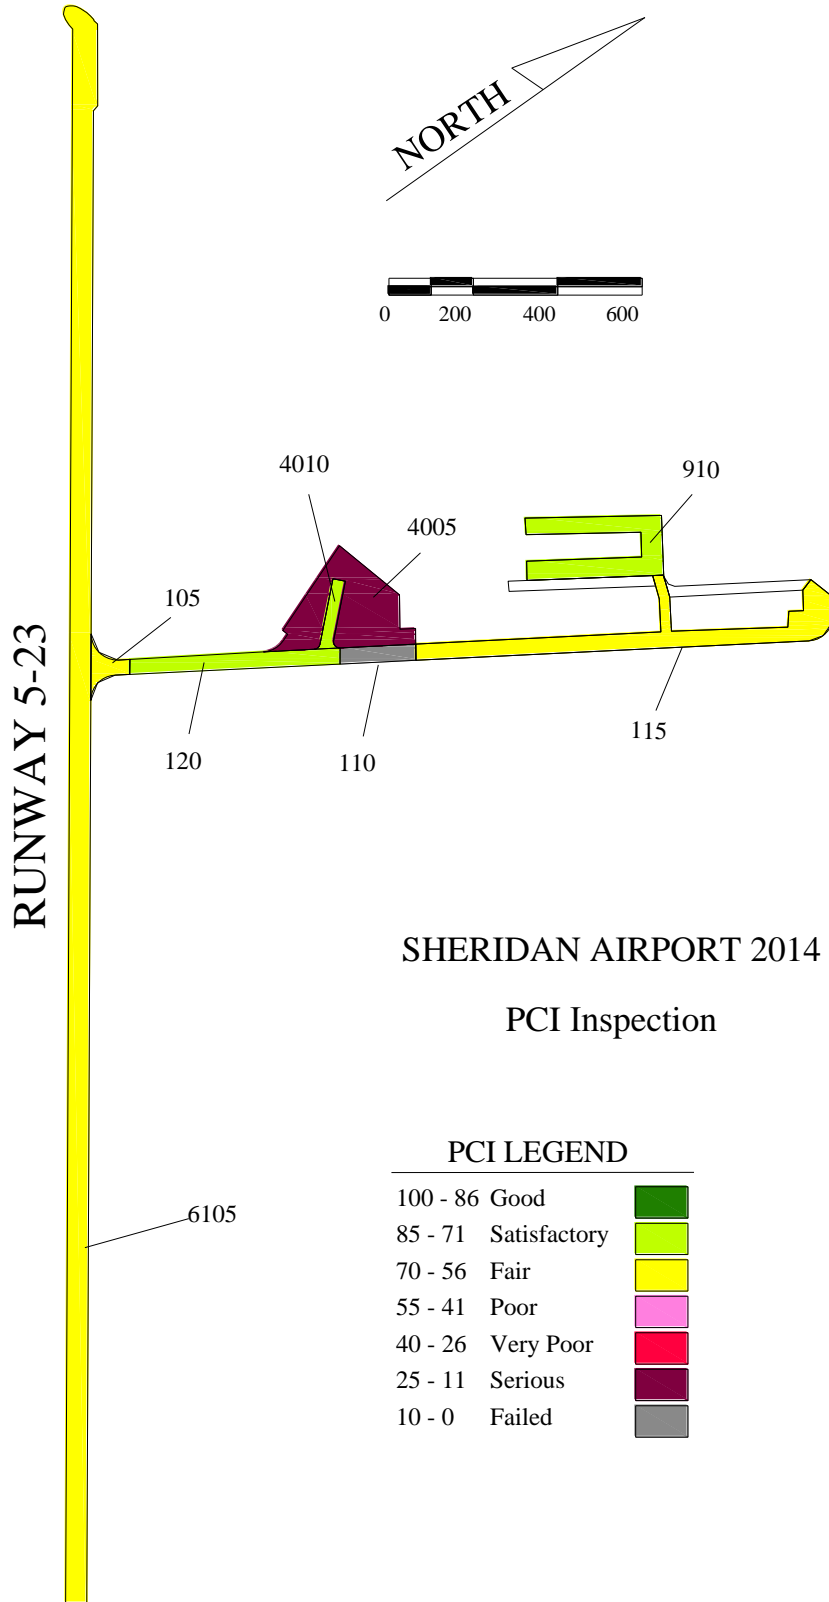
Figure 2-1. Inspected Pavement Condition

11-25	SERIOUS: Pavement has mainly high-severity distresses that cause operational restrictions; immediate repairs are needed.	41,715	12%
	0-10	FAILED: Pavement deterioration has progressed to the point that safe operations are no longer possible; complete reconstruction is required.	6,885	2%
