# Pavement Condition Report

## Wabash Municipal Airport

Project 13801869

**January 2013**

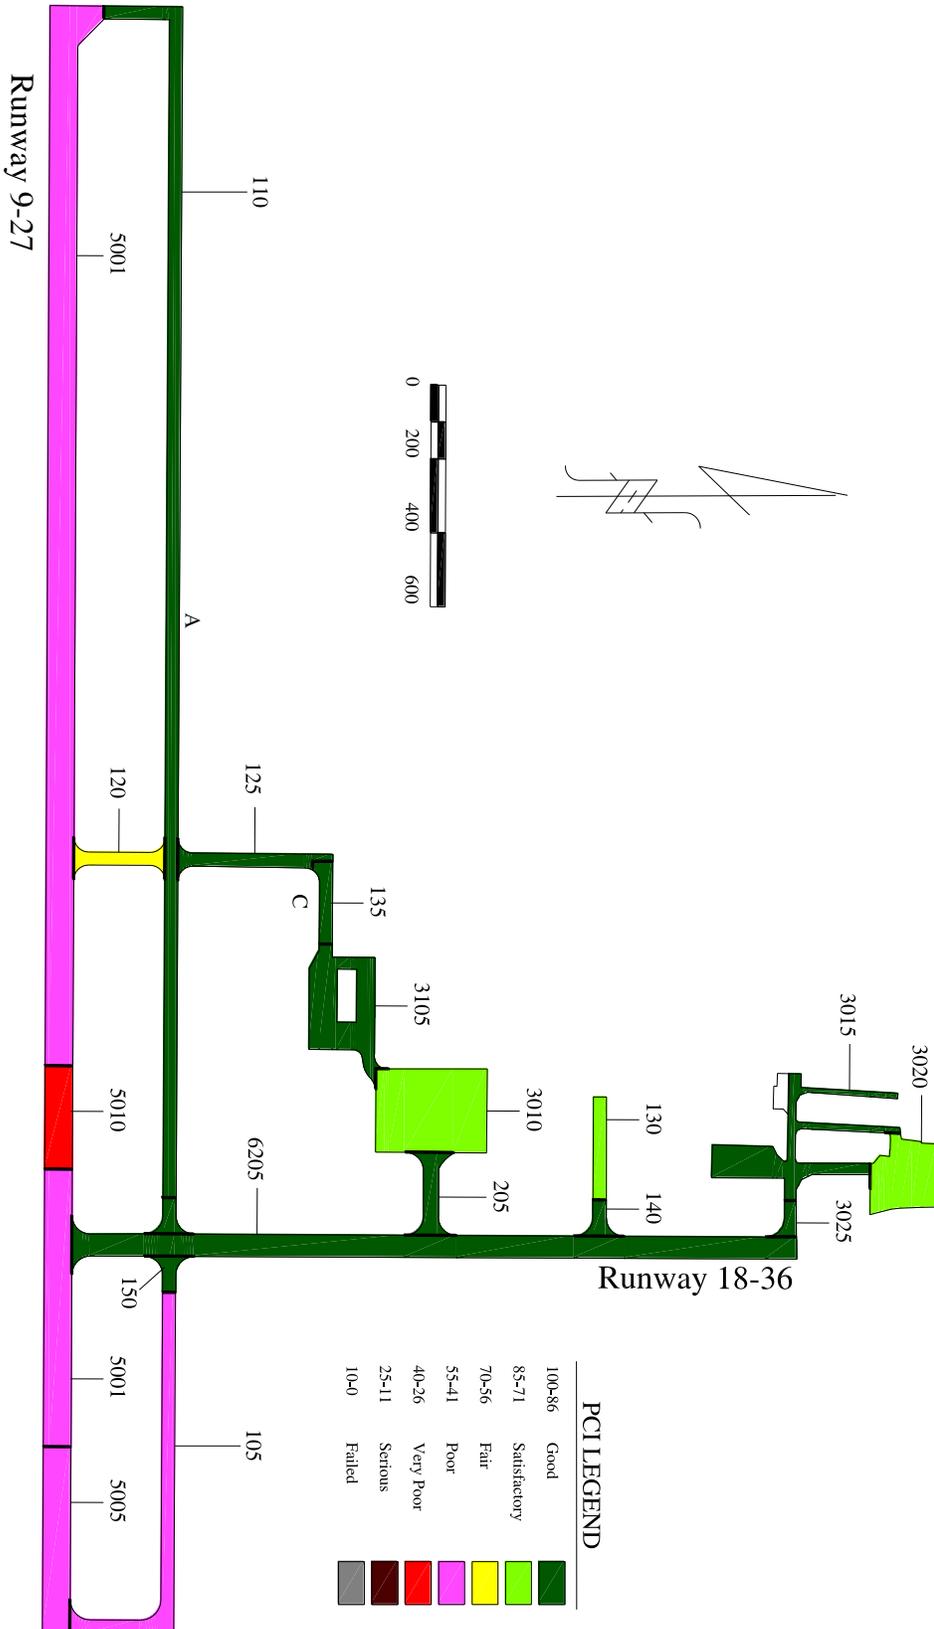
Figure 2-1. Inspected Pavement Condition

Four pavement sections had a simplified PCI rating of Poor, indicating that near-term maintenance needs may range from routine up to a reconstruction to maintain serviceability. The pavement within each of the PCI condition categories is shown in Figure 2-1. The inspected PCI is summarized by branch use in Figure 2-2, and the photographs that follow provide examples of the condition categories.

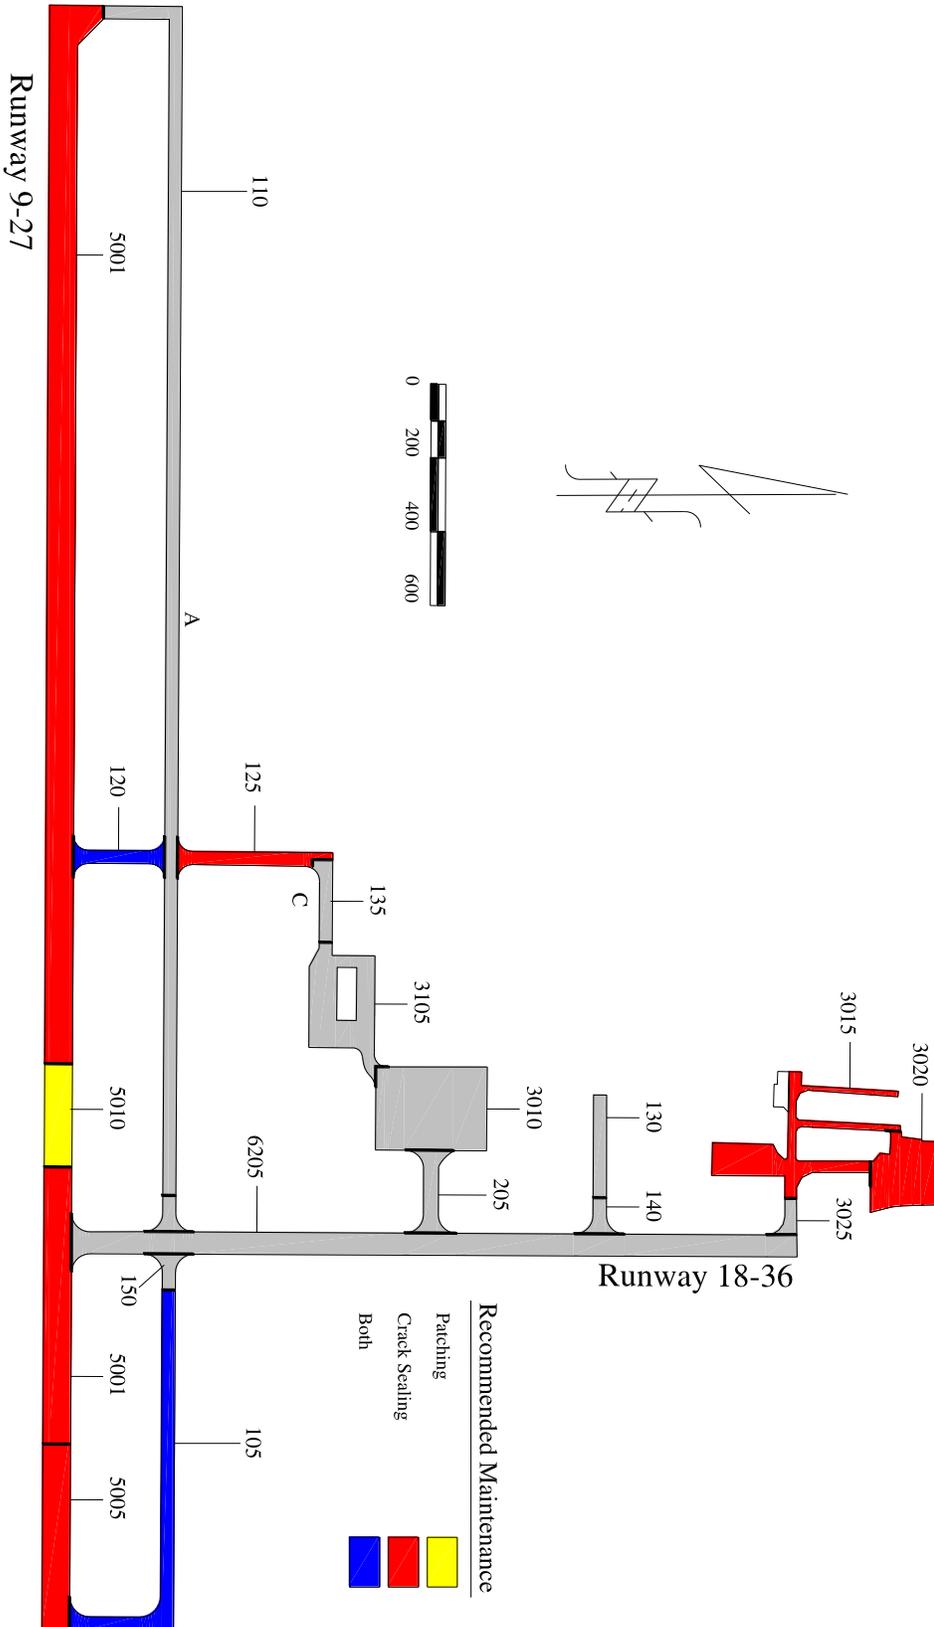
Figure 4-1. Recommended Maintenance

Analysis of potential maintenance projects identified approximately 1,200 square feet of patching needs and approximately 12,000 linear feet of crack sealing and crack repair needs, at an estimated total cost of approximately \$21,000.
