Pavement Condition Report

Winchester-Randolph County Airport

Project 15805741

February 2015

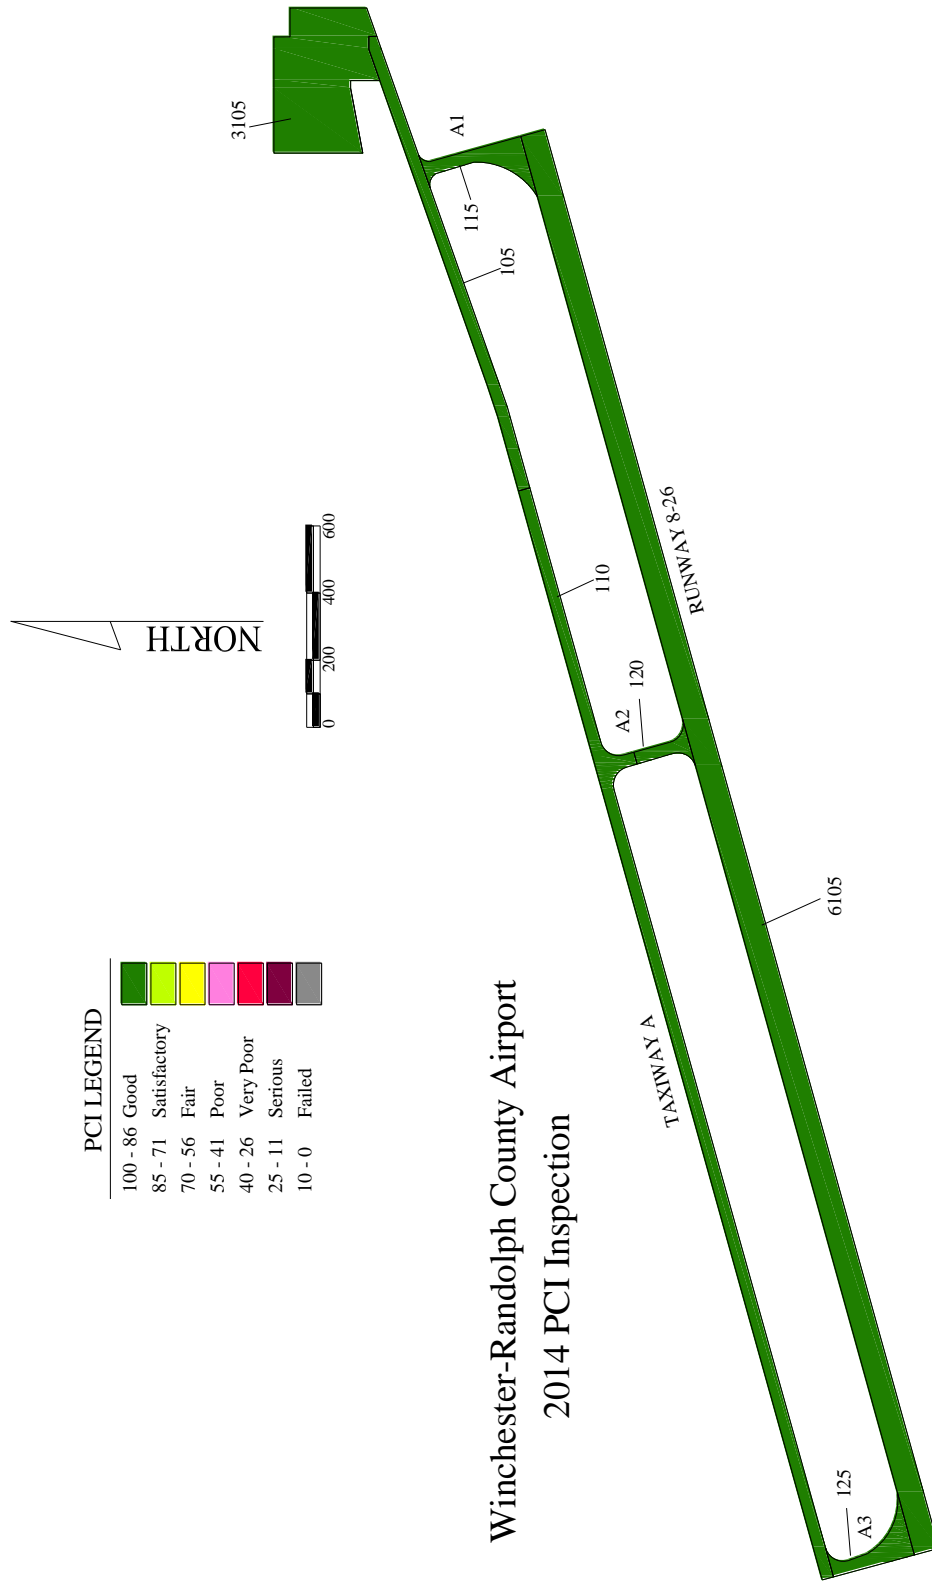
Figure 2-1. Inspected Pavement Condition

The pavement within each of the PCI condition categories is shown in Figure 2-1. The inspected PCI is summarized by branch use in Figure 2-2, and the photographs in Figure 2-3 through Figure 2-5 provide examples of the condition categories.

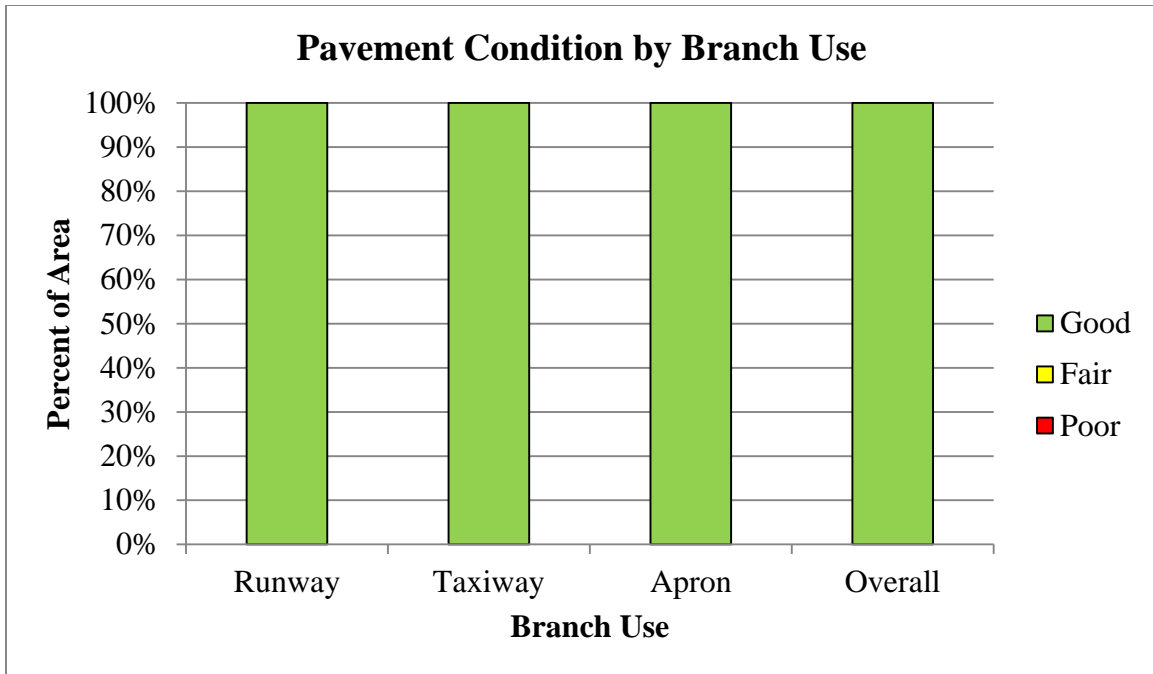
Figure 2-2. Pavement Condition by Branch Use

The average inspected Pavement Condition Index (PCI) for all the airfield pavements was 92. Runways had an average inspected PCI of 86 and were above the desired MSL of 60. Taxiways had an average inspected PCI of 96, and ramps had an average inspected PCI of 100.

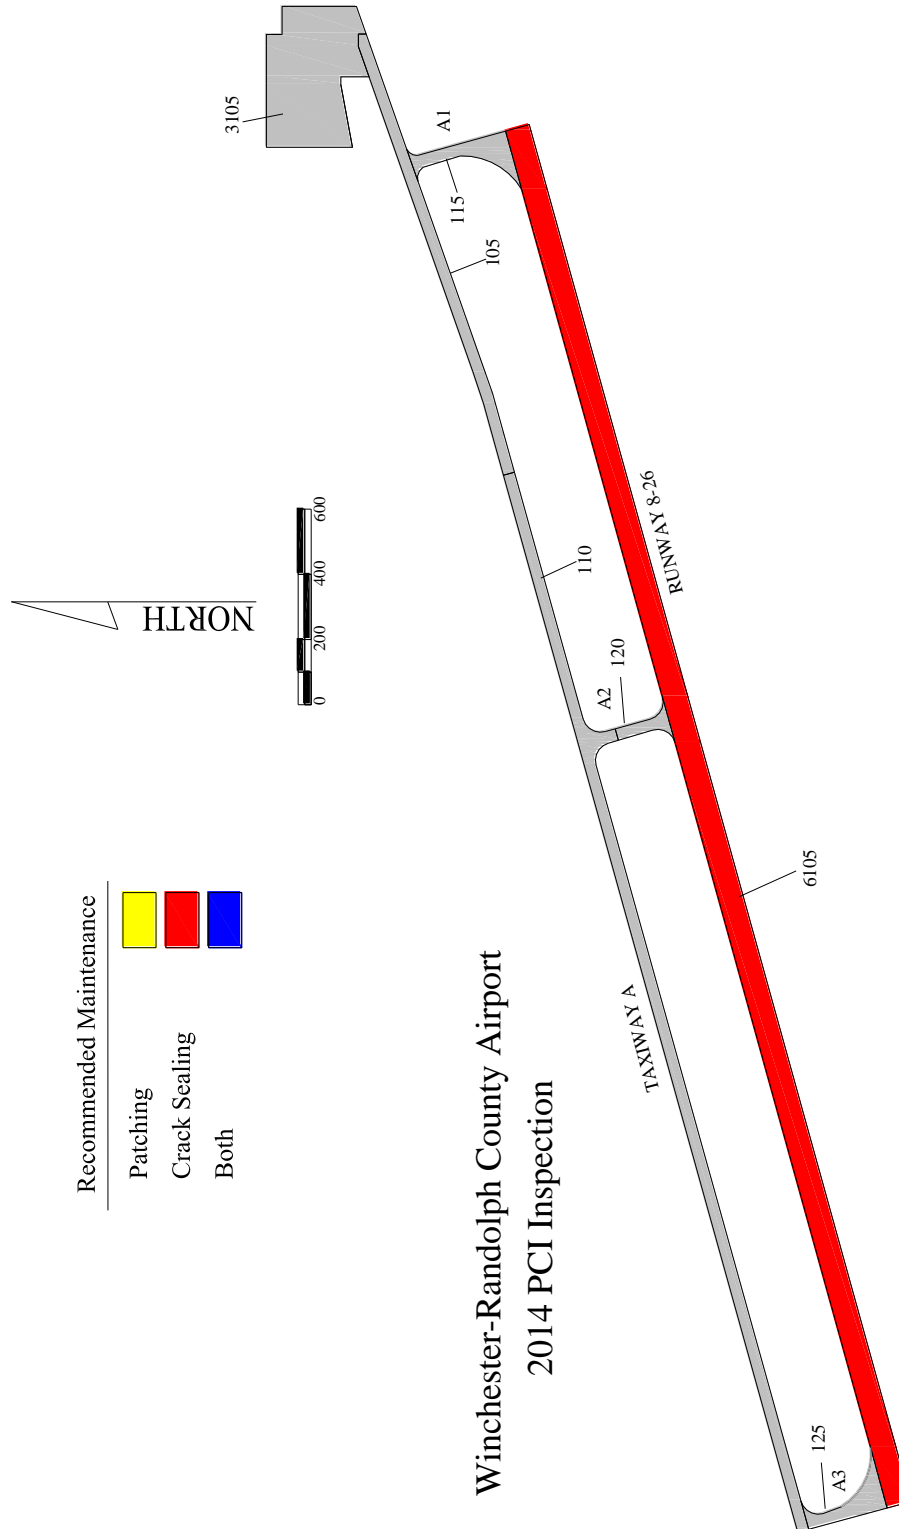
Figure 4-1. Recommended Maintenance

| Feature | Work Item | Amount | Insp. PCI | Change | Est. PCI |
|---|---|---|---|---|---|
| 6105 | AC SUSTAINING CRACK REPAIR | 1,969 L.F. | 86 | - | N/A |

4.2.1 Crack Seal

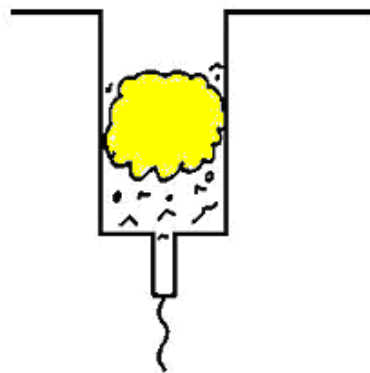
Typical failed joint sealant, w/ debris and incompressibles.
