# Pavement Condition Report

## Crawfordsville Municipal Airport

Project 16801839

**January 2016**

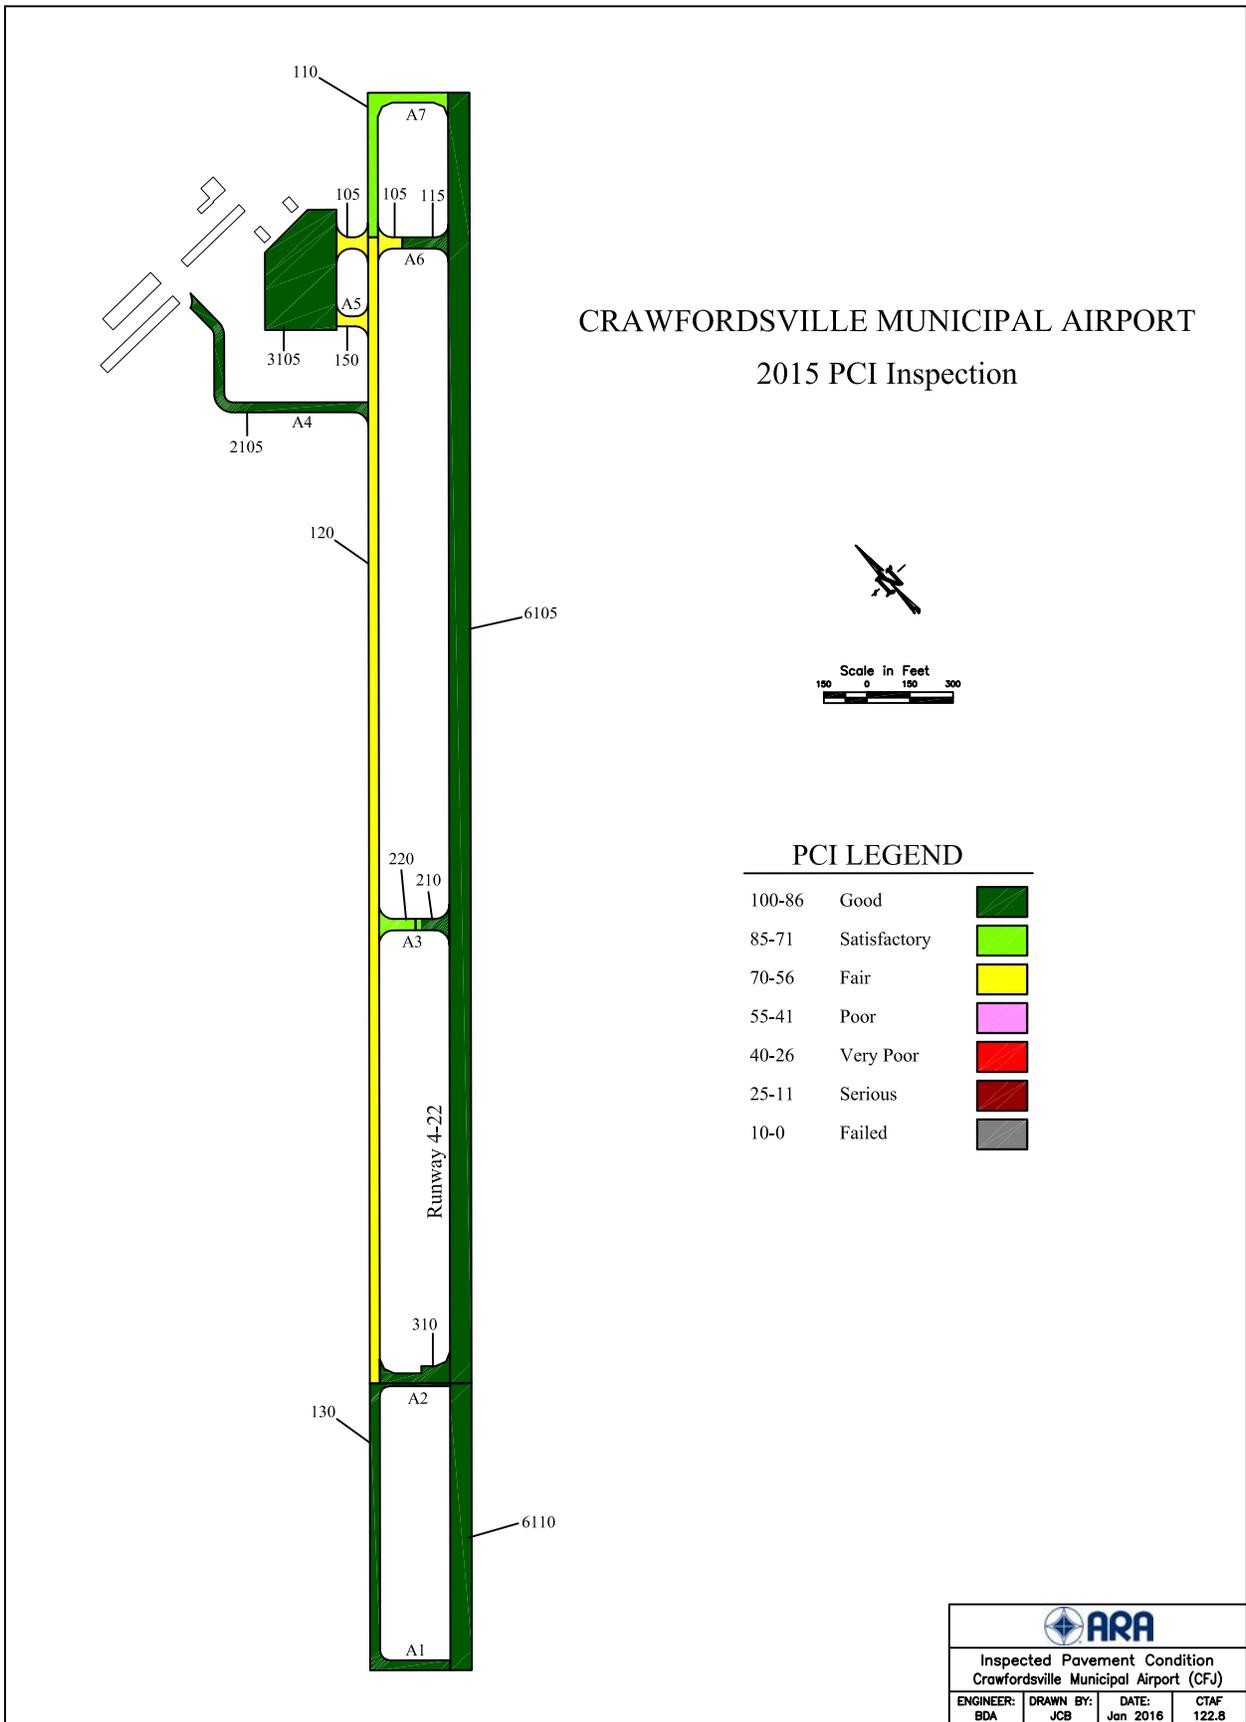
Figure 2-1. Inspected Pavement Condition at Crawfordsville Municipal Airport (CFJ).

The average inspected Pavement Condition Index (PCI) for all the airfield pavements was 87. Runways had an average inspected PCI of 91 and were above the desired MSL of 60. Taxiways had an average inspected PCI of 79, and ramps had an average inspected PCI of 97.
