# Pavement Condition Report

## Frankfort Municipal Airport

Project 16801839

**January 2016**

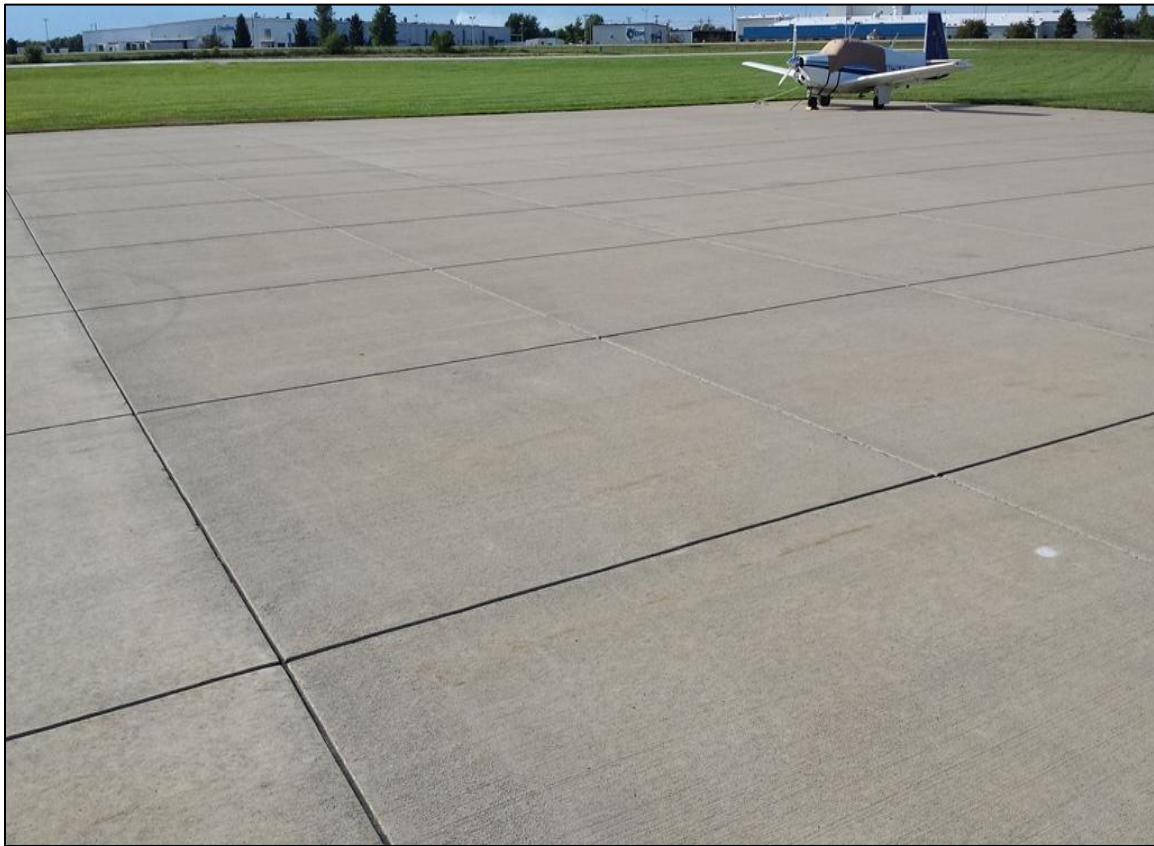
Figure 2-3. Typical PCC Pavement in Good Condition (Feature 3015)

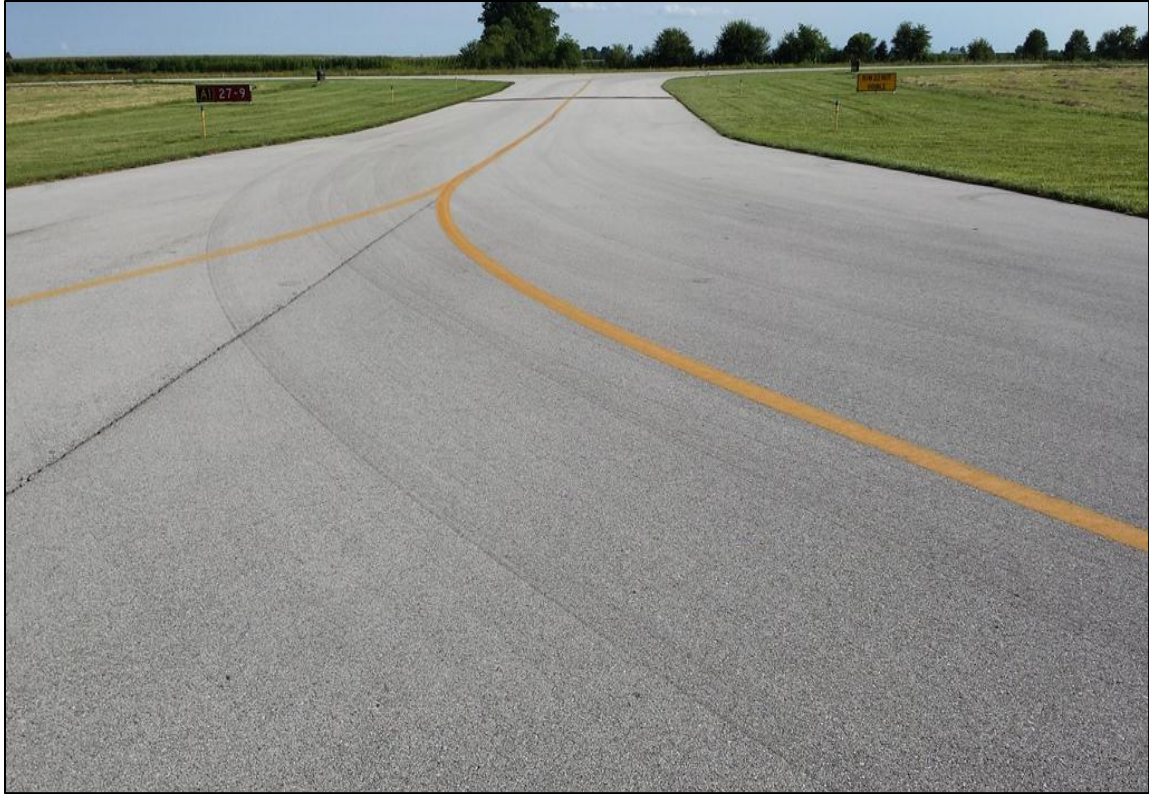
Figure 2-4. Typical AC Pavement in Good Condition (Feature 130)

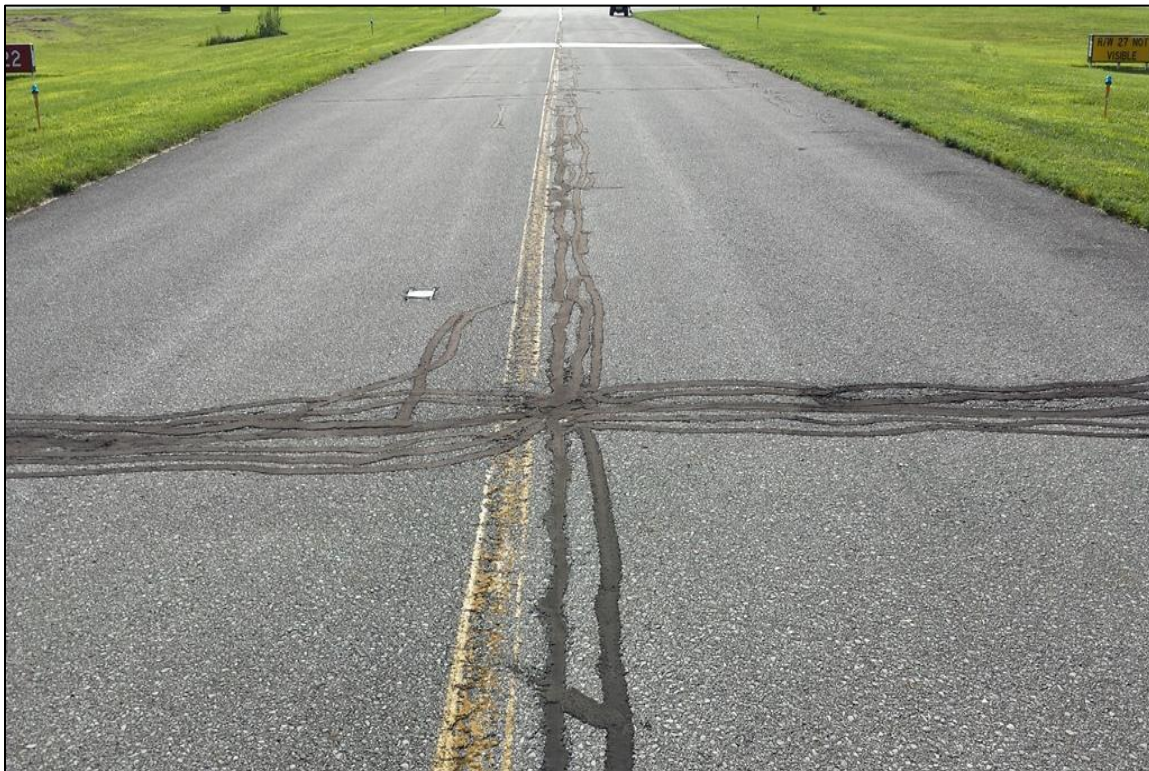
Figure 2-5. Typical AC Pavement in Fair Condition (Feature 101)

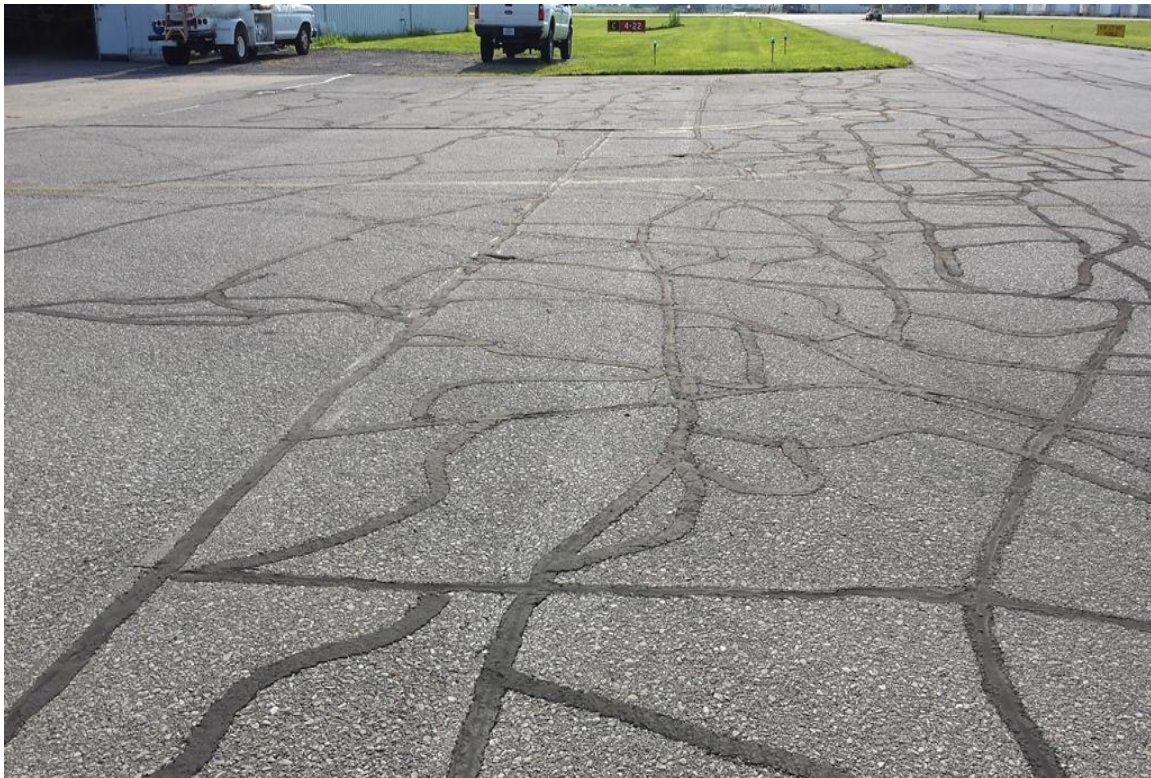
Figure 2-6. Typical AC Pavement in Poor Condition (Feature 210)
