Pavement Condition Report

Greencastle-Putnam County Airport

Project 16801839

January 2016

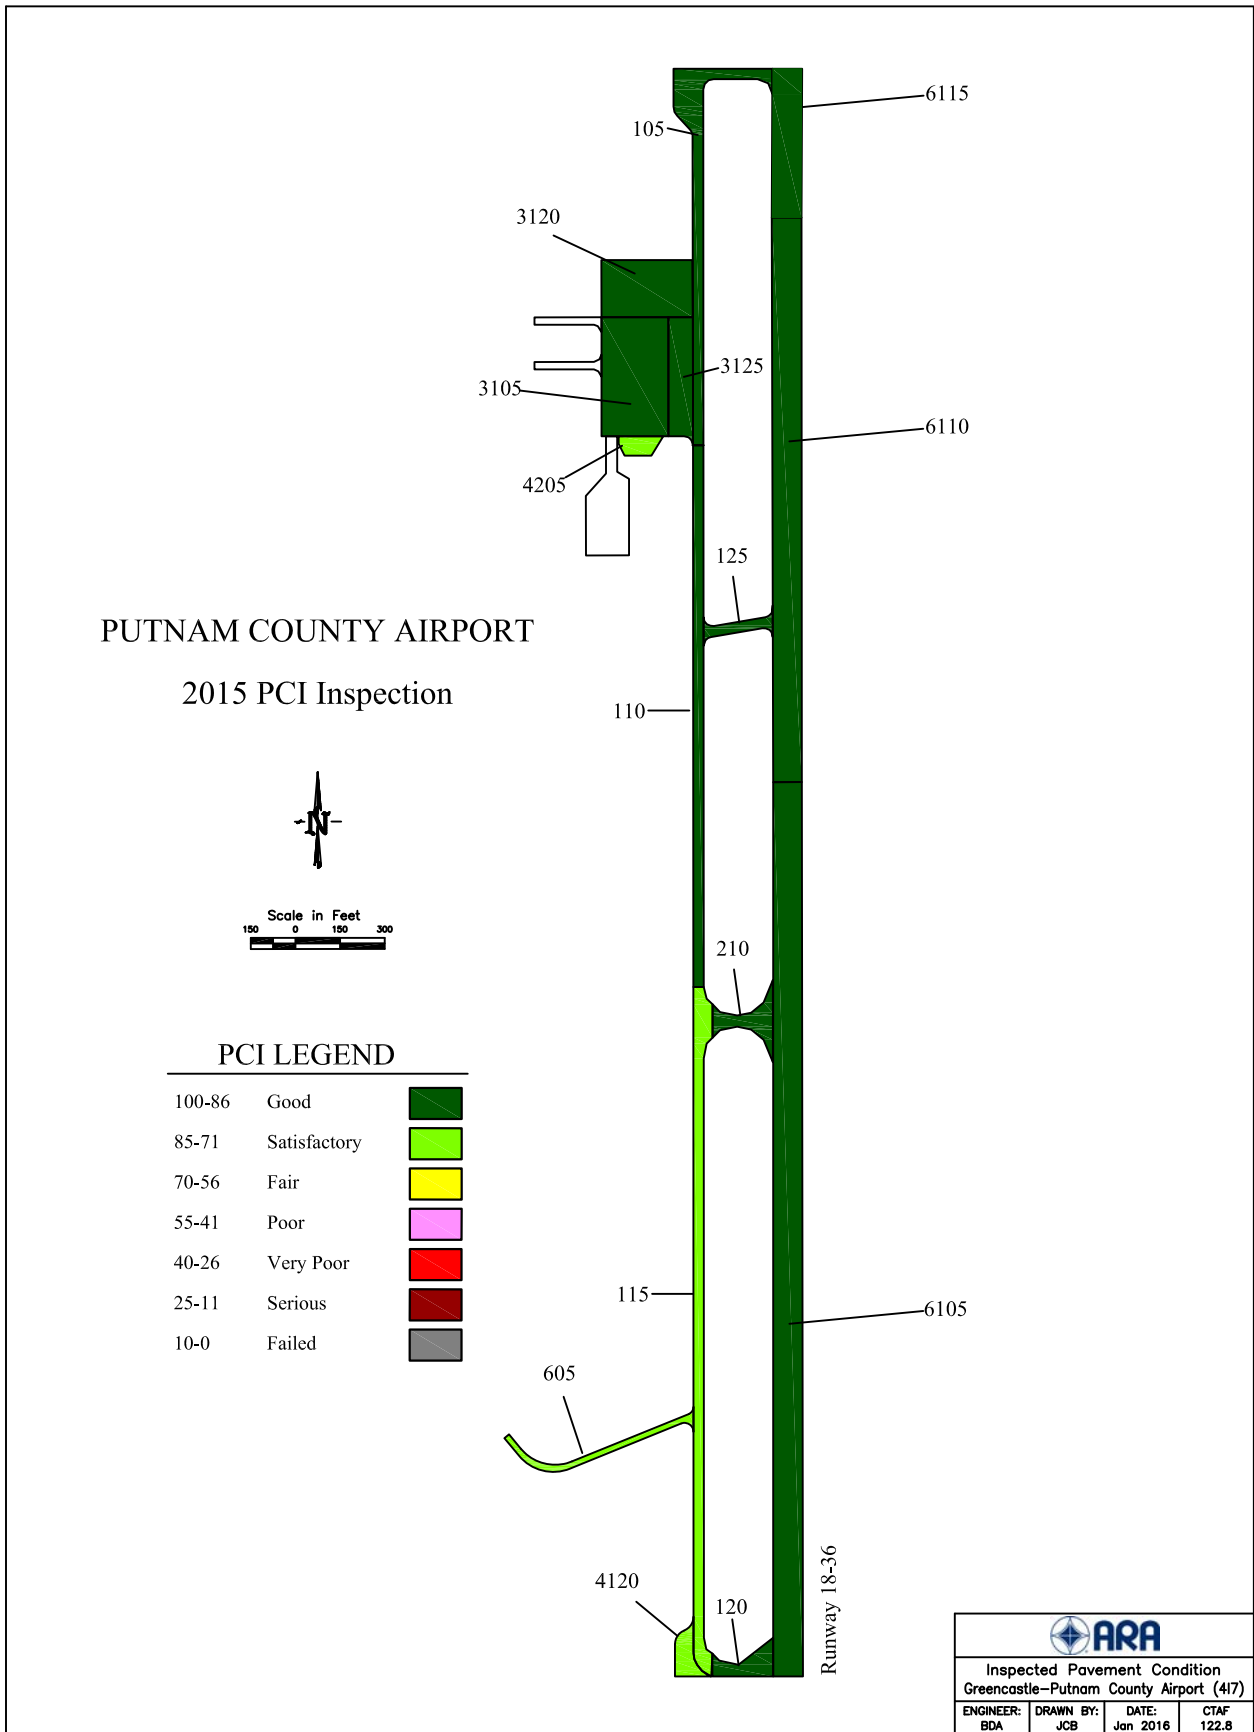
The pavement within each of the PCI condition categories is shown in Figure 2-1. The inspected PCI is summarized by branch use in Figure 2-2, and the photographs in Figure 2-3 through Figure 2-5 provide examples of the condition categories.

Figure 2-1. Inspected Pavement Condition at Greencastle-Putnam County Airport (417).

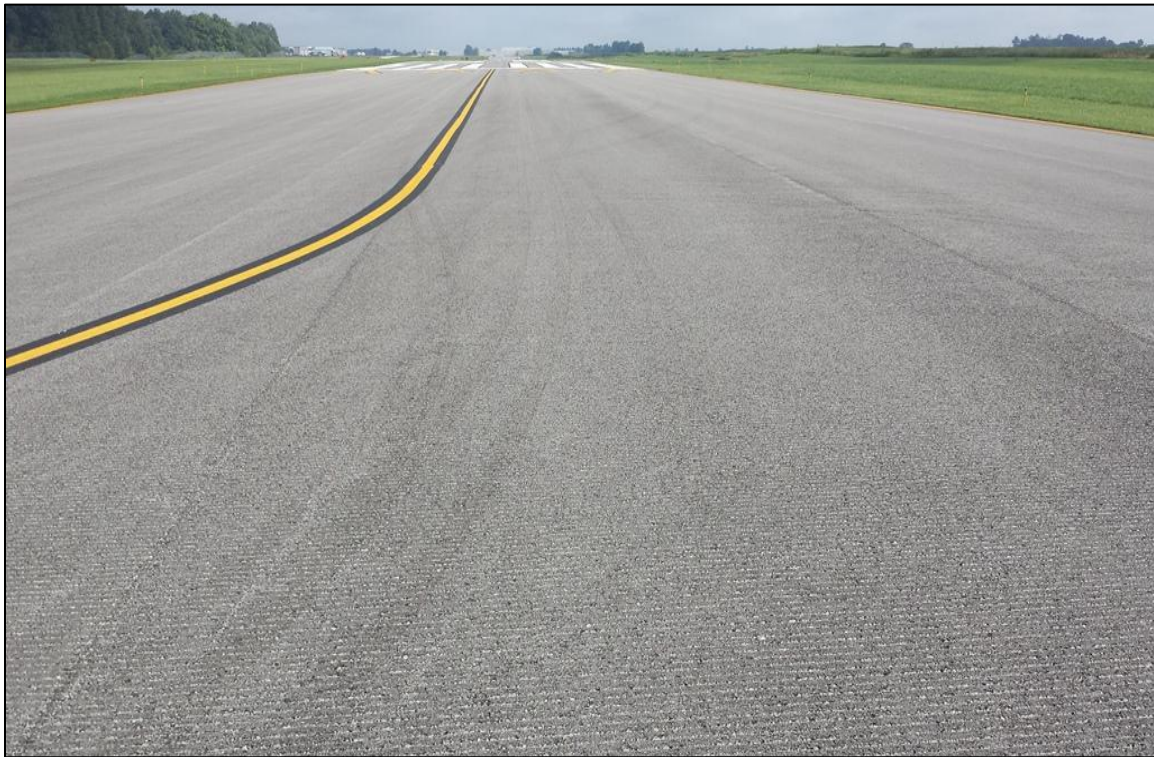
Figure 2-3. Typical AC Pavement in Good Condition (Feature 6105)

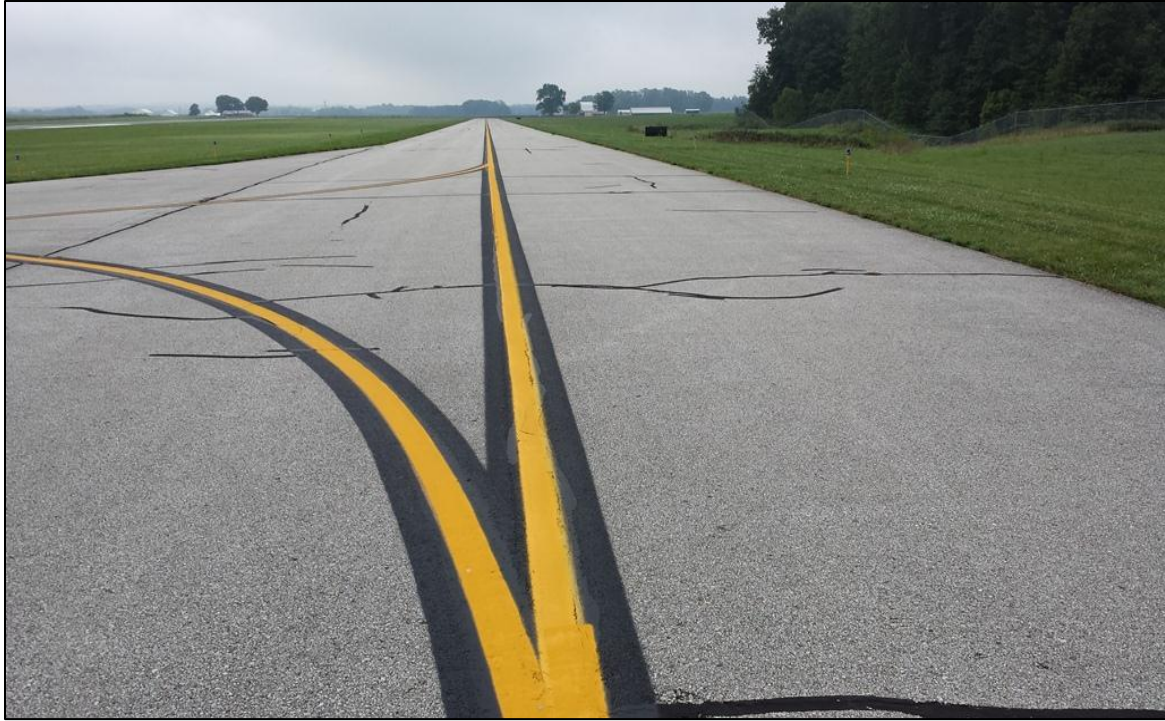
Figure 2-4. Typical AC Pavement in Good Condition (Feature 115)

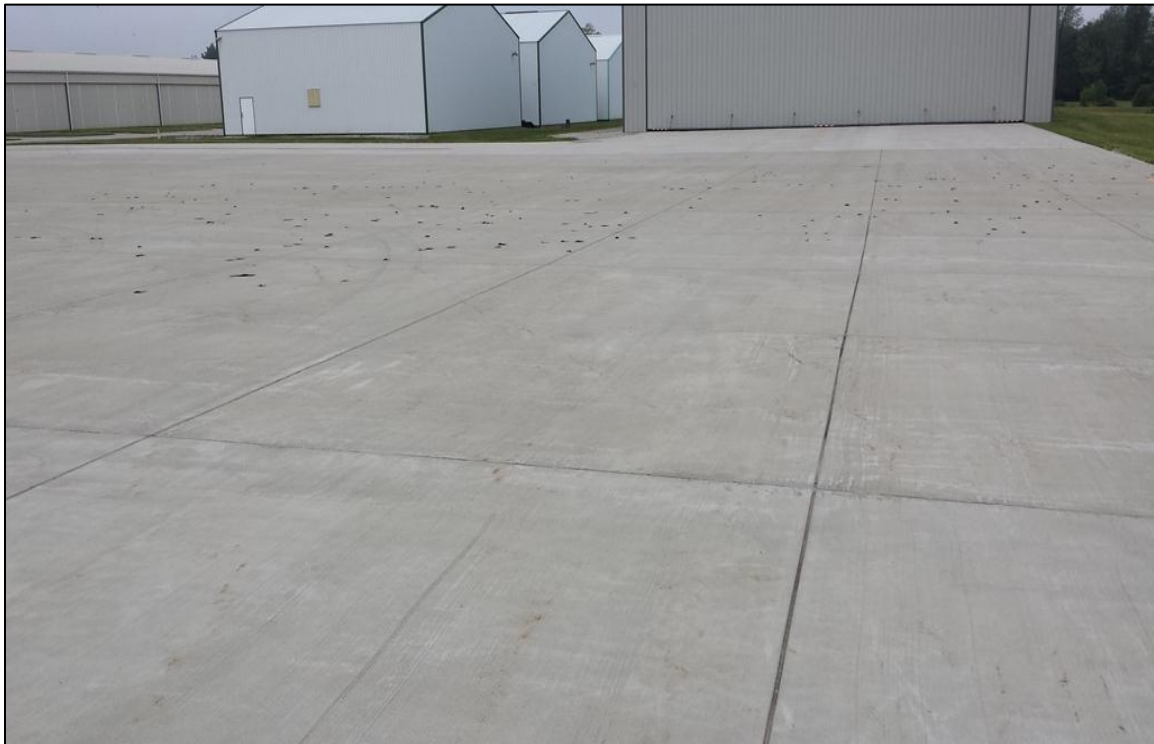
Figure 2-5. Typical PCC Pavement in Good Condition (Feature 3120)

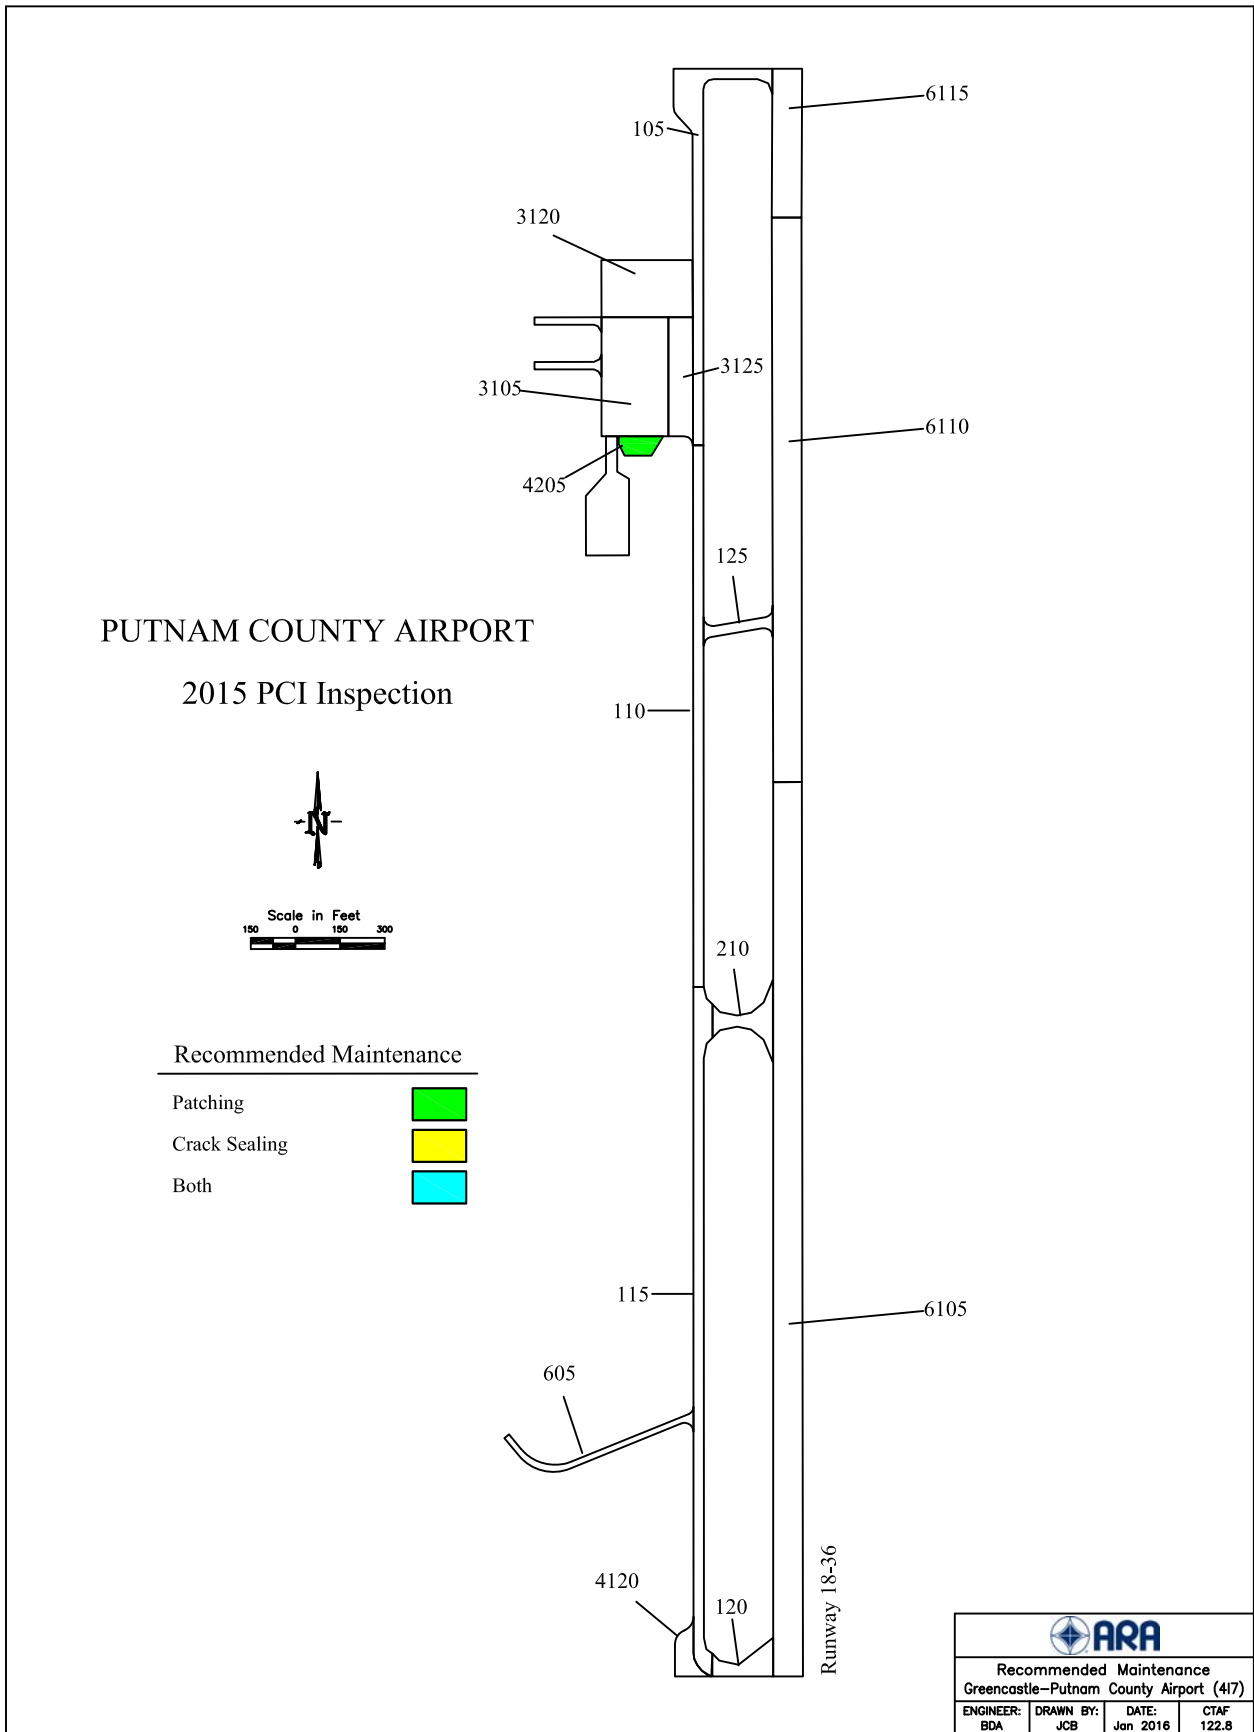
Figure 4-1. Recommended Maintenance at Greencastle-Putnam County Airport (417).

Feature	Work Item	Amount	Insp. PCI	Change	Est. PCI
4205	PCC Slab Repair/Replace	634	81	7	88
	TOTAL:	634	S.F.		
EQUIPMENT: SAW, AIR COMPRESSOR, JACK HAMMER, MIXER, Loader, HAND TOOLS					
EST. MATERIALS: 26 CUBIC YARDS CONCRETE MIX					
EST. MATERIAL COST: \$2,509					
EST. CREW HOURS: .42.3					
EST. CREW COST: \$5,418					
EST. PROJECT COST: \$7,927
