Pavement Condition Report

Indianapolis Executive Airport

Project 16801839

January 2016

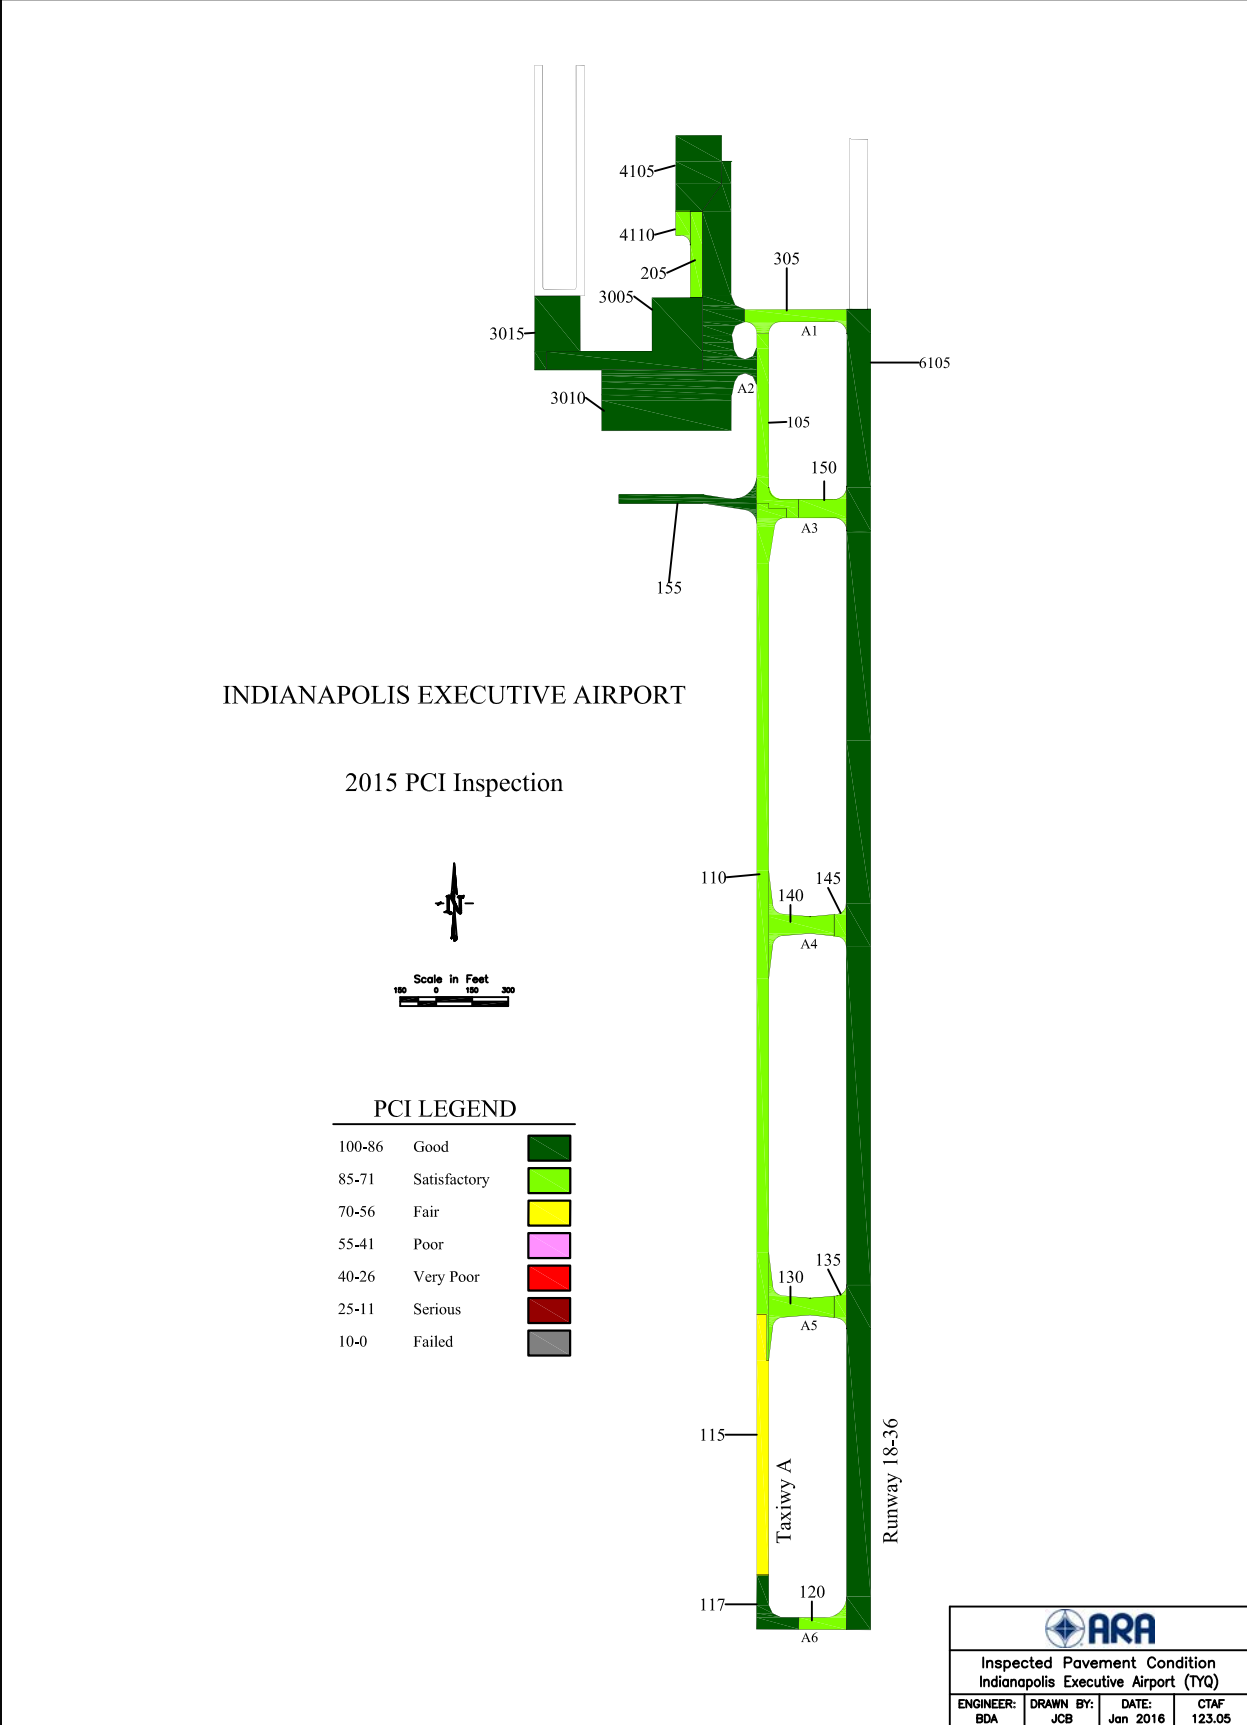
The pavement within each of the PCI condition categories is shown in Figure 2-1. The inspected PCI is summarized by branch use in Figure 2-2, and the photographs in Figure 2-3 through Figure 2-5 provide examples of the condition categories.

Figure 2-1. Inspected Pavement Condition at Indianapolis Executive Airport (TYQ).

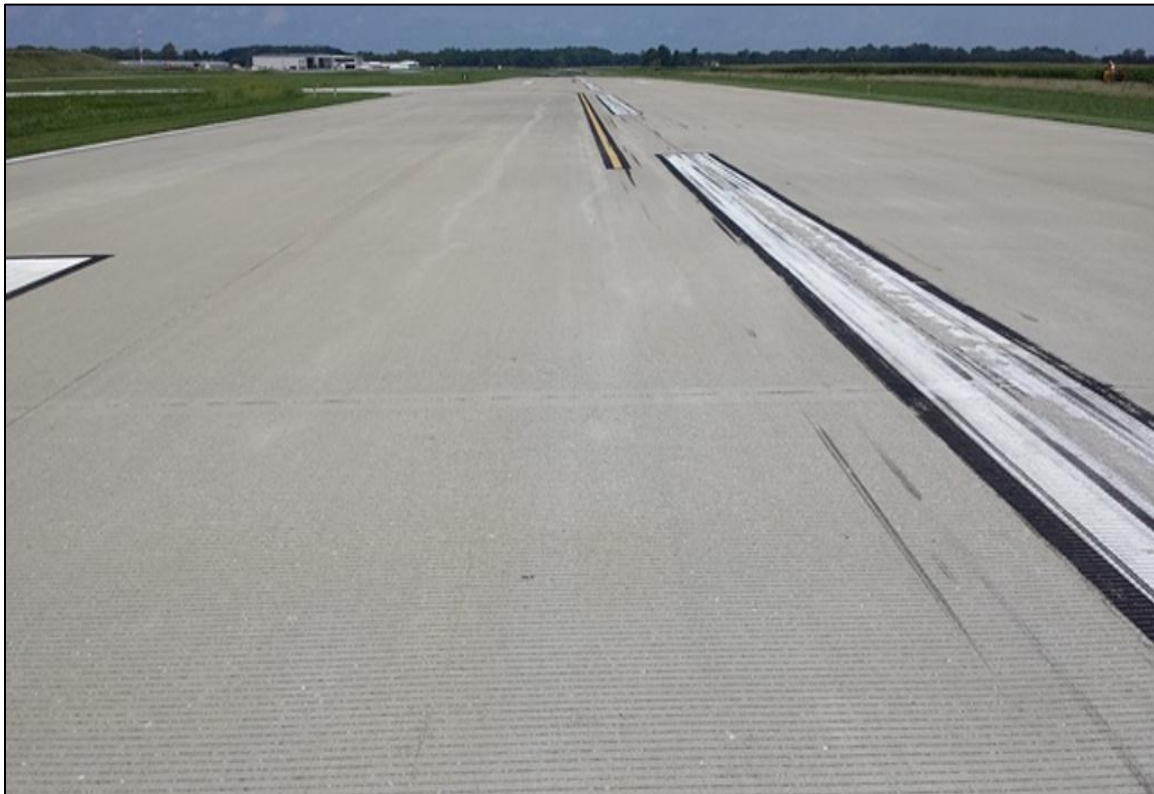
Figure 2-3. Typical PCC Pavement in Good Condition (Feature 6105)

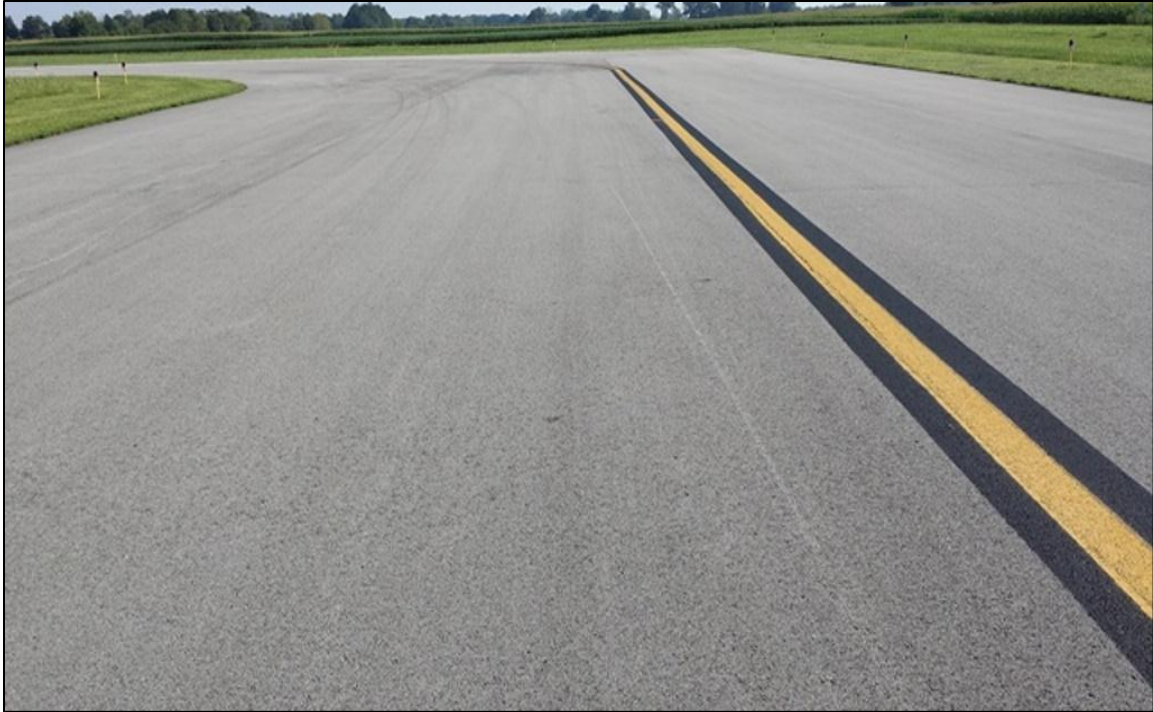
Figure 2-4. Typical AC Pavement in Good Condition (Feature 117)

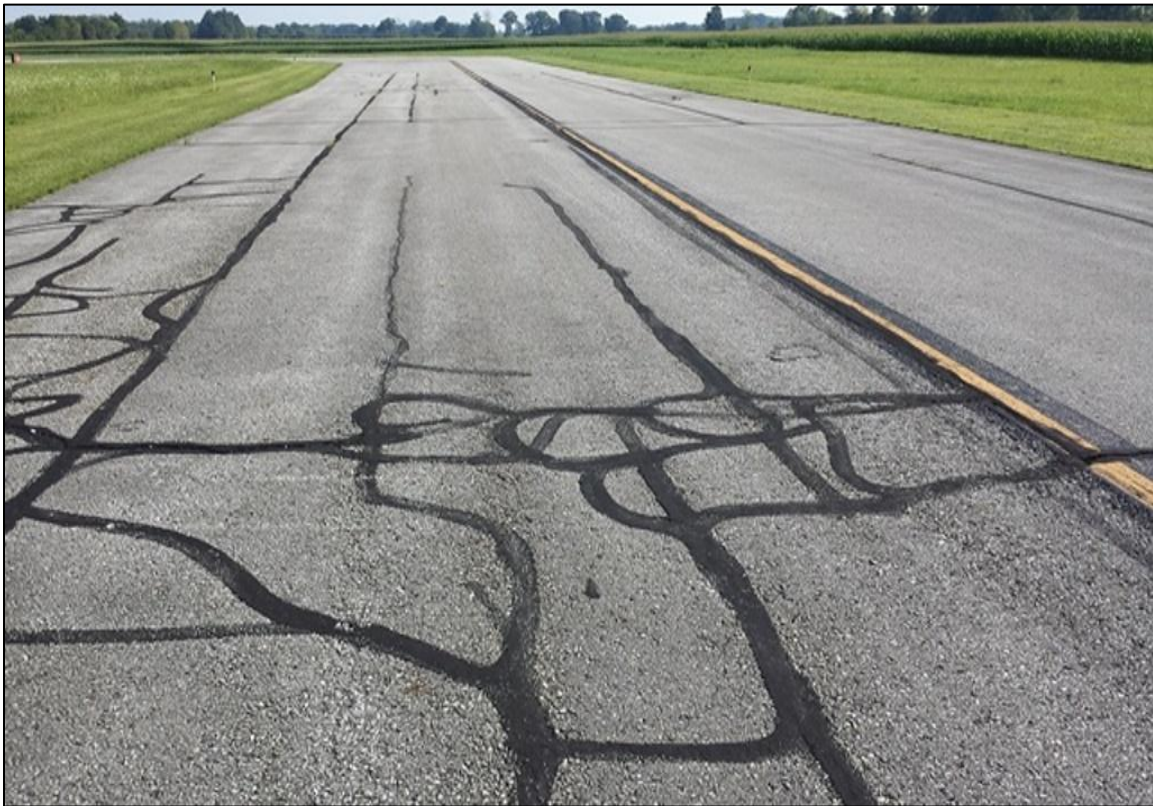
Figure 2-5. Typical AC Pavement in Fair Condition (Feature 115)

The taxiways consisted of 12 sections of AC and 1 section of PCC pavement. The total area of the taxiways was 498,018 ft². The PCC taxiway pavement was in Good condition with no recorded distress. Excluding feature 115 which had a PCI of 56, the remaining AC taxiway features were all in Good condition. The taxiway pavement distribution by PCI range is shown in Table 2-6.

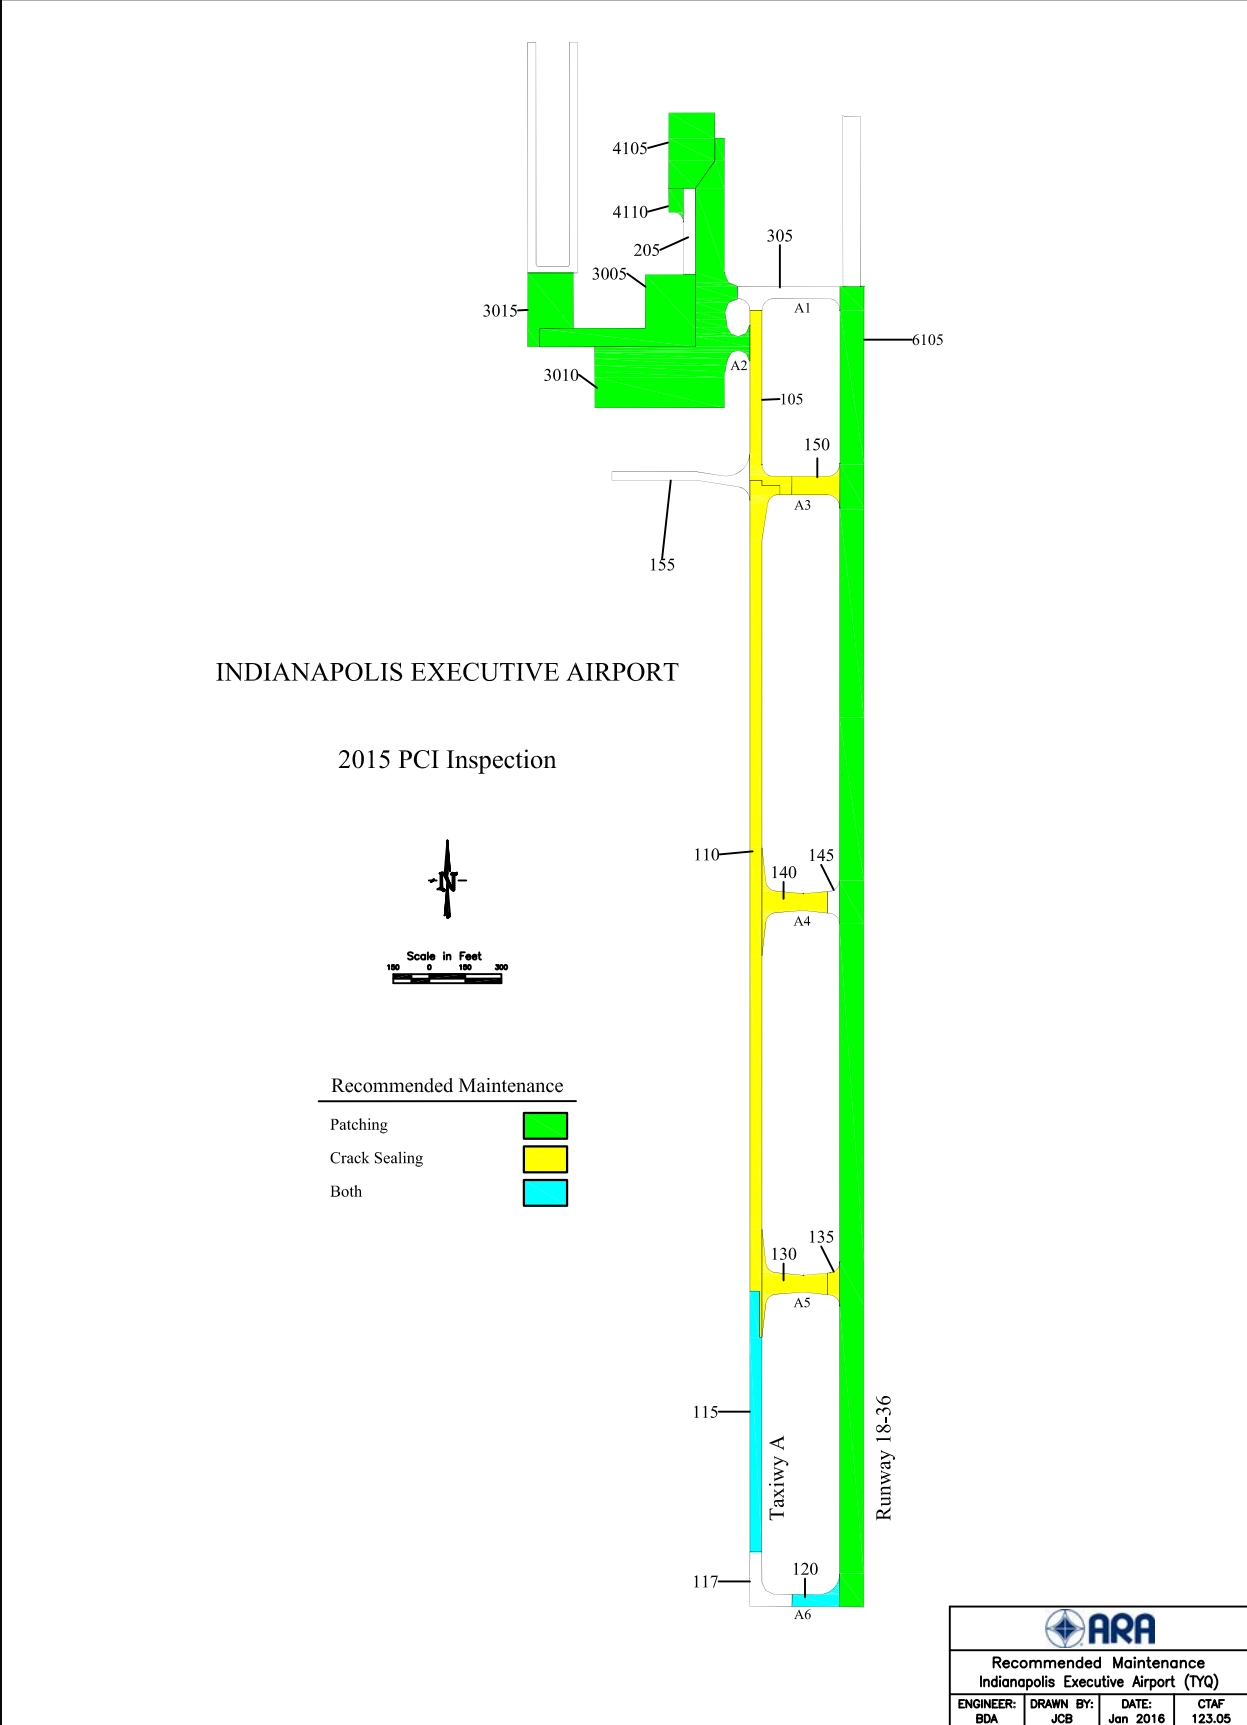
Figure 4-1. Recommended Maintenance at Indianapolis Executive Airport (TYQ).

Feature	Work Item	Amount	Insp. PCI	Change	Est. PCI
3010	SLAB REPAIR/REPLACEMENT	3,059	97	-	97
4105	SLAB REPAIR/REPLACEMENT	145	87	-	87
4110	SLAB REPAIR/REPLACEMENT	376	85	5	90
	TOTAL:	3,580	S.F.		
EQUIPMENT: SAW, AIR COMPRESSOR, JACK HAMMER, MIXER, LOADER, HAND TOOLS					
EST. MATERIALS: 146 CUBIC YARDS CONCRETE MIX					
EST. MATERIAL COST: \$14,150					
EST. CREW HOURS: 238.7					
EST. CREW COST: \$30,556					
EST. PROJECT COST: \$44,706
