Pavement Condition Report

Kendallville Municipal Airport

Project 16801839

January 2016

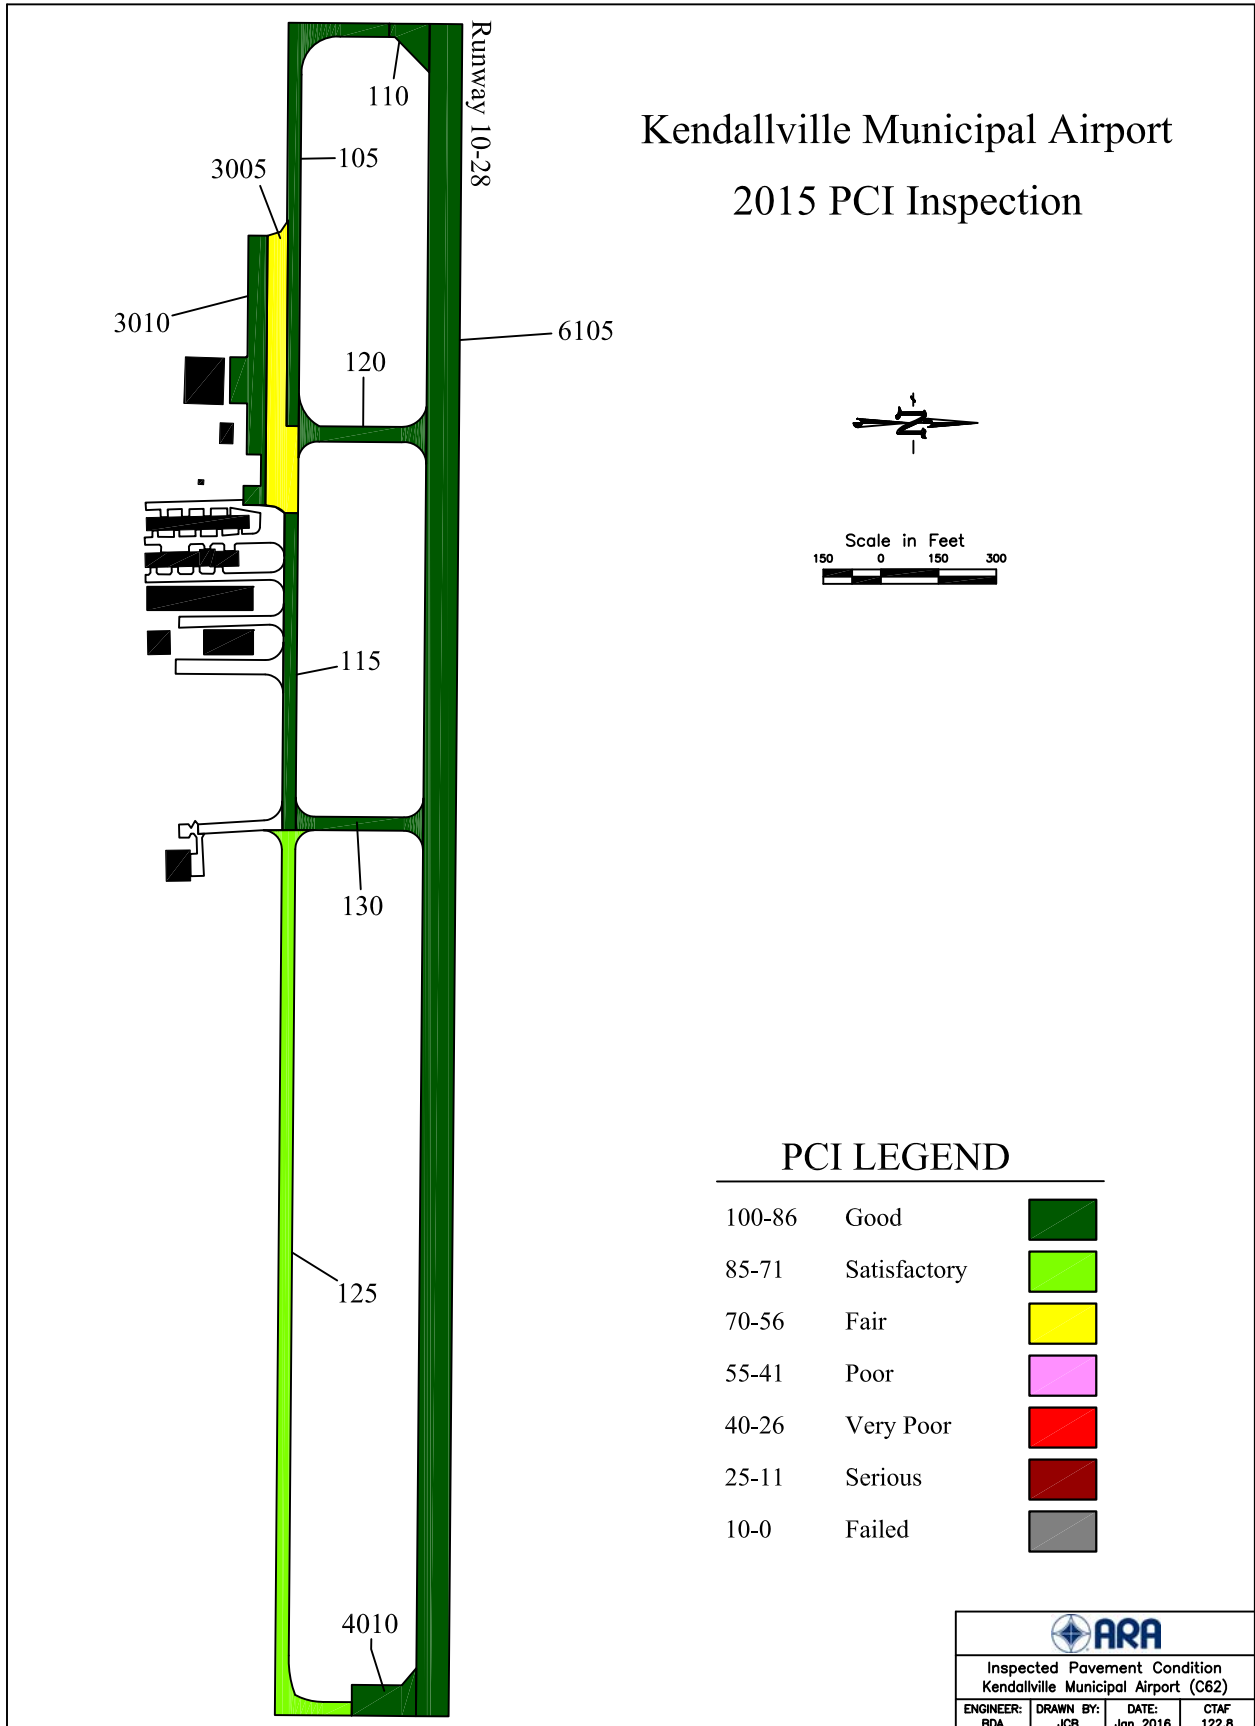
Figure 2-1. Inspected Pavement Condition at Kendallville Municipal Airport (C62).

The pavement within each of the PCI condition categories is shown in Figure 2-1. The inspected PCI is summarized by branch use in Figure 2-2, and the photographs in Figure 2-3 through Figure 2-5 provide examples of the condition categories.
