Pavement Condition Report

Kentland Municipal Airport

Project 16801839

January 2016

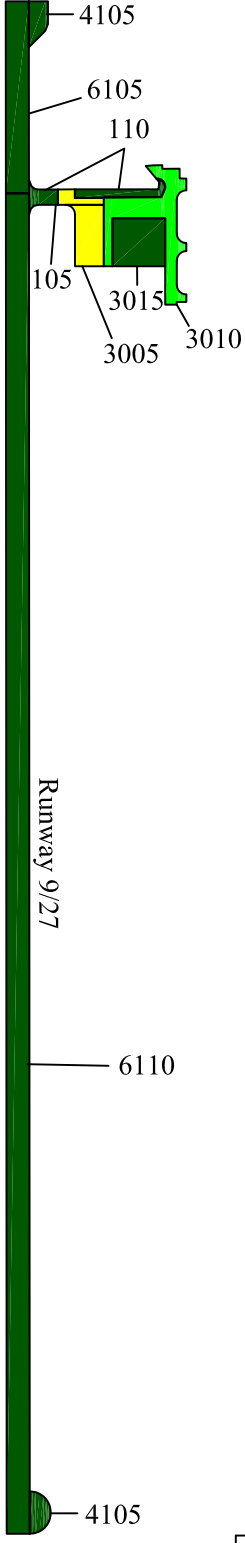
Figure 2-1. Inspected Pavement Condition at Kentland Municipal Airport (50).

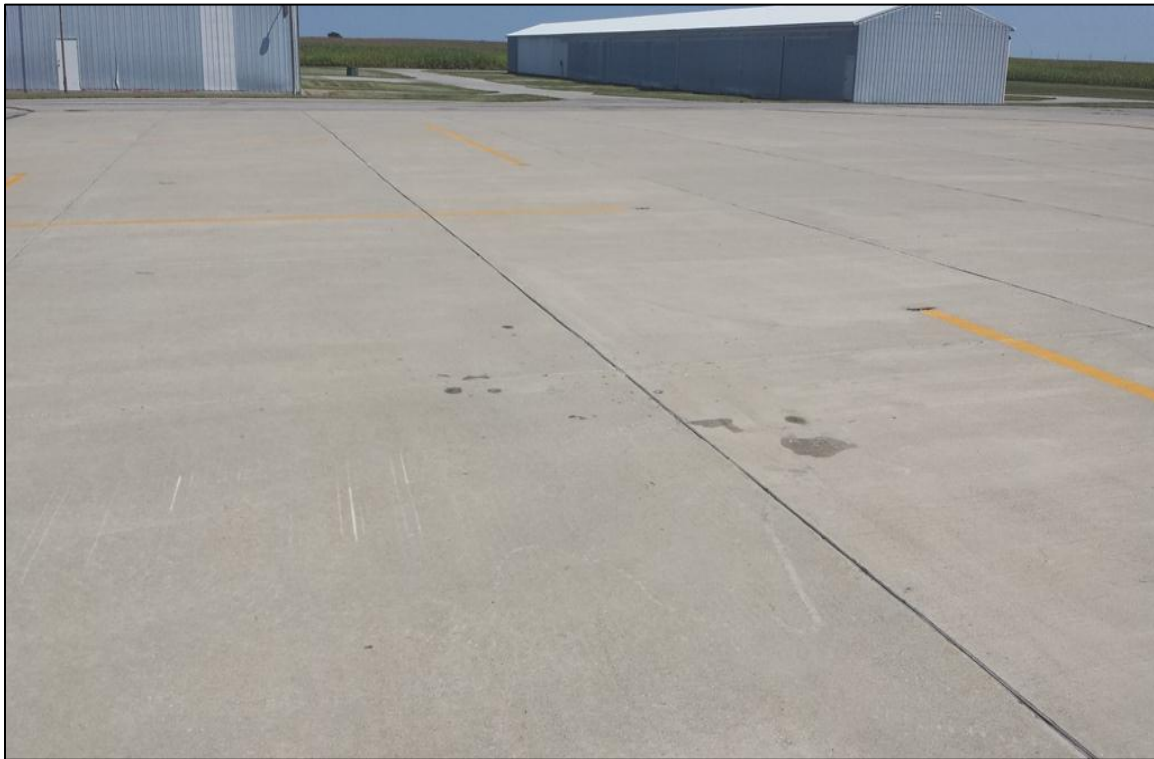
Figure 2-3. Typical PCC Pavement in Good Condition (Feature 3015)

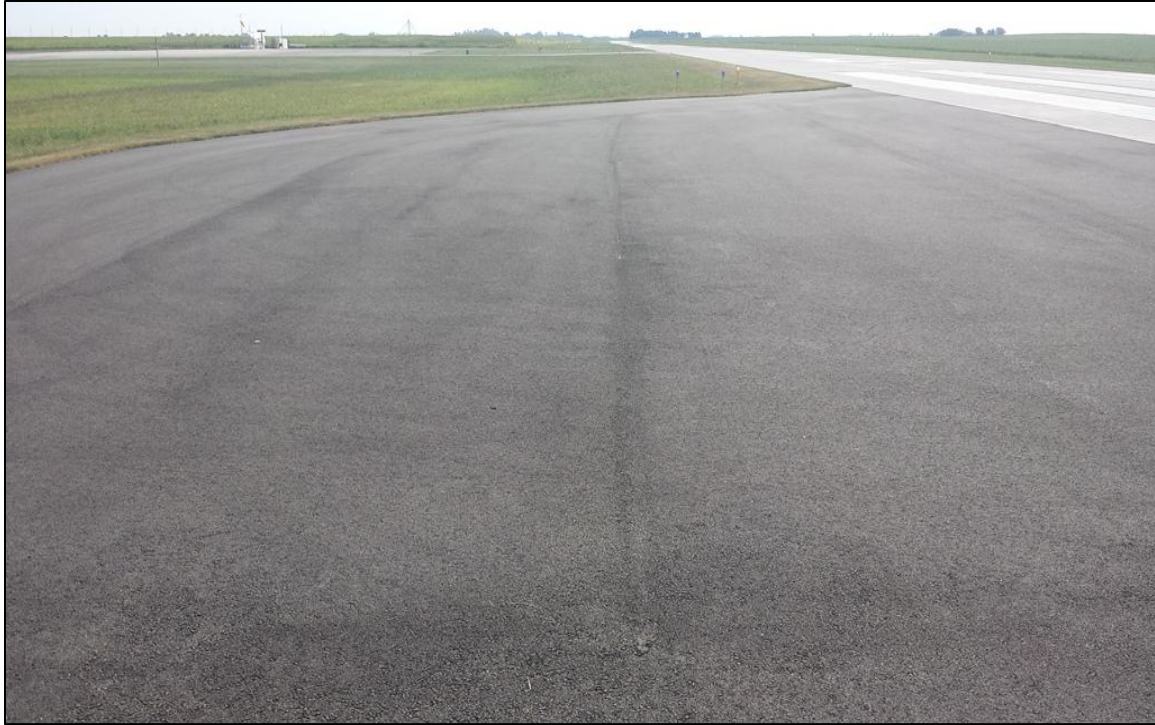
Figure 2-4. Typical AC Pavement in Good Condition (Feature 4105)

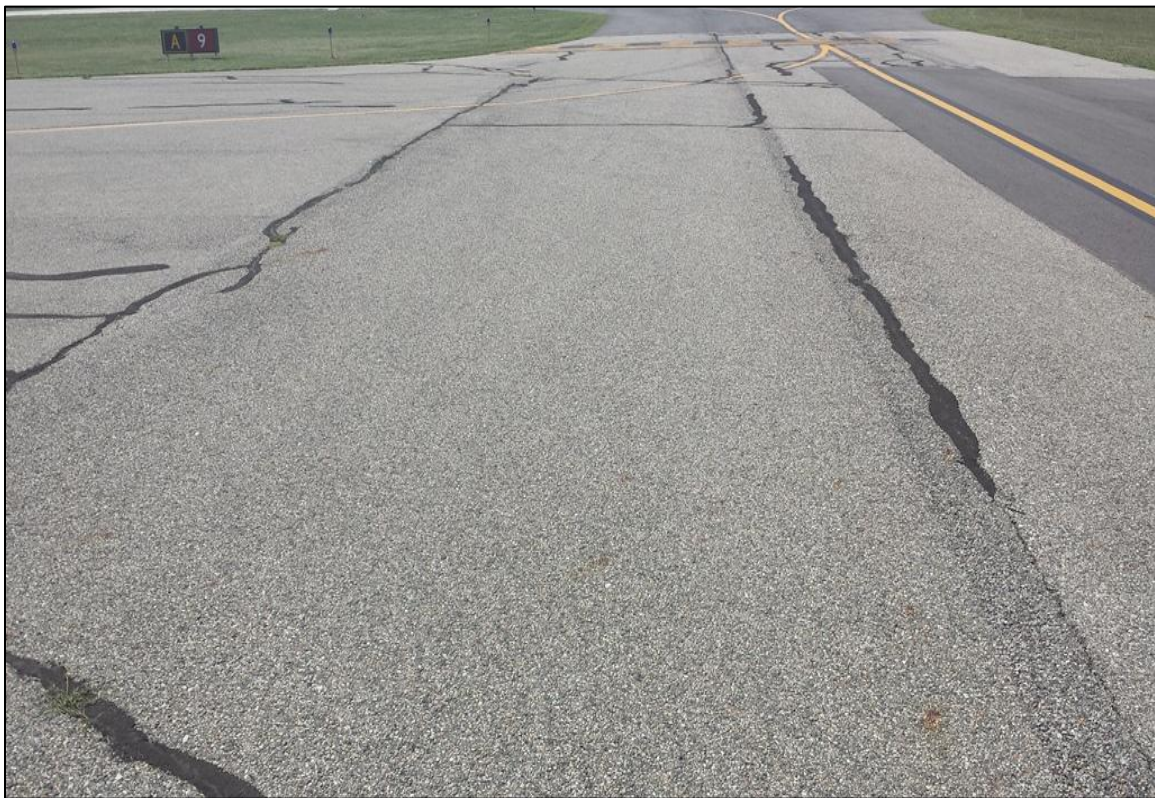
Figure 2-5. Typical AC Pavement in Fair Condition (Feature 105)

The taxiway consisted of two sections of AC pavement. The total area of the taxiway was 11,852 ft² and the area-weighted average PCI was 88 (Good). One section was new and had no recorded distress. The other section (feature 105) was in fair condition with mostly L&T cracking and weathering as the main causes of deterioration. The distribution of taxiway pavement by PCI range is shown in Table 2-6.

Feature	Built	Description	Action Yr	Work Item	Cost, \$
105	1999	TAXIWAY	2017	Surface Treatment	1,303
105	1999	TAXIWAY	2017	Crack Repair	460
105	1999	TAXIWAY	2017	Resurfacing	4,752
3005	2006	RAMP	2022	Surface Treatment	4,732
3005	2006	RAMP	2022	Resurfacing	17,472
