Pavement Condition Report

Logansport-Cass County Airport

Project 16801839

January 2016

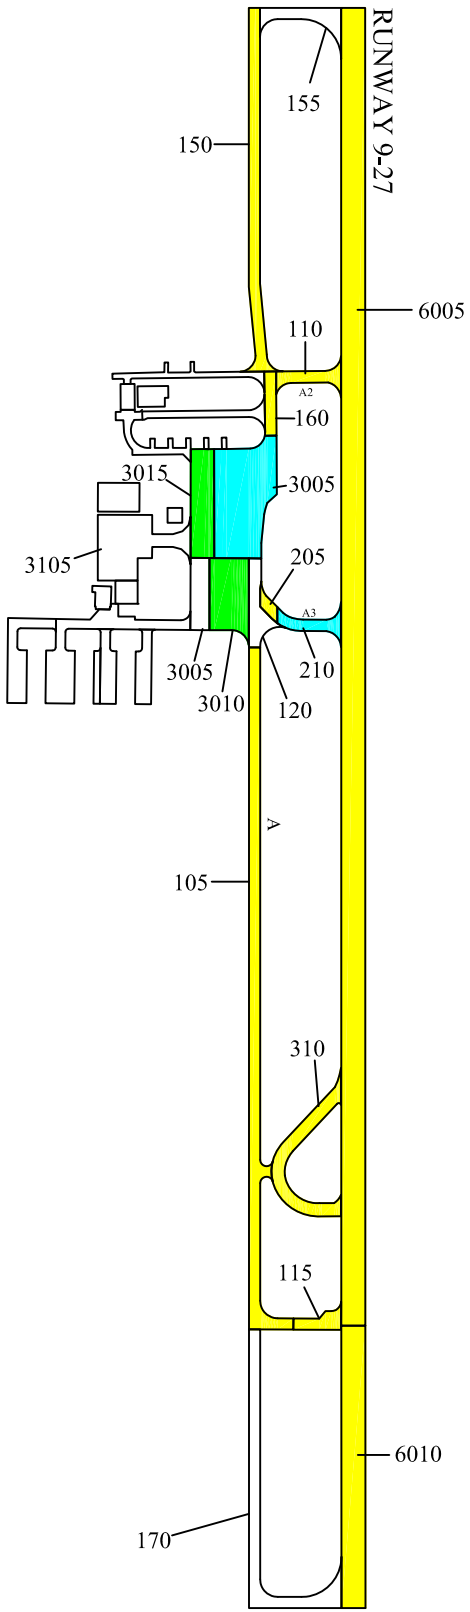
Logansport Municipal Airport 2015 PCI Inspection

Analysis of potential maintenance projects identified approximately 11,000 linear feet of crack sealing / crack repair and approximately 600 square feet of patching needs, at an estimated total cost of approximately \$17,000.

- Patching
- Crack Sealing
- Both

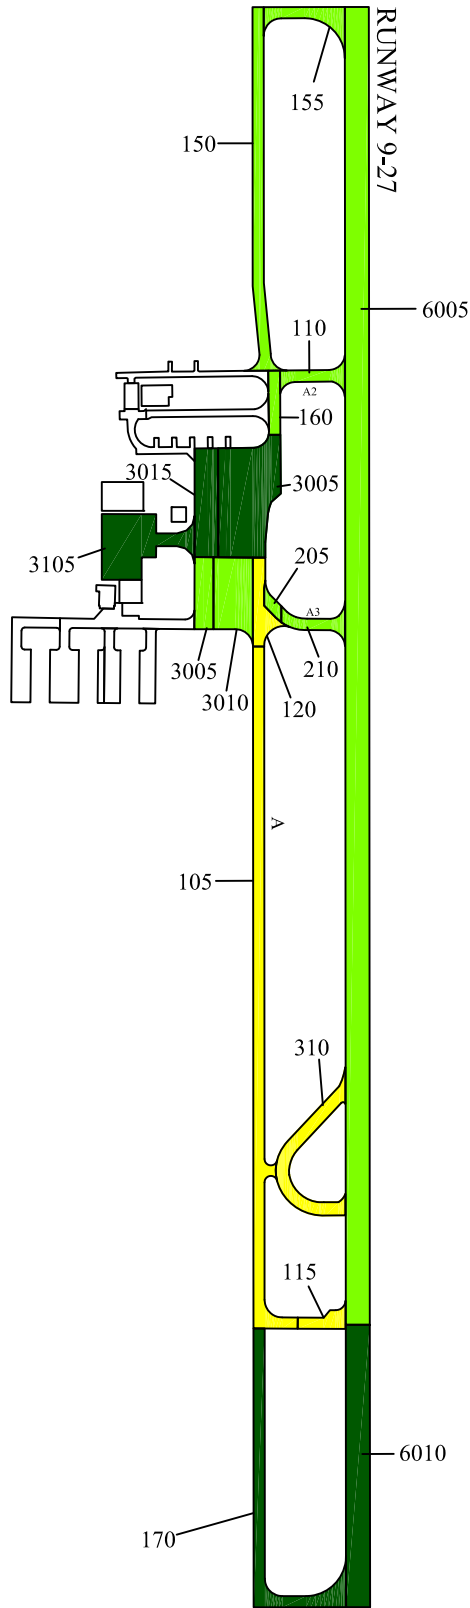
Figure 2-1. Inspected Pavement Condition at Logansport-Cass County Airport (GGP).

The pavement within each of the PCI condition categories is shown in Figure 2-1. The inspected PCI is summarized by branch use in Figure 2-2, and the photographs in Figure 2-3 through Figure 2-5 provide examples of the condition categories.

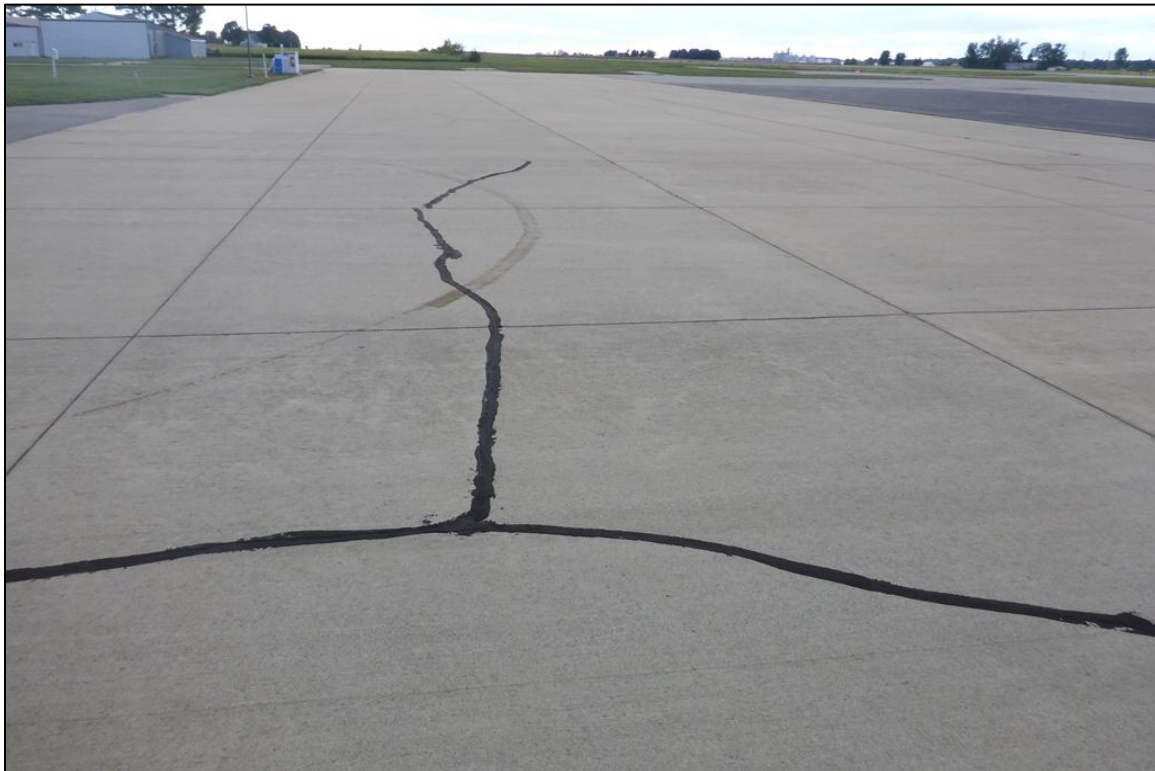
Figure 2-3. Typical PCC Pavement in Good Condition (Feature 3015)

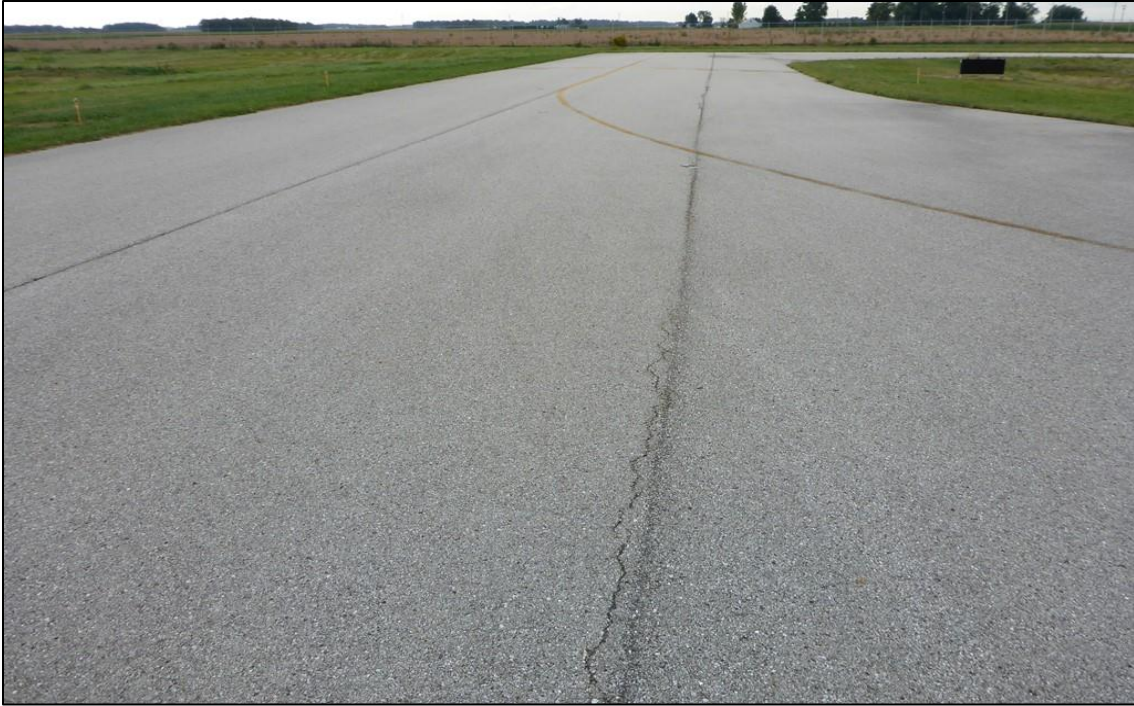
Figure 2-4. Typical AC Pavement in Good Condition (Feature 170)

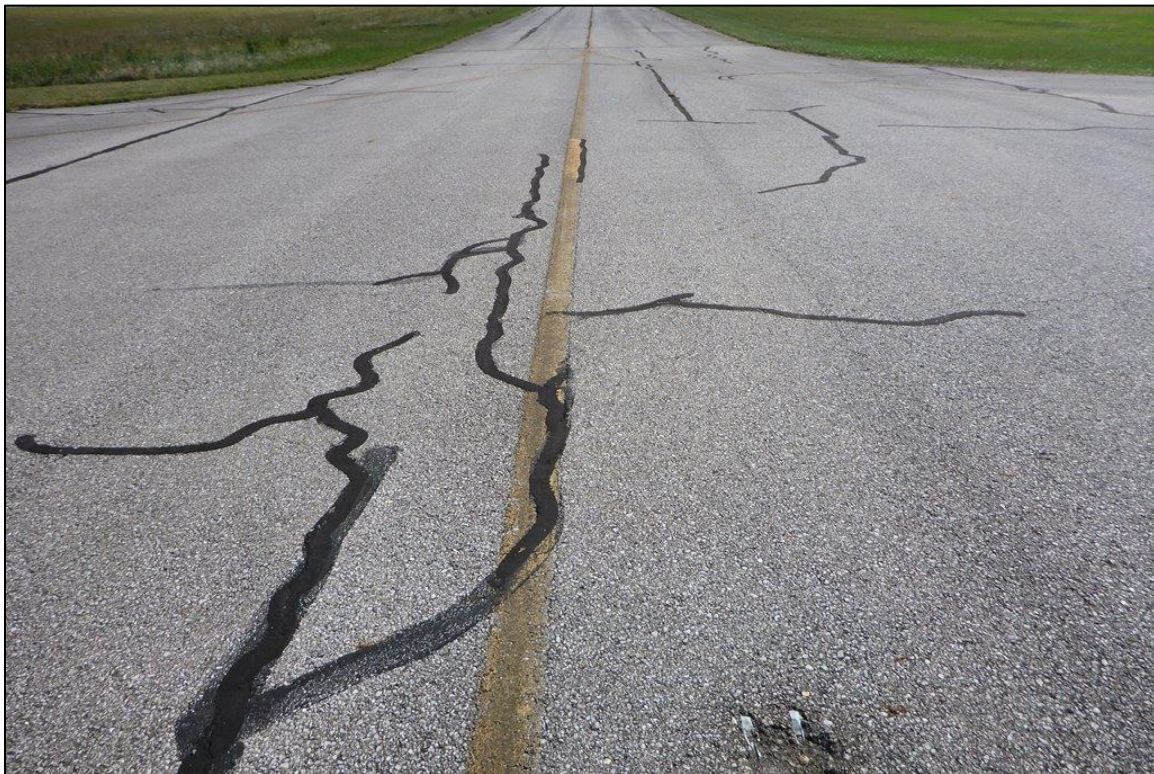
Figure 2-5. Typical AC Pavement in Fair Condition (Feature 120)
