Pavement Condition Report

Marion Municipal Airport

Project 16801839

January 2016

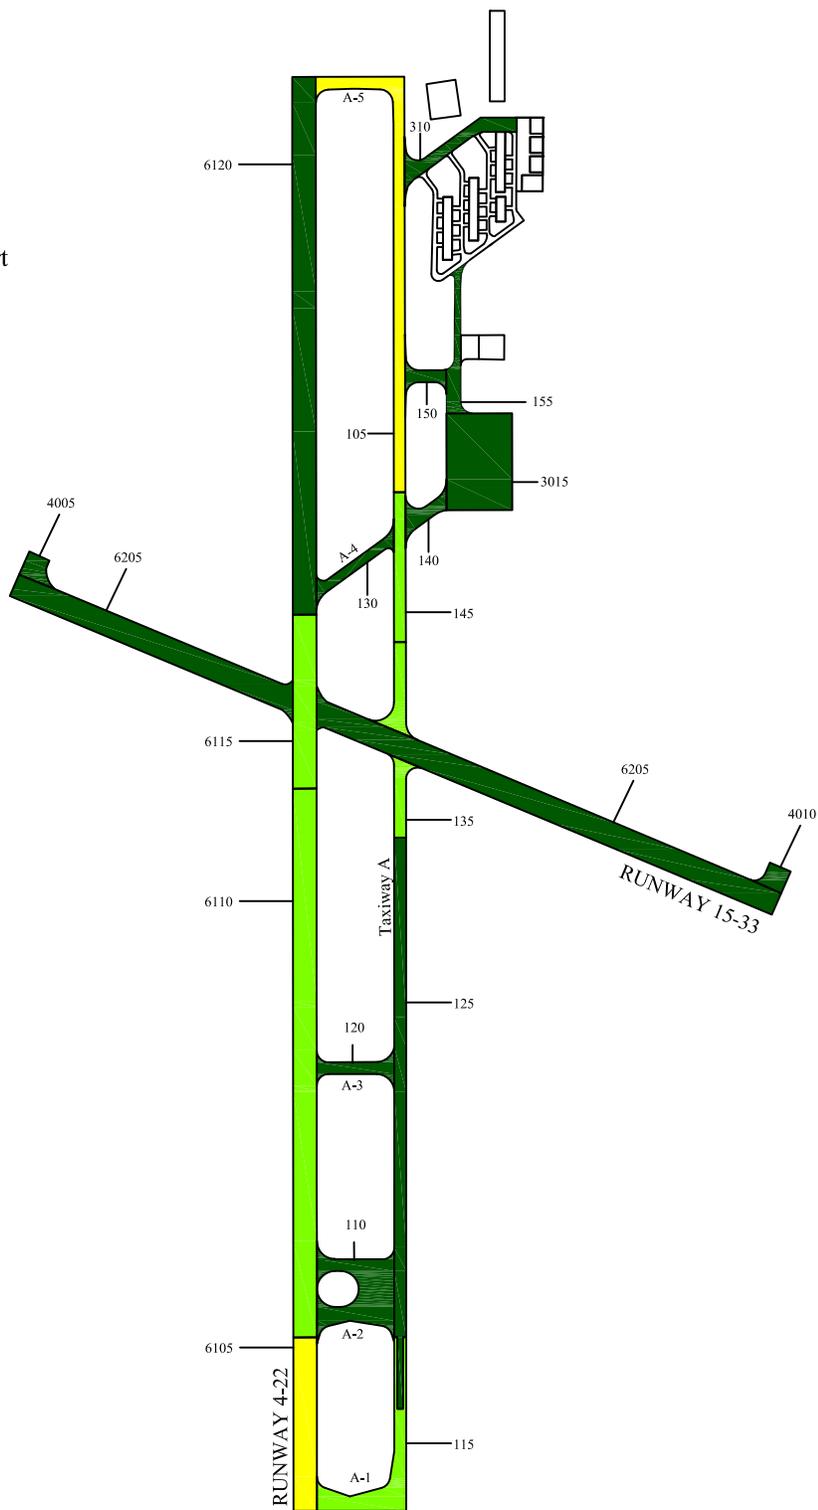
Figure 2-1. Inspected Pavement Condition at Marion Municipal Airport (MZZ).

The pavement within each of the PCI condition categories is shown in Figure 2-1. The inspected PCI is summarized by branch use in Figure 2-2, and the photographs in Figure 2-3 through Figure 2-5 provide examples of the condition categories.

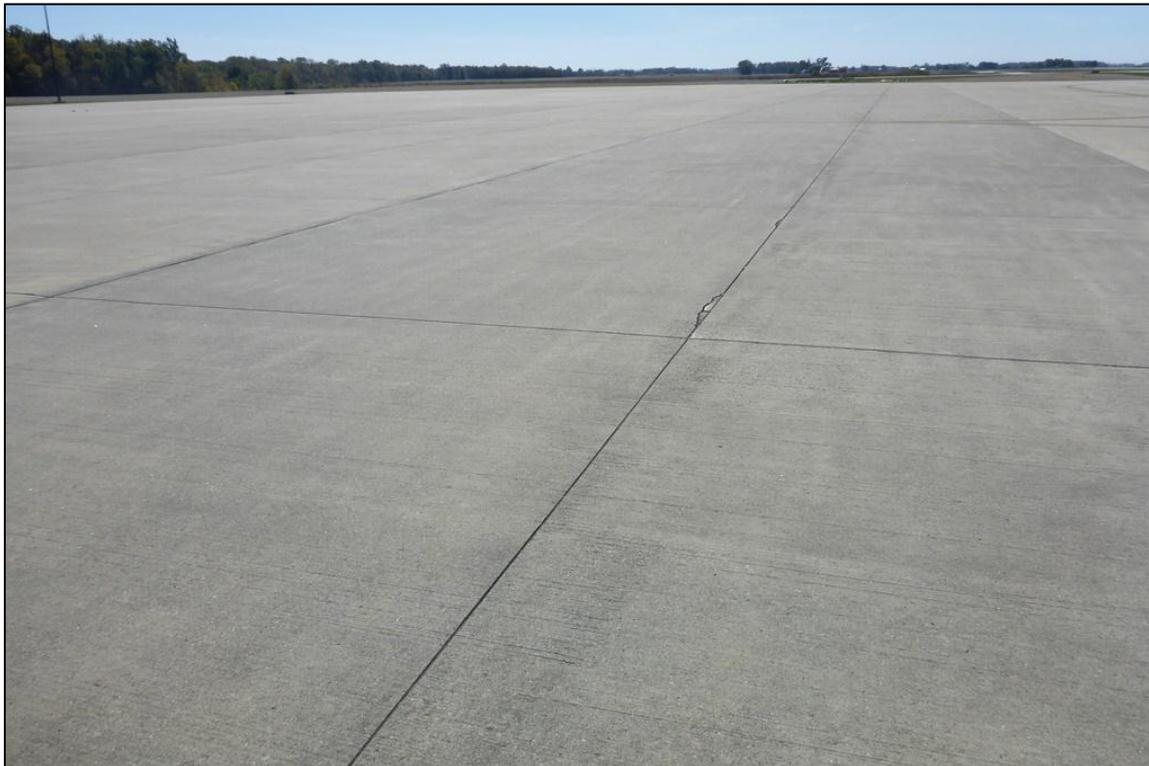
Figure 2-3. Typical PCC Pavement in Good Condition (Feature 3015)

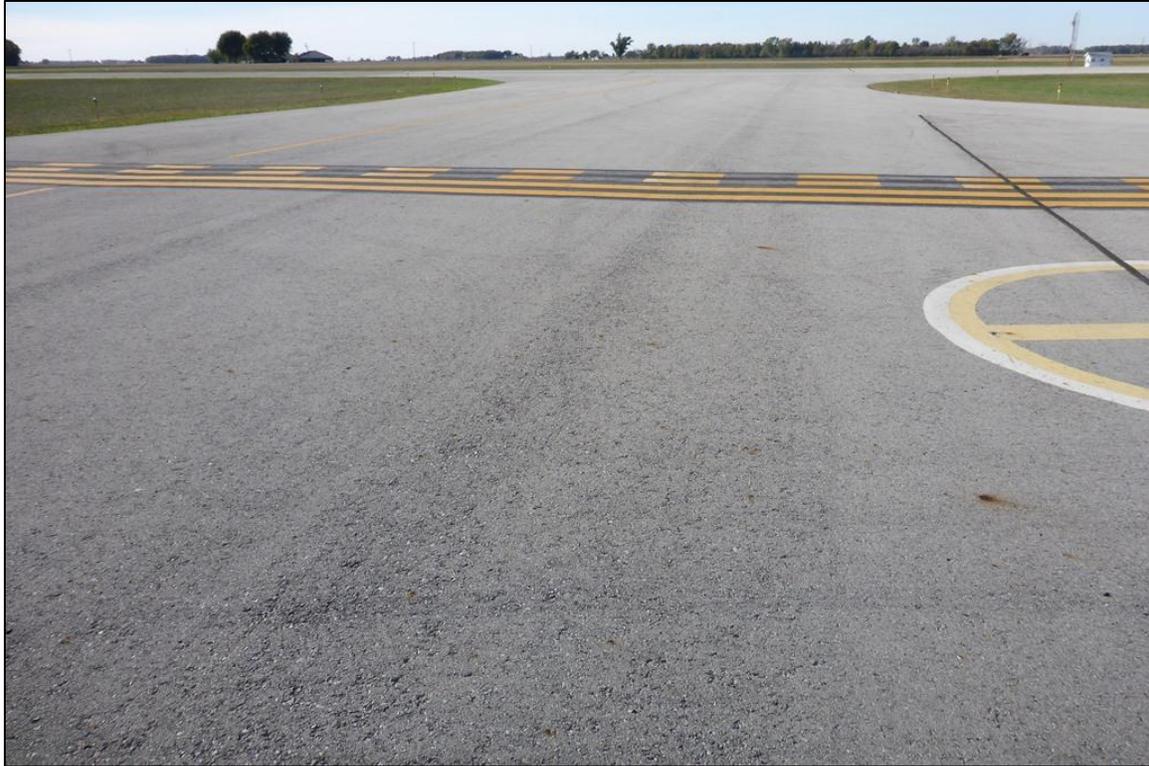
Figure 2-4. Typical AC Pavement in Good Condition (Feature 110)

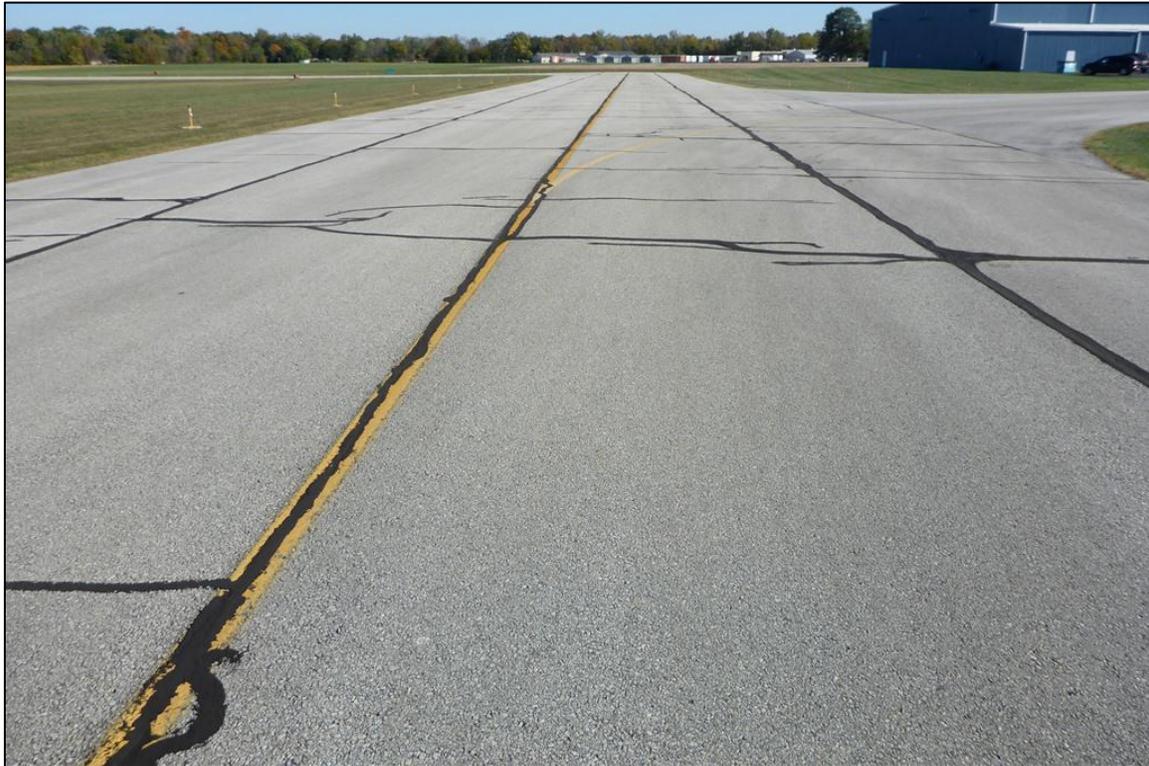
Figure 2-5. Typical AC Pavement in Fair Condition (Feature 105)
