# Pavement Condition Report

## Michigan City Municipal Airport

Project 16801839

## 2015 PCI Inspection

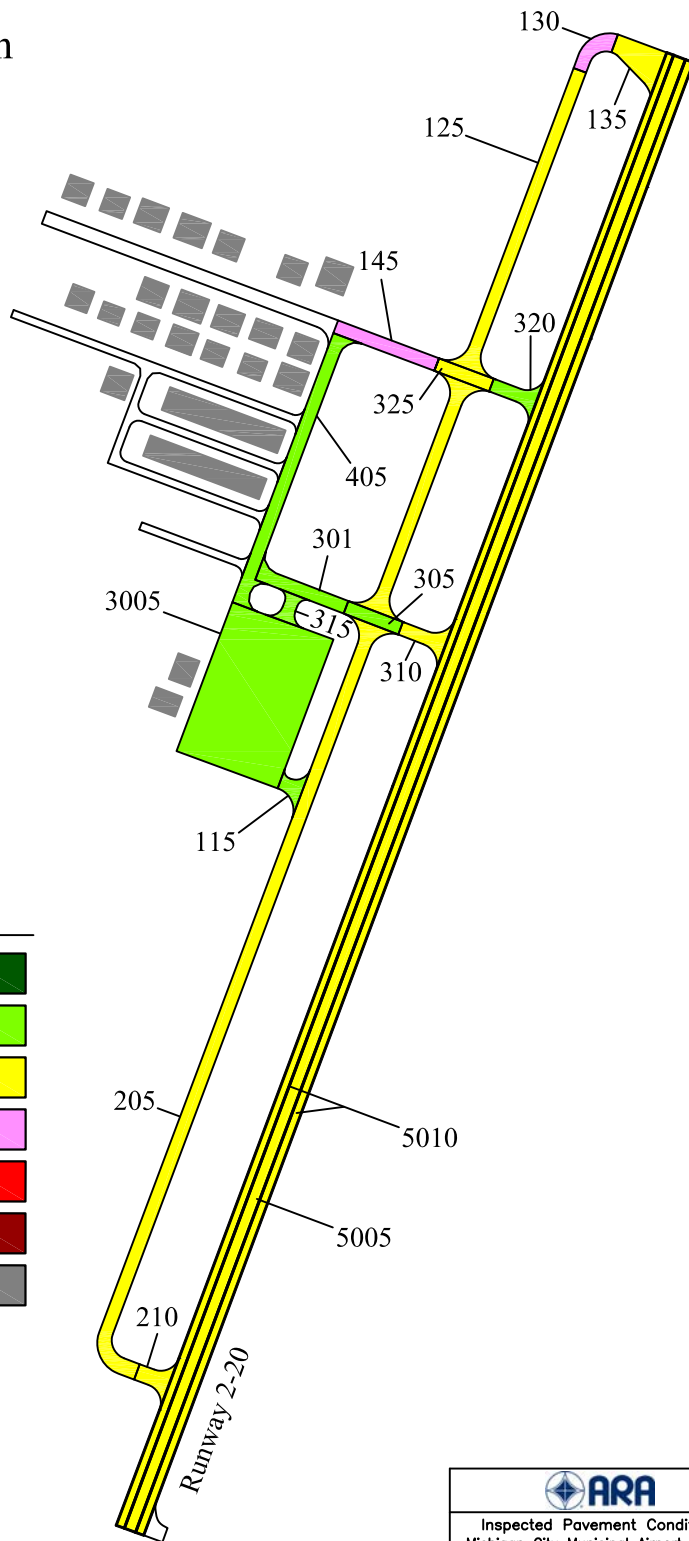
Figure 2-1. Inspected Pavement Condition at Michigan City Municipal Airport (MGC).

The average inspected Pavement Condition Index (PCI) for all the airfield pavements was 67. Runways had an average inspected PCI of 63 and were above the desired MSL of 60. Taxiways had an average inspected PCI of 68, and ramps had an average inspected PCI of 74.

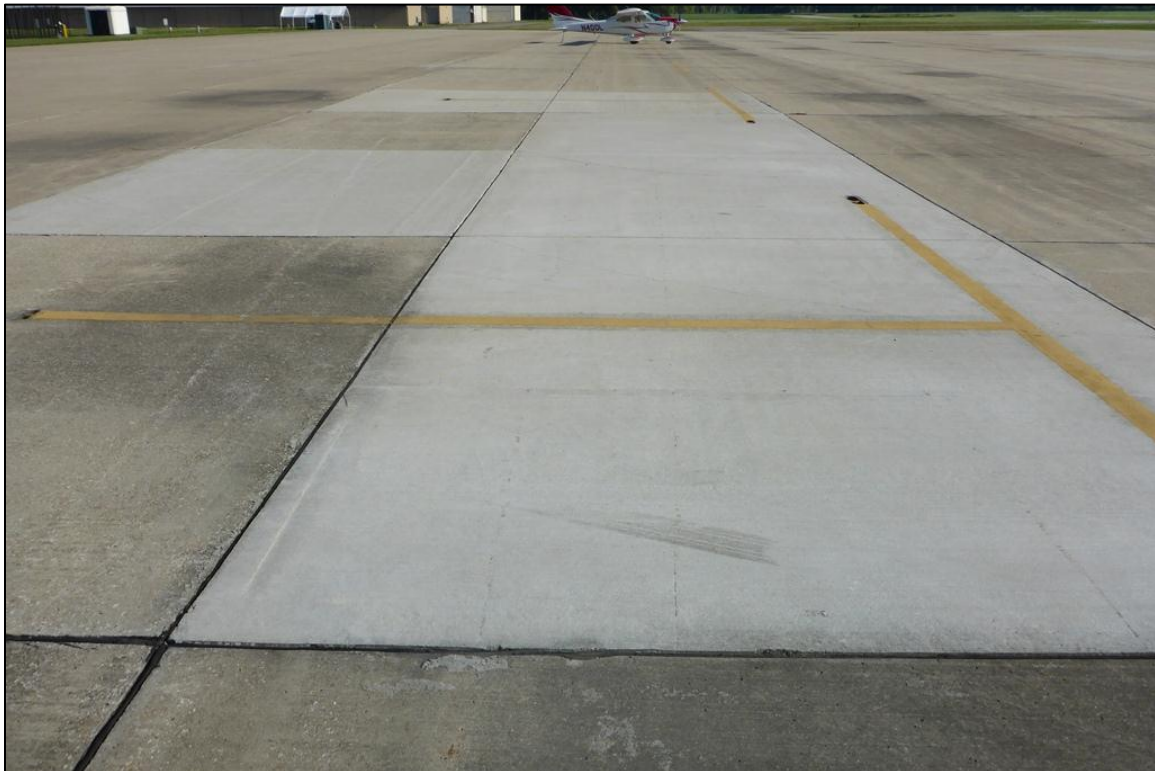
Figure 2-3. Typical PCC Pavement in Good Condition (Feature 3005)

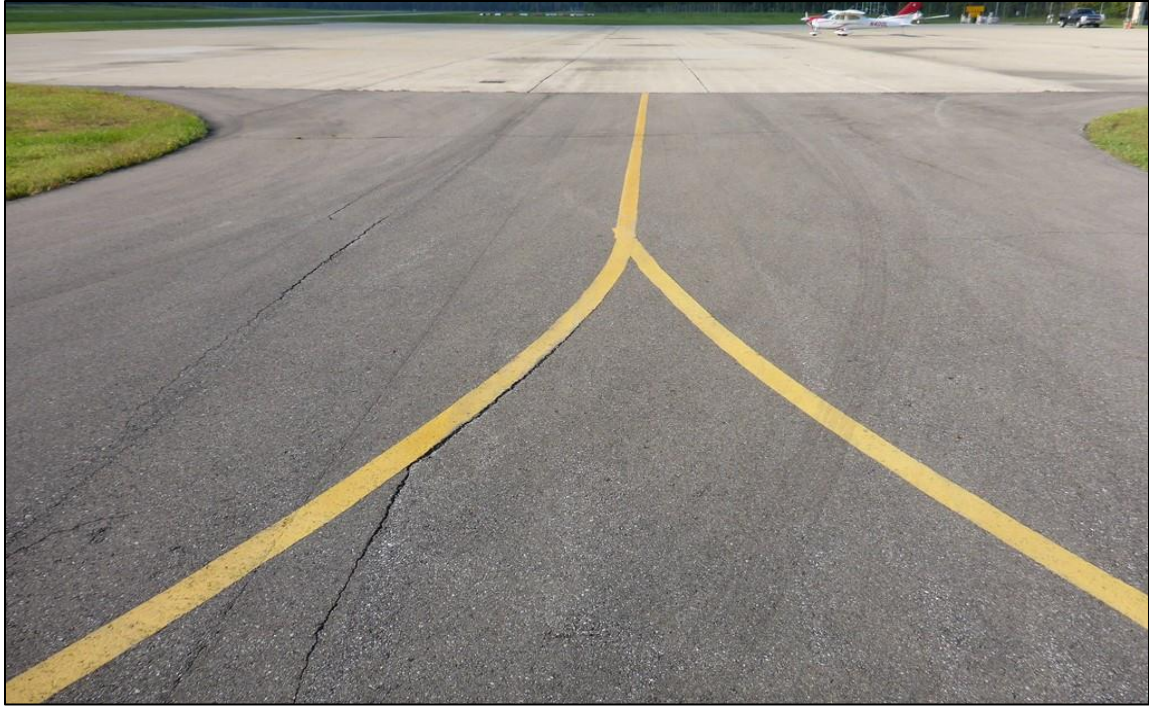
Figure 2-4. Typical AC Pavement in Good Condition (Feature 315)

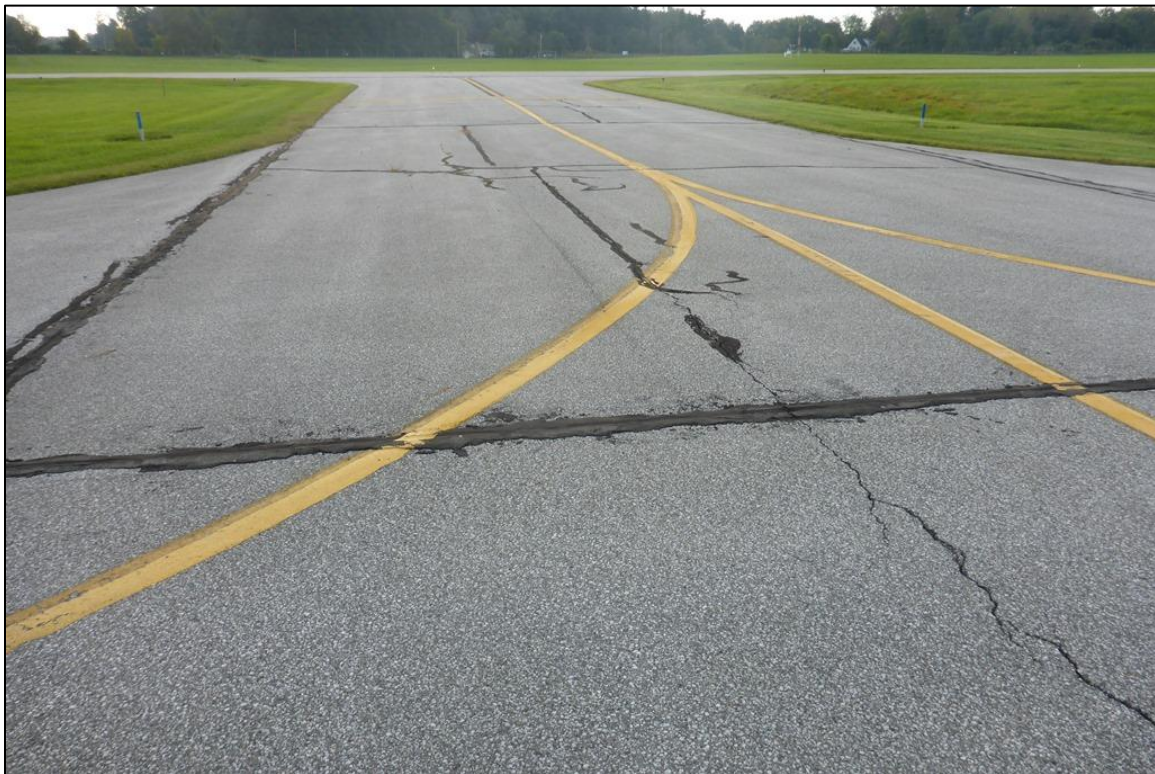
Figure 2-5. Typical AC Pavement in Fair Condition (Feature 325)

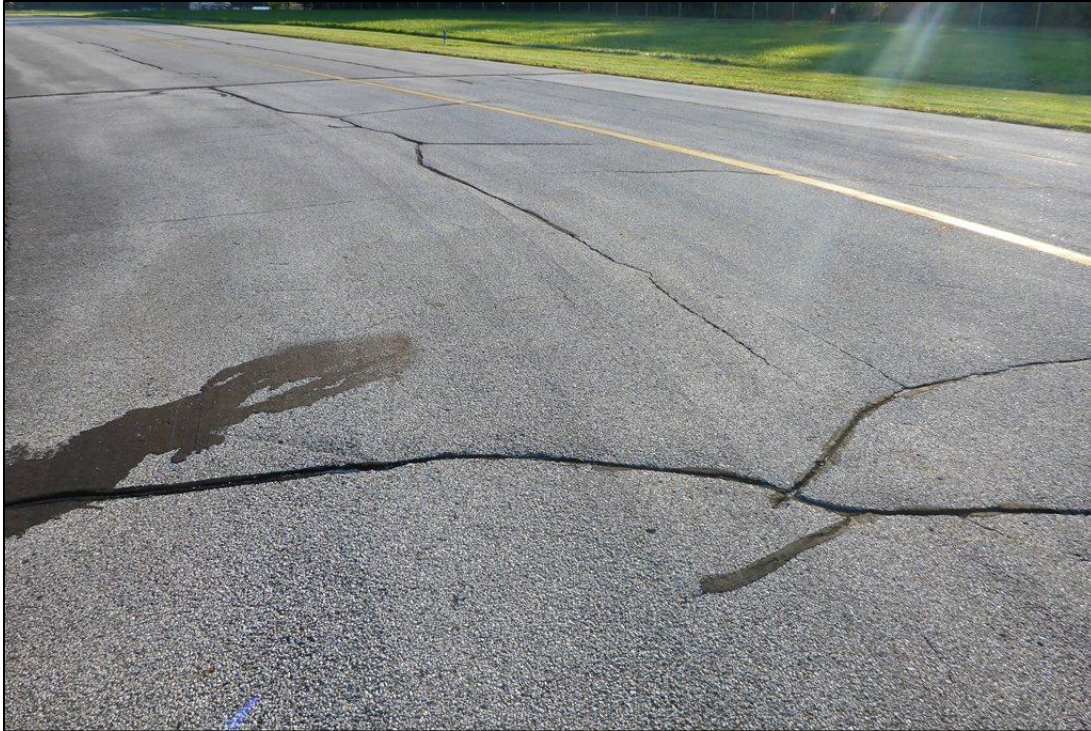
Figure 2-6. Typical AC Pavement in Poor Condition (Feature 130)
