Pavement Condition Report

Paoli Municipal Airport

Project 16801839

January 2016

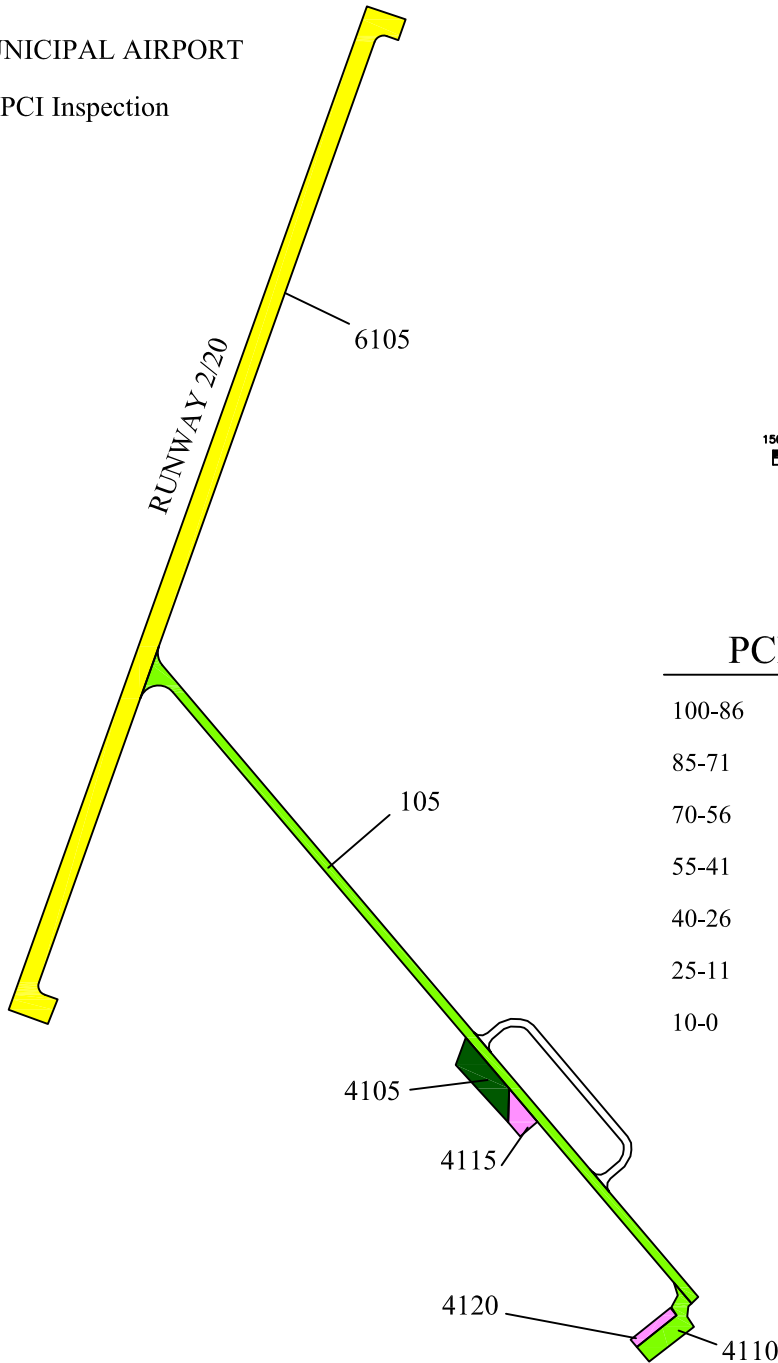
Figure 2-1. Inspected Pavement Condition at Paoli Municipal Airport (142).

The average inspected Pavement Condition Index (PCI) for all the airfield pavements was 69. The runway had an average inspected PCI of 63 and was above the desired MSL of 55. Taxiways had an average inspected PCI of 79, and ramps had an average inspected PCI of 79.
