Pavement Condition Report

Peru Municipal Airport

Project 16801839

January 2016

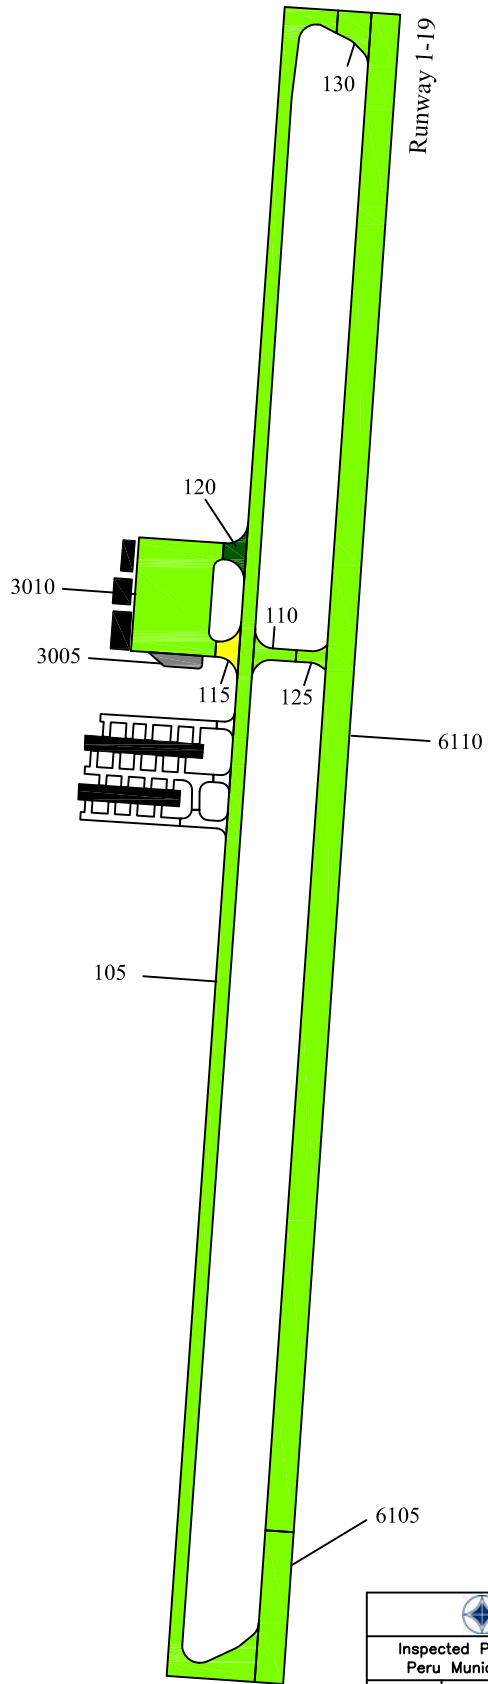
Figure 2-1. Inspected Pavement Condition at Peru Municipal Airport (176).

The average inspected Pavement Condition Index (PCI) for all the airfield pavements was 83. Runways had an average inspected PCI of 85 and were above the desired MSL of 60. Taxiways had an average inspected PCI of 83, and ramps had an average inspected PCI of 74.

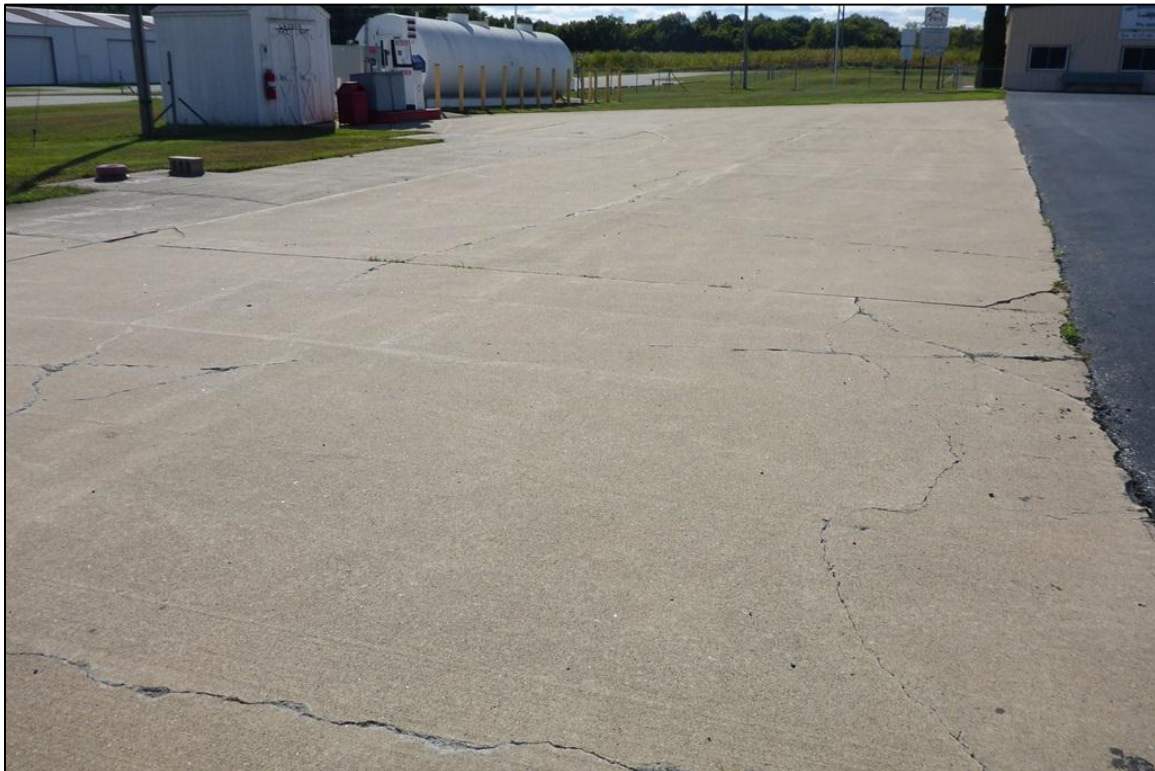
Figure 2-3. Typical PCC Pavement in Poor Condition (Feature 3005)

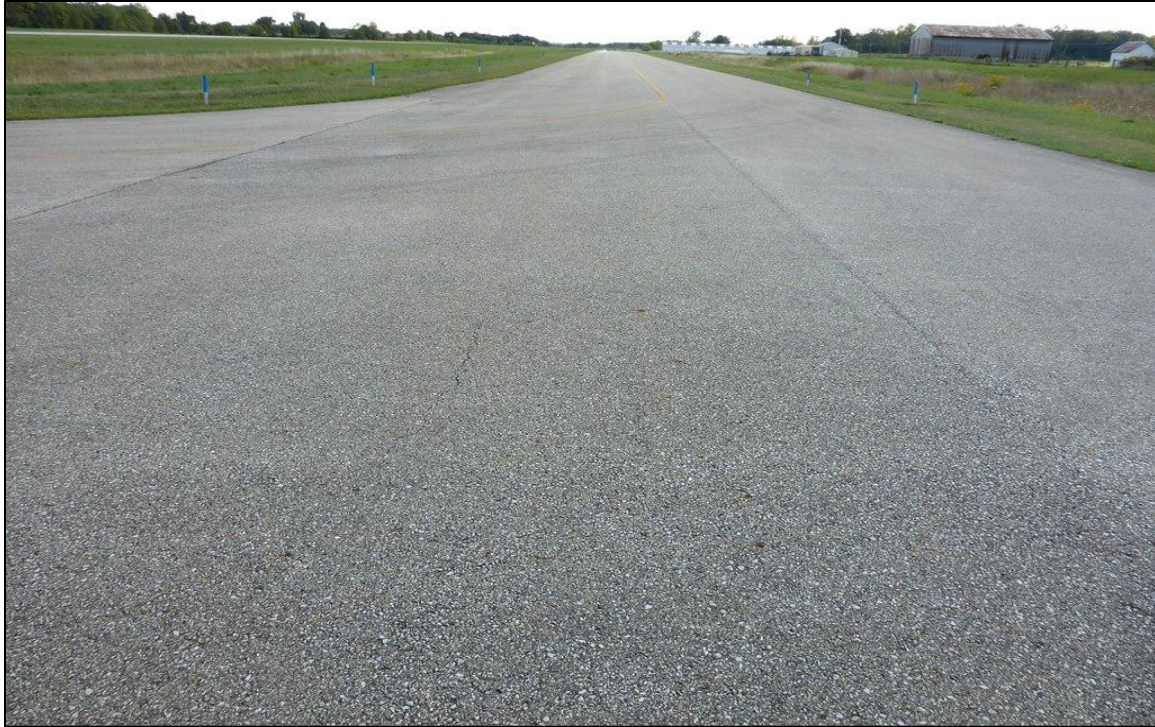
Figure 2-4. Typical AC Pavement in Good Condition (Feature 105)

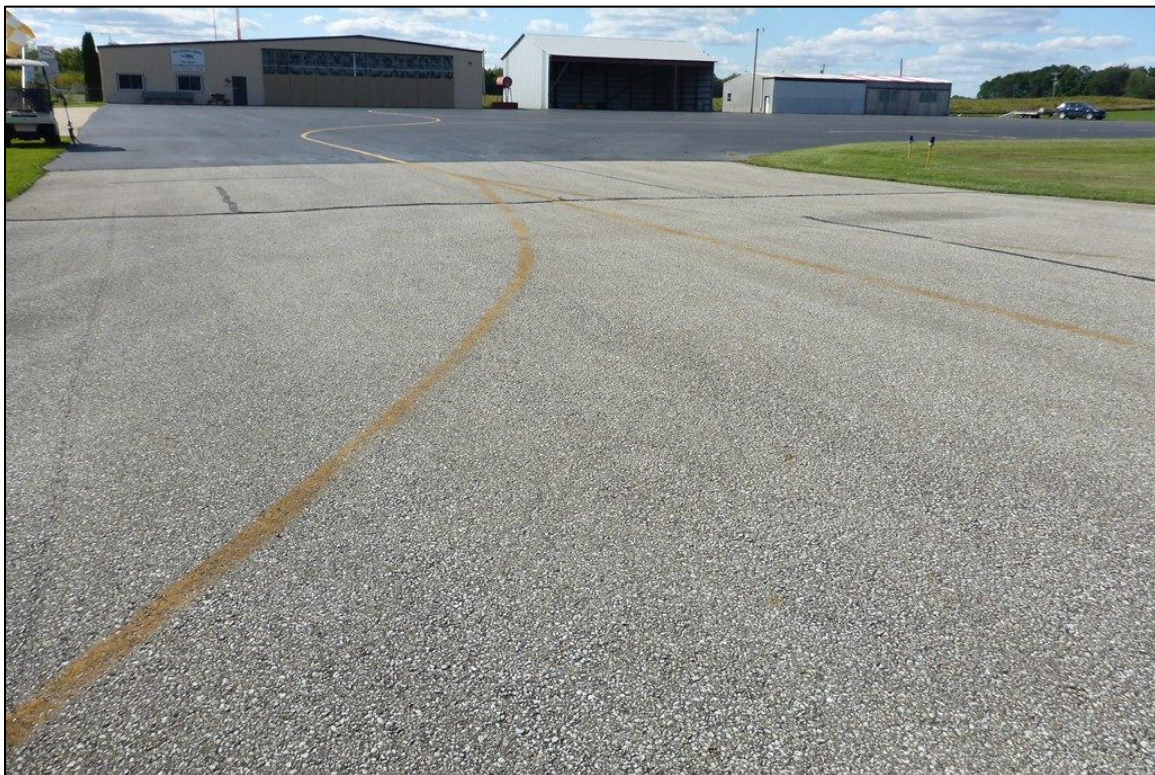
Figure 2-5. Typical AC Pavement in Fair Condition (Feature 115)
