BRIDGE HYDRAULIC REPORT

Bridge Number: I70-59-05180 CEBL & JCWB

Crossing: Branch of McCracken Creek

Prepared by:
Robyn M. Toole, P.E.
WSP | Parsons Brinckerhoff
September 22, 2016

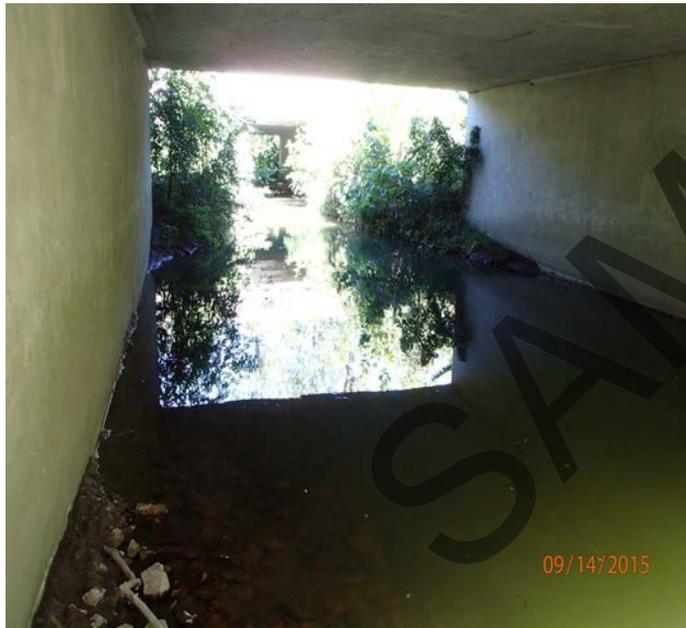
PHOTO 1 Description

Deficiency Description:
Unwanted trees and brush around bridge.
Work Description:

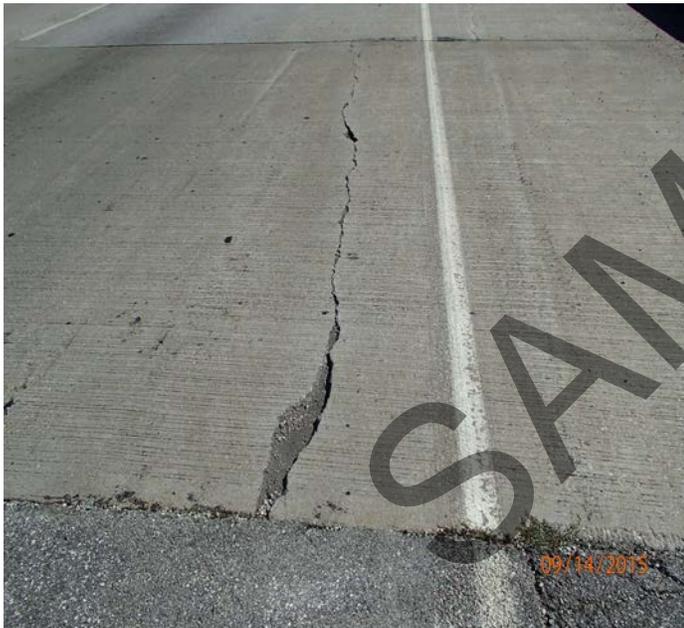
PHOTO 1 Description

Deficiency Description:
West approach slab has a 1' x 1' spall in the driving lane.
Work Description:

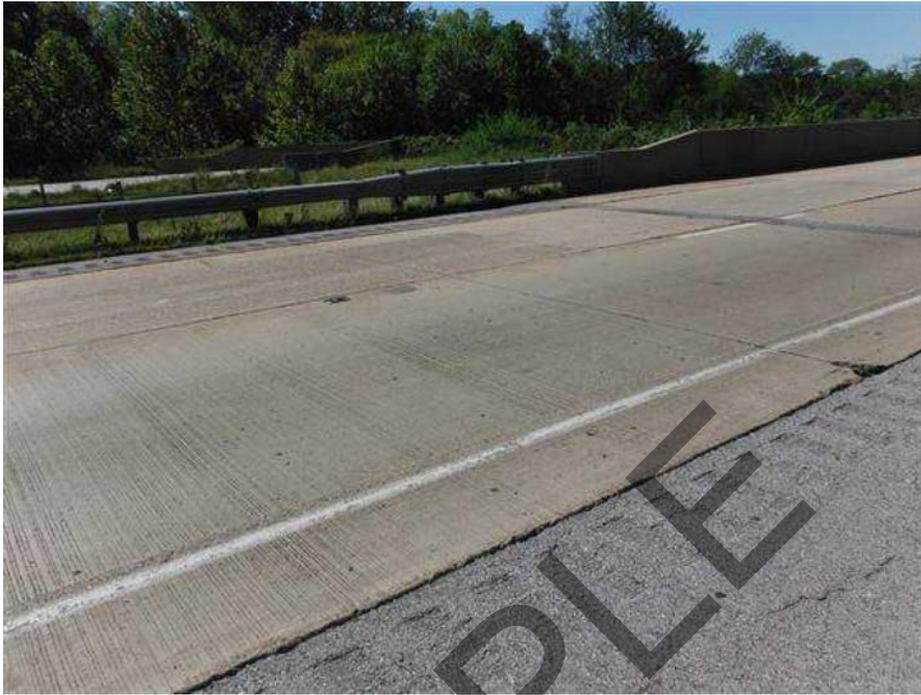
PHOTO 3

Description 9-14-2015 I70-60-05180JCWB (2) East approach pavement & guardrail condition

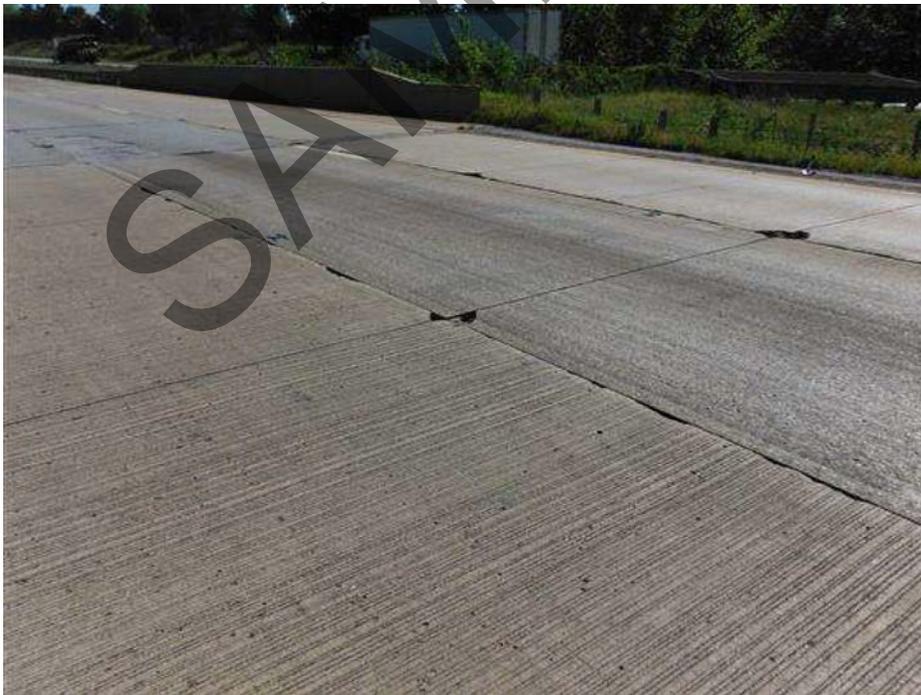
PHOTO 4

Description 9-14-2015 I70-60-05180JCWB (16) West approach pavement condition

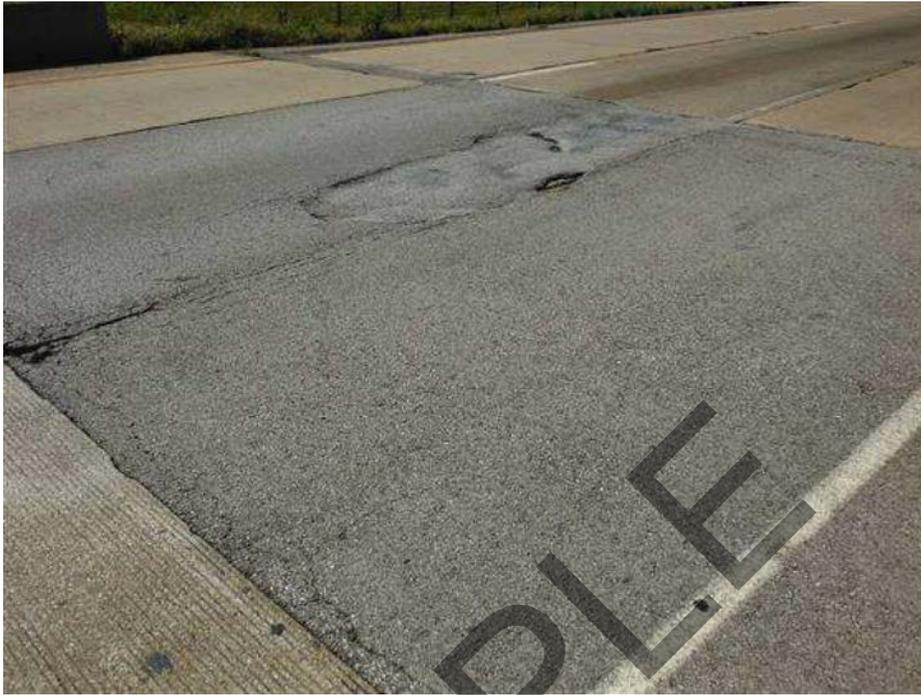
PHOTO 5

Description 9-14-2015 I70-60-05180JCWB (14) West approach has asphalt on the right, emergency & ramp exit lanes

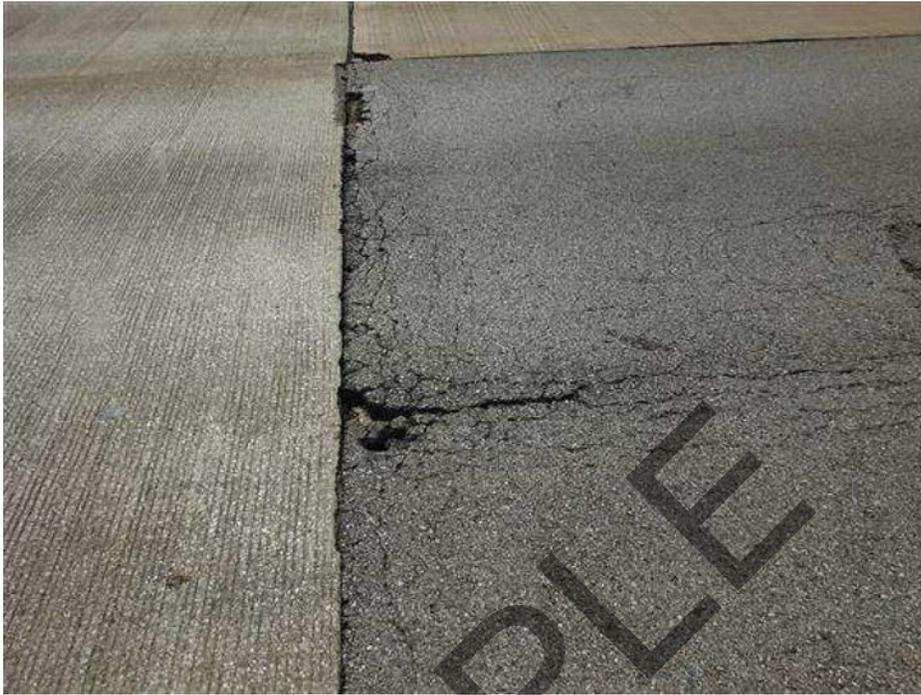
PHOTO 7

Description 9-14-2015 I70-60-05180JCWB (13) Asphalt portion of the West approach slab has spalls & cracks in the joint area

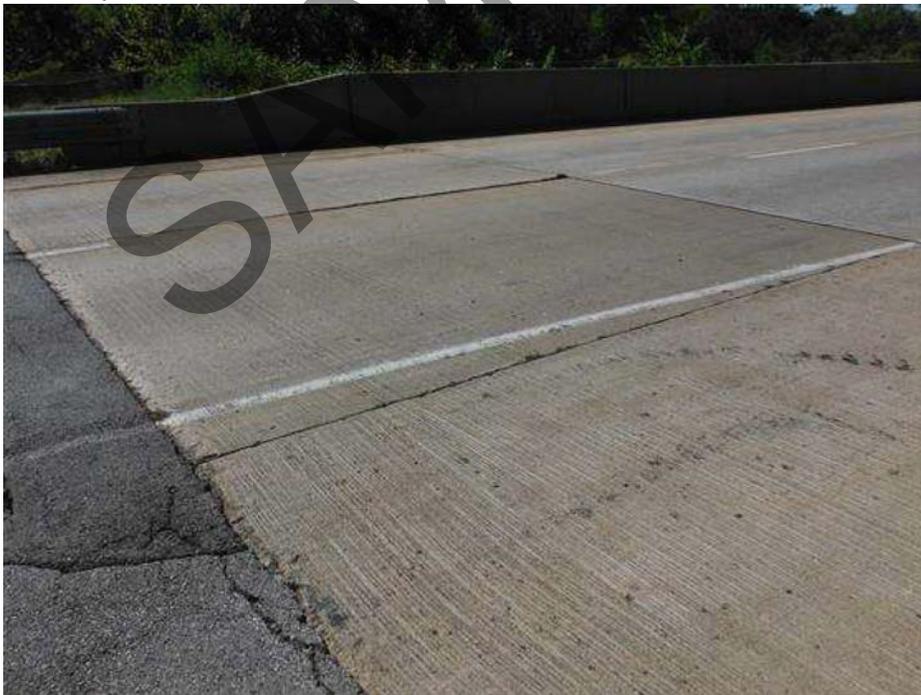
PHOTO 8

Description 9-14-2015 I70-60-05180JCWB (3) East concrete approach slab condition

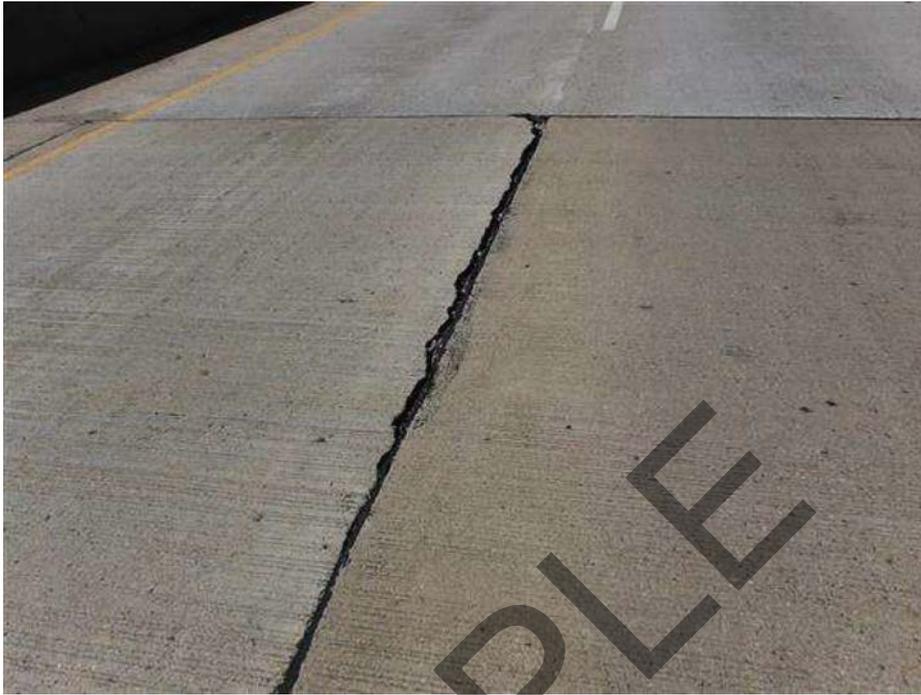
PHOTO 9

Description 9-14-2015 I70-60-05180JCWB (4) East concrete approach slab has spall along center line

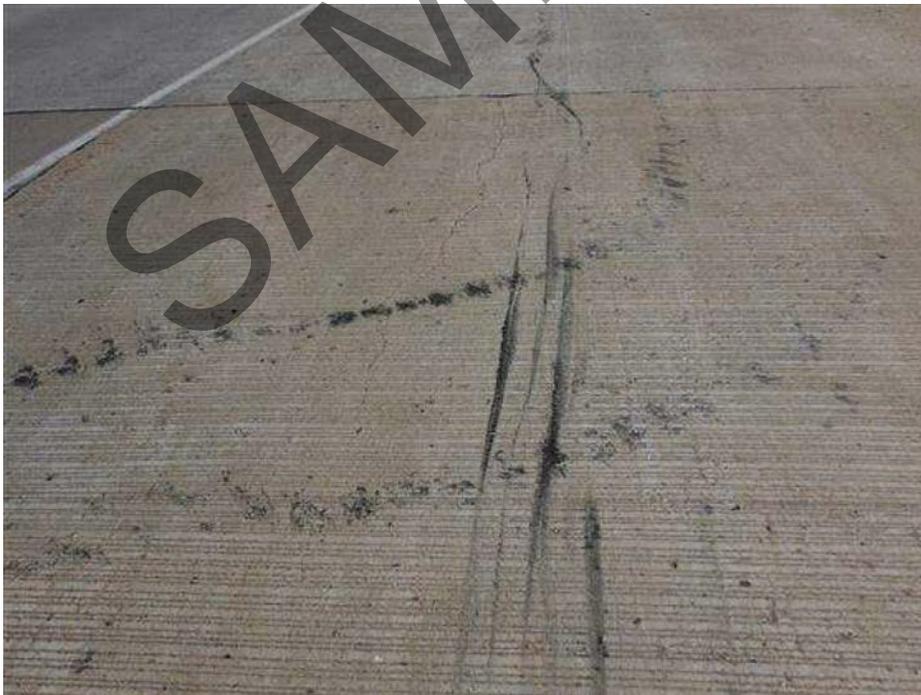
PHOTO 10

Description 9-14-2015 I70-60-05180JCWB (5) East concrete approach slab has wide crack in the North cold joint

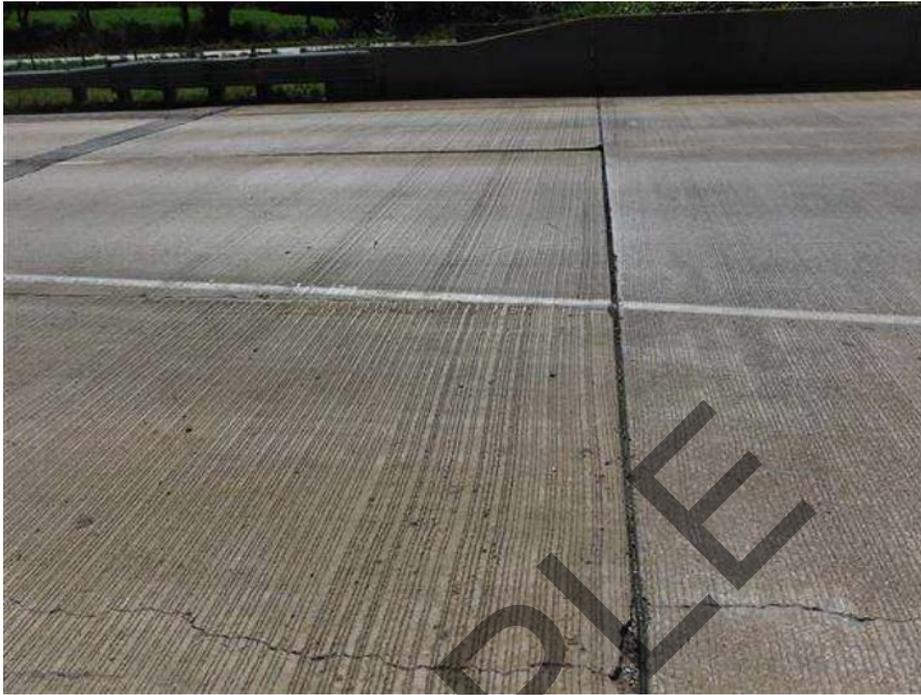
PHOTO 11
Description 9-14-2015 I70-60-05180JCWB (6) East 1A bridge joint condition

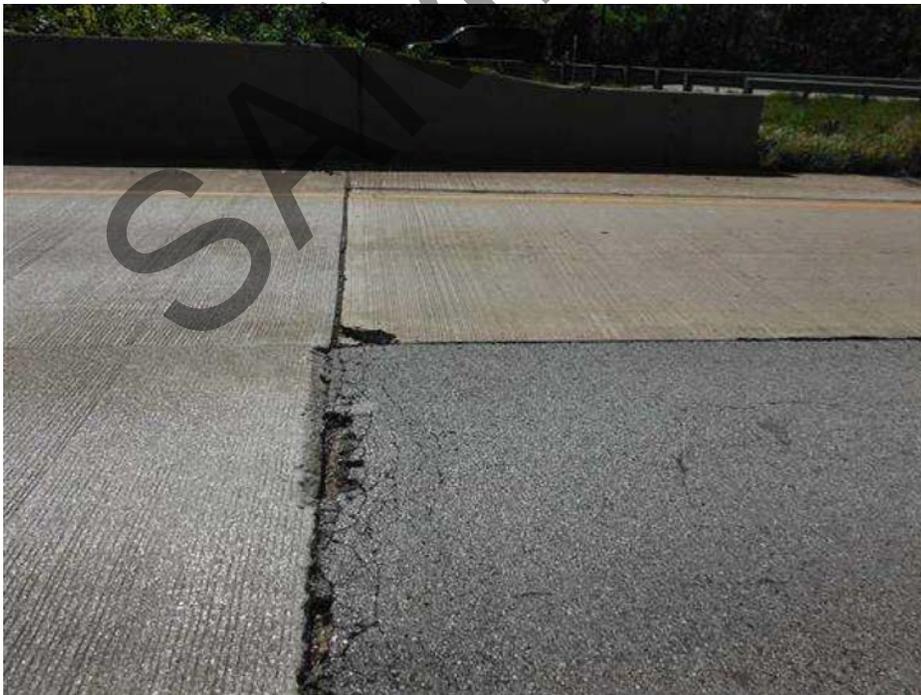
PHOTO 12
Description 9-14-2015 I70-60-05180JCWB (12) West 1A rubber is only in the left lane

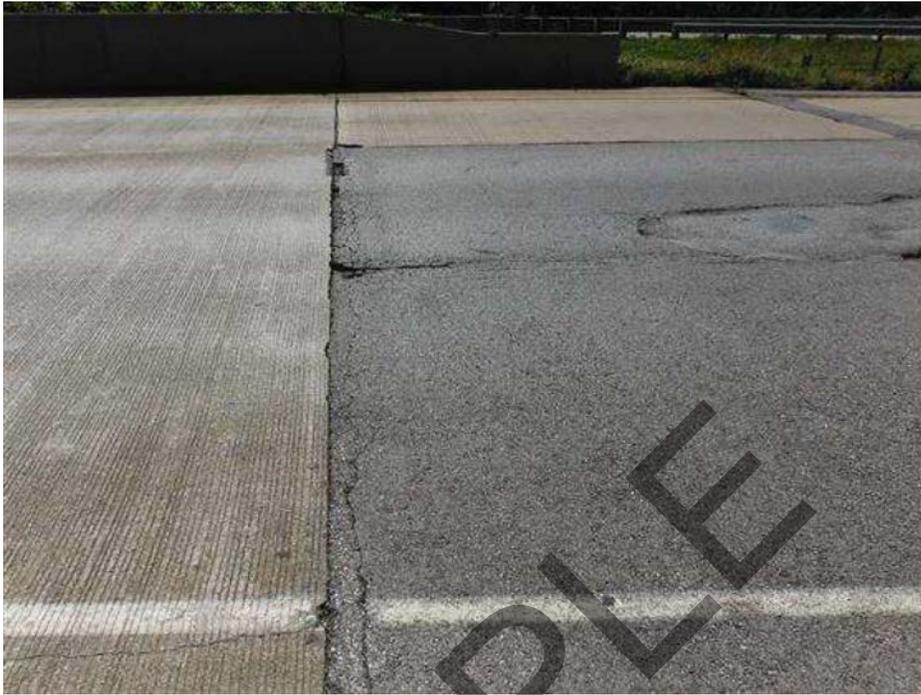
PHOTO 13

Description 9-14-2015 I70-60-05180JCWB (11) West 1A bridge joint is missing in the right & exit lanes

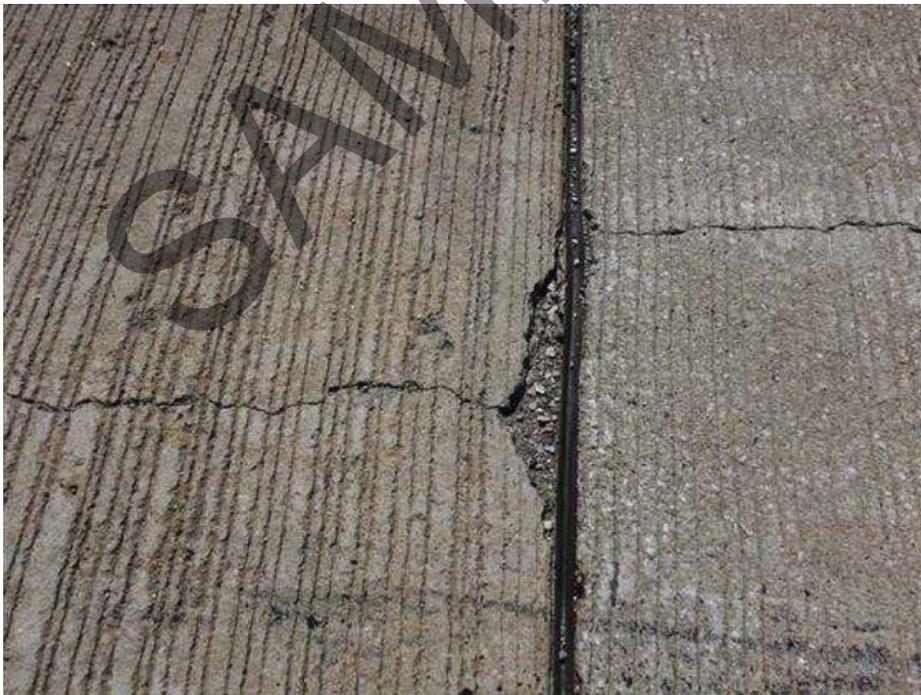
PHOTO 14

Description 9-14-2015 I70-60-05180JCWB (7) East 1A bridge joint has spall in shoulder area & missing rubber in right lane

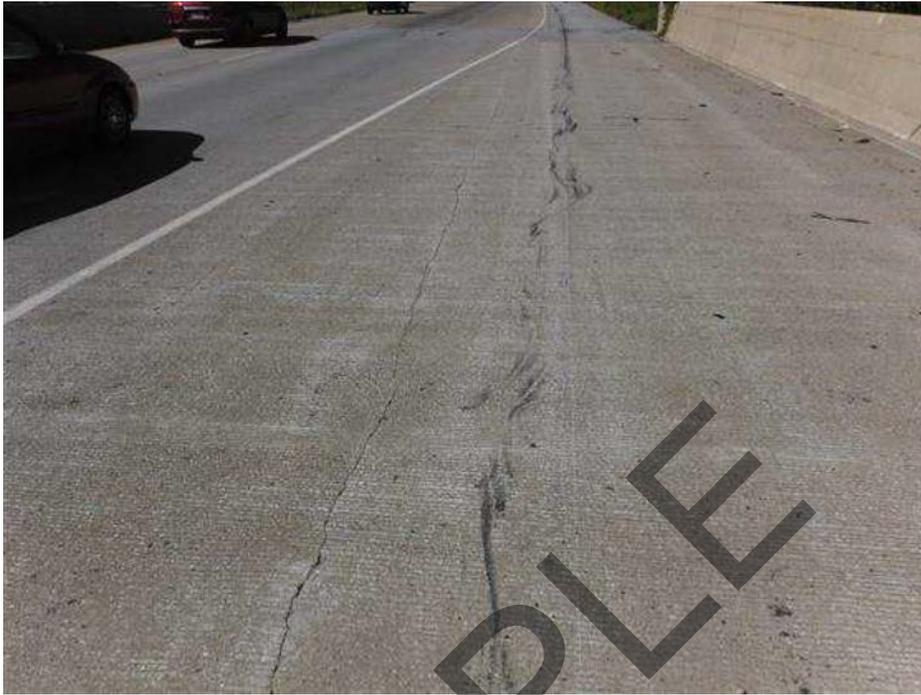
PHOTO 15

The Wearing surface has a wide longitudinal crack in the Emergency lane. I did note 3 longitudinal hair line cracks in the main line lanes of the bridge. Photos were taken & sketch was done. Both are attached to the report. Dan Bewley 9/14/2015

Description 9-14-2015 I70-60-05180JCWB (8) Wearing surface has wide crack on North cold joint

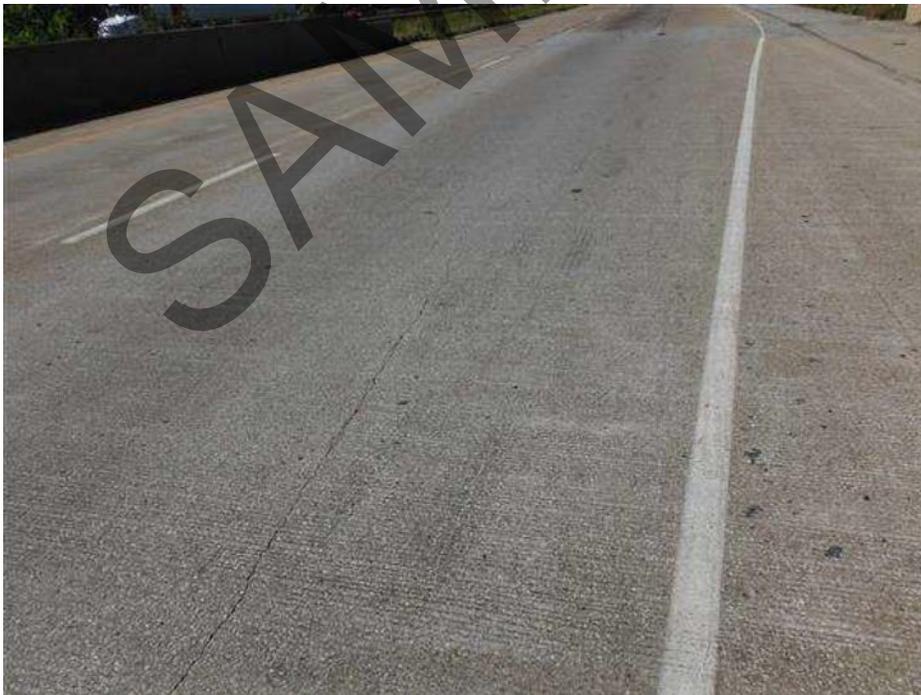
PHOTO 16

Description 9-14-2015 I70-60-05180JCWB (9) Wearing surface has 2 longitudinal hair line cracks in the right lane

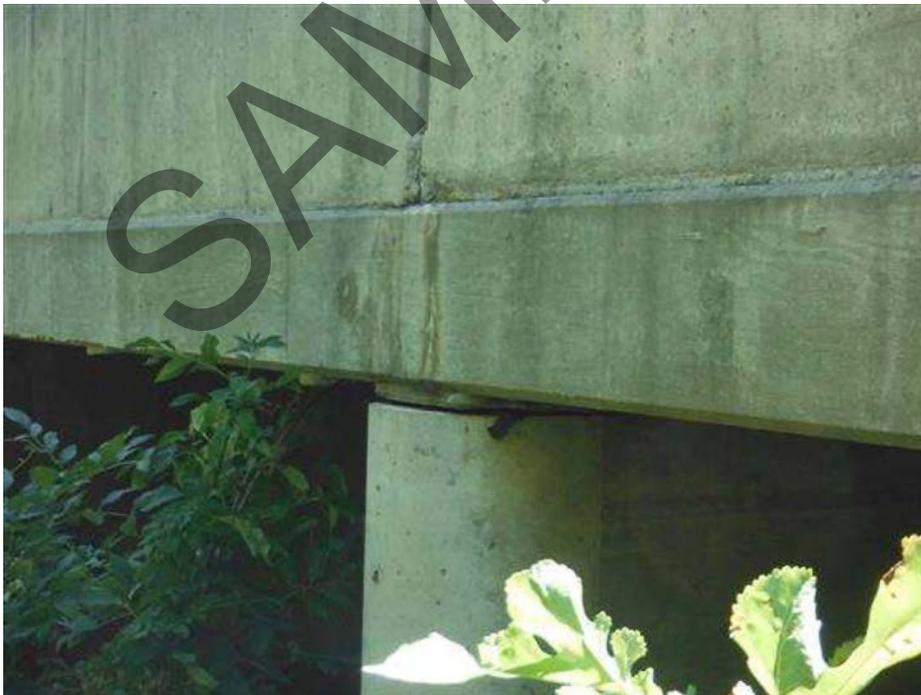
PHOTO 20

Description 9-14-2015 I70-60-05180JCWB (28) North coping has leached vertical cracks at both interior piers

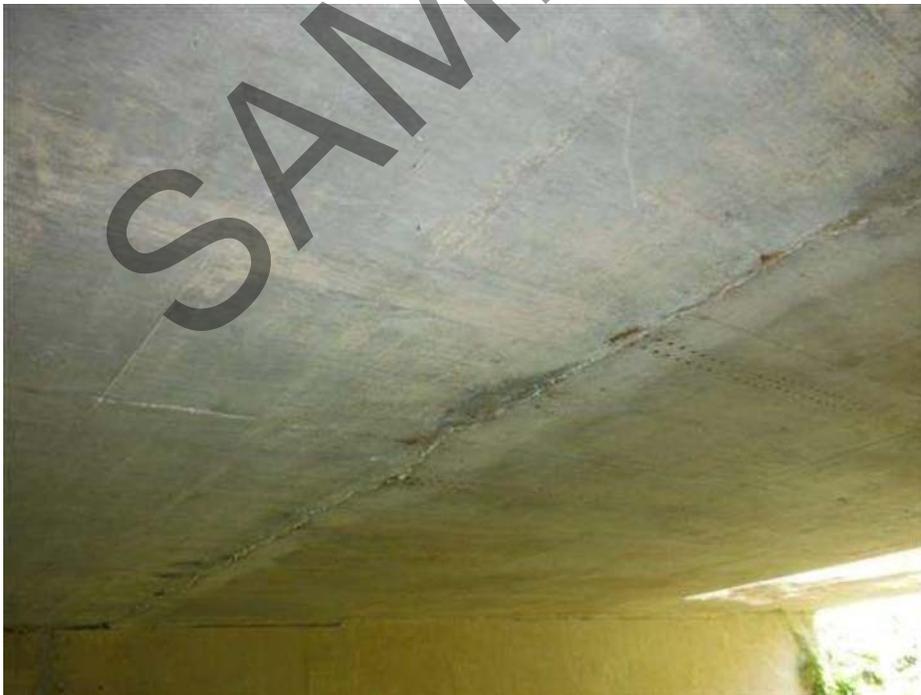
PHOTO 26

Description 9-14-2015 I70-60-05180JCWB (25) Center span condition

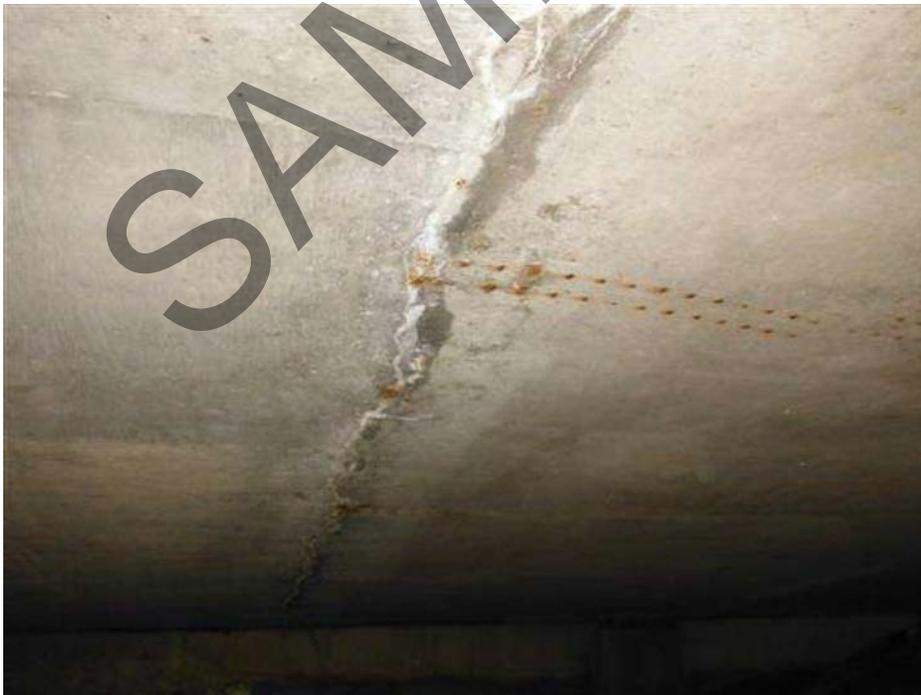
The bottom of the deck has a wide crack with efflorescence on the North cold joint. Some of the crack is wet. Photos were taken, sketch was drawn & both are attached to the report. Dan Bewley 9/14/2015

PHOTO 28
Description 9-14-2015 I70-60-05180JCWB (31) East span has efflorescence on the North cold joint

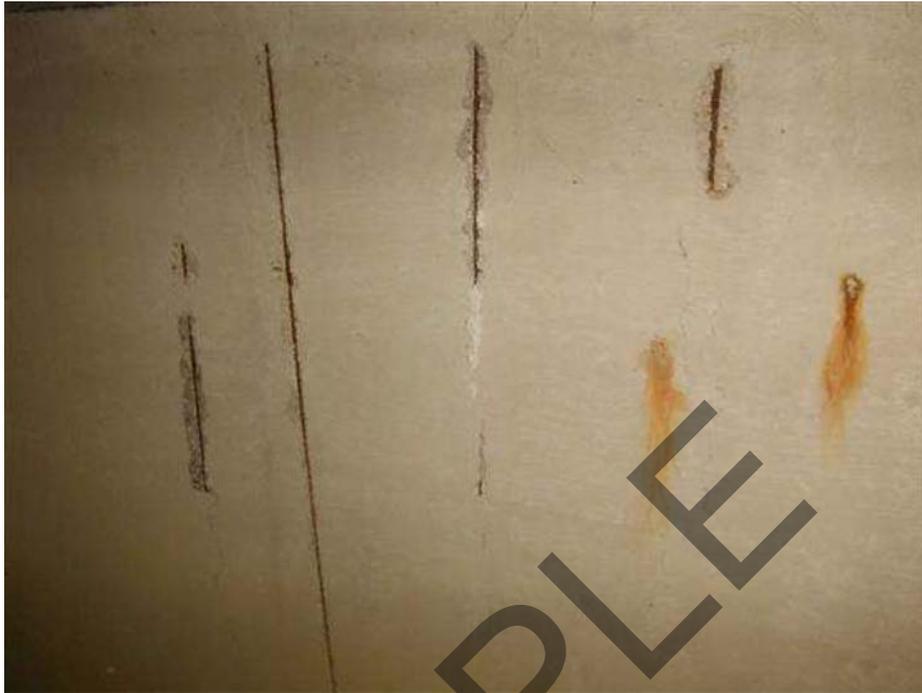
PHOTO 31

Description 9-14-2015 I70-60-05180JCWB (34) East interior pier has about 8' of spalling with exposed rebar on the East face

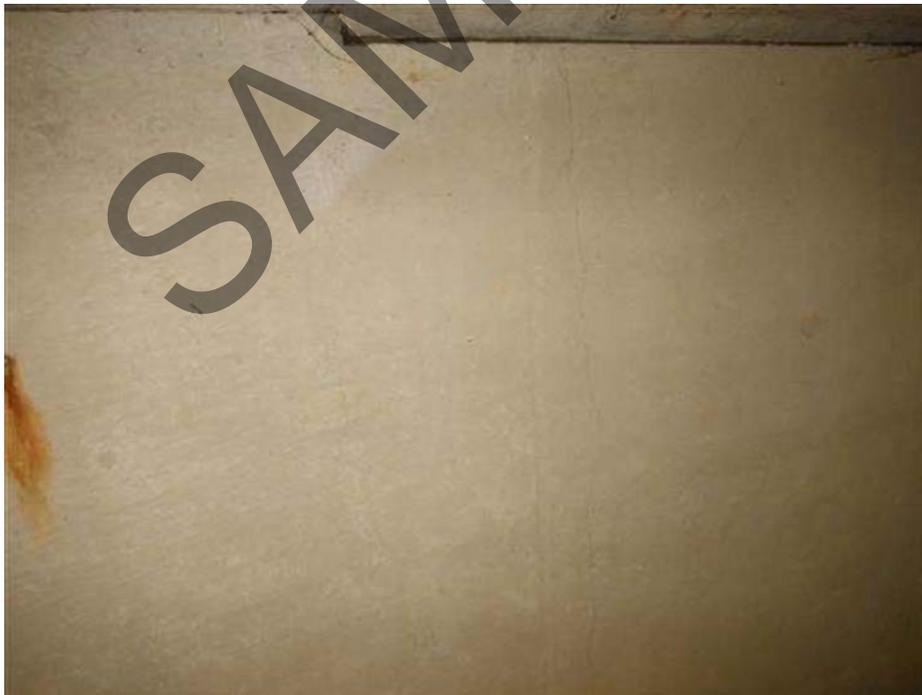
PHOTO 32

Description 9-14-2015 I70-60-05180JCWB (35) East interior pier has wide vertical crack on the East face about mid span
