# Pavement Condition Report

## Sullivan County Airport

Project 16801839

**January 2016**

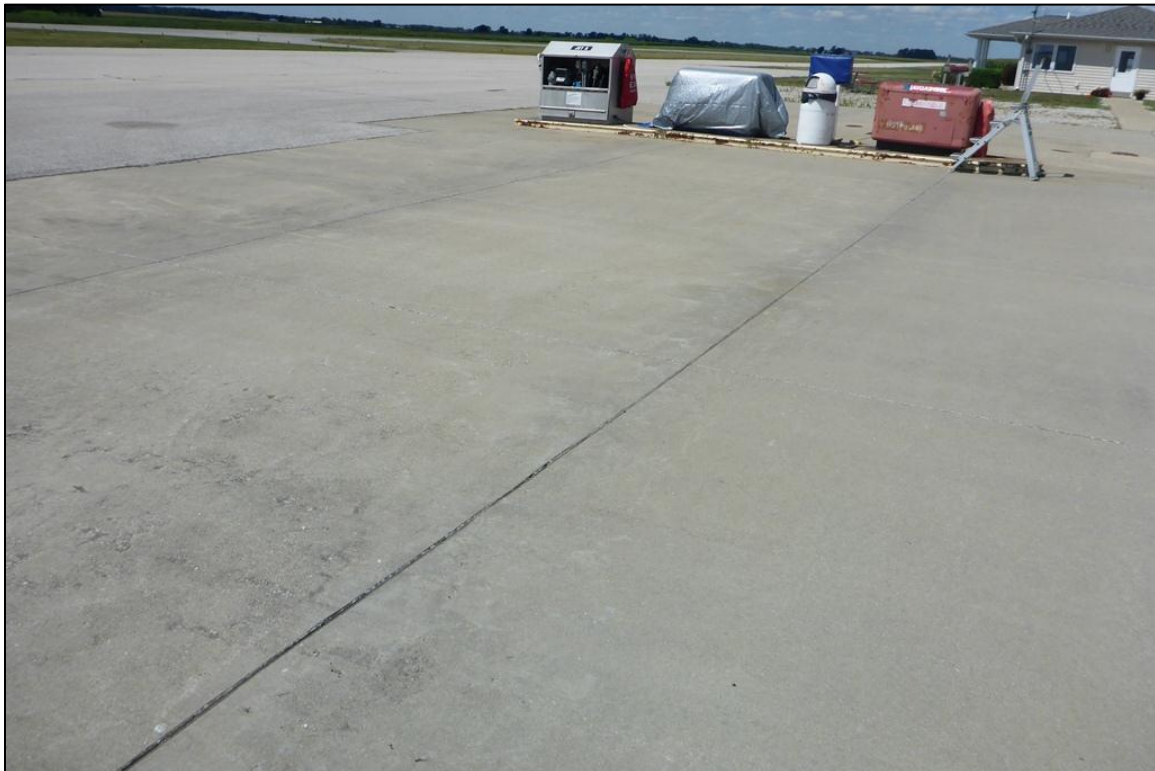
Figure 2-3. Typical PCC Pavement in Good Condition (Feature 3050)

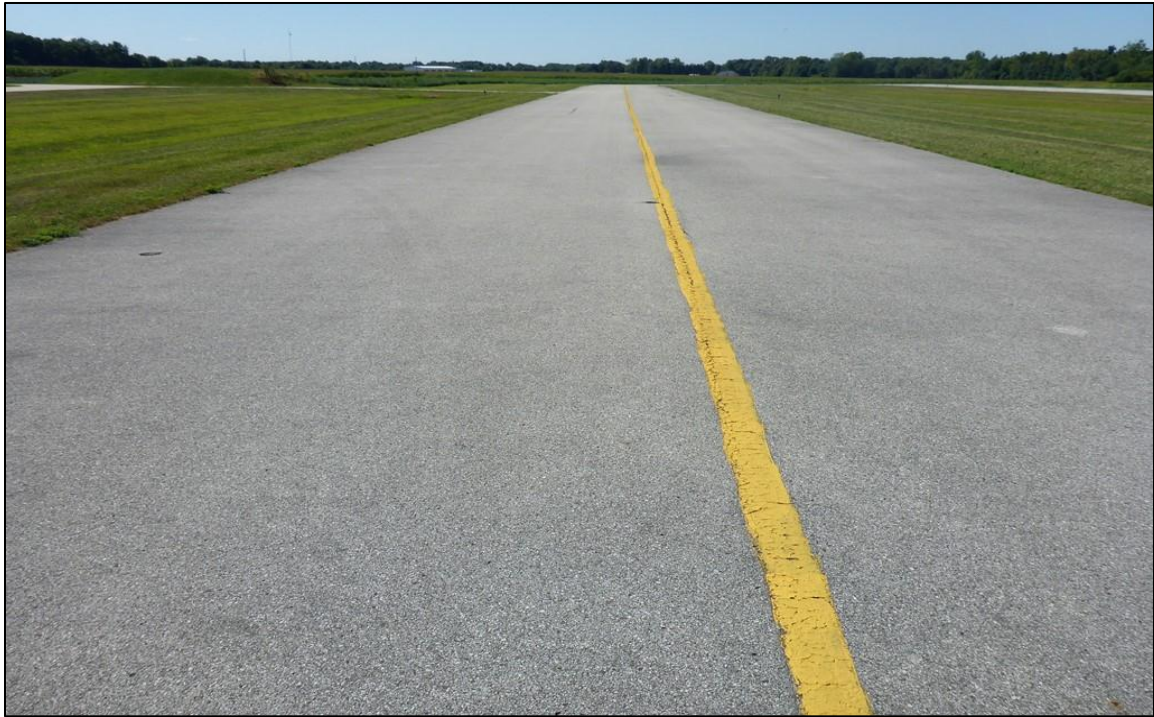
Figure 2-4. Typical AC Pavement in Good Condition (Feature 110)

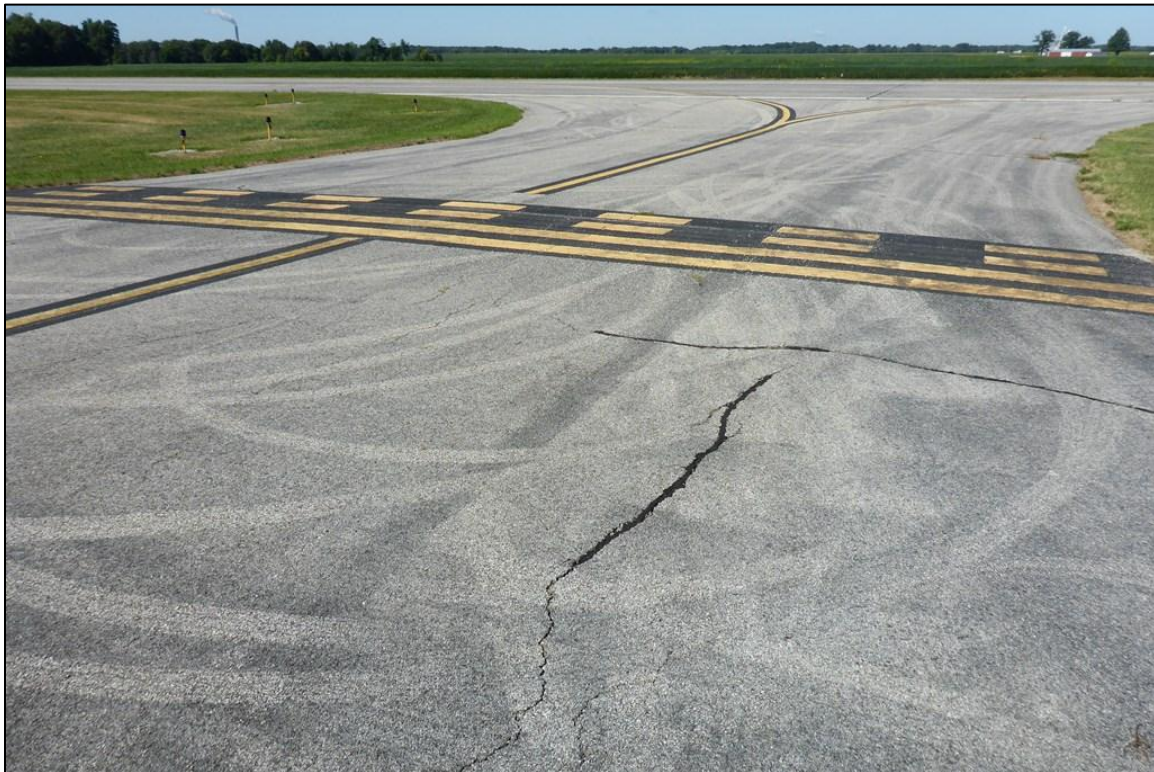
Figure 2-5. Typical AC Pavement in Fair Condition (Feature 405)
