# Pavement Condition Report

## Terre Haute International Airport

Project 16801839

**January 2016**

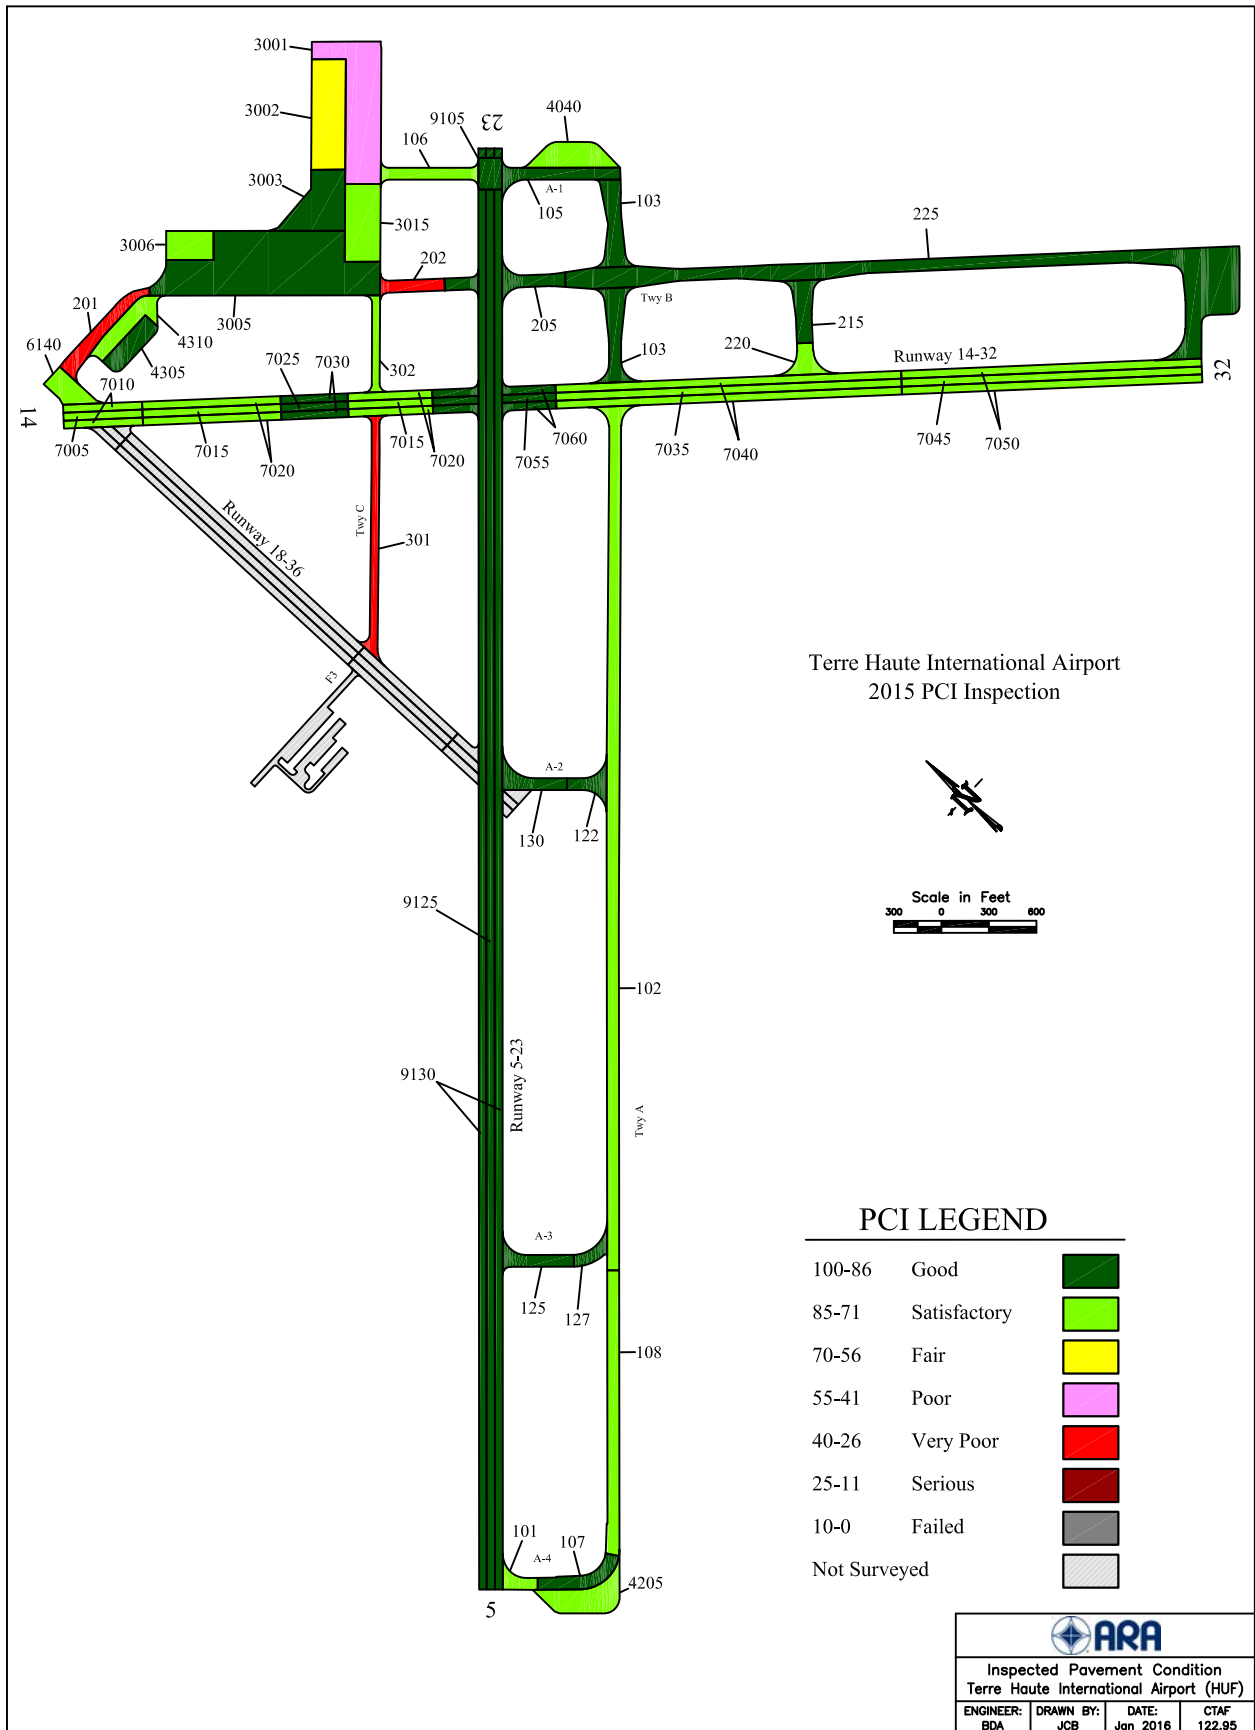
Figure 2-1. Inspected Pavement Condition at Terre Haute International Airport (HUF).

The pavement within each of the PCI condition categories is shown in Figure 2-1. The inspected PCI is summarized by branch use in Figure 2-2, and the photographs in Figure 2-3 through Figure 2-7 provide examples of the condition categories.

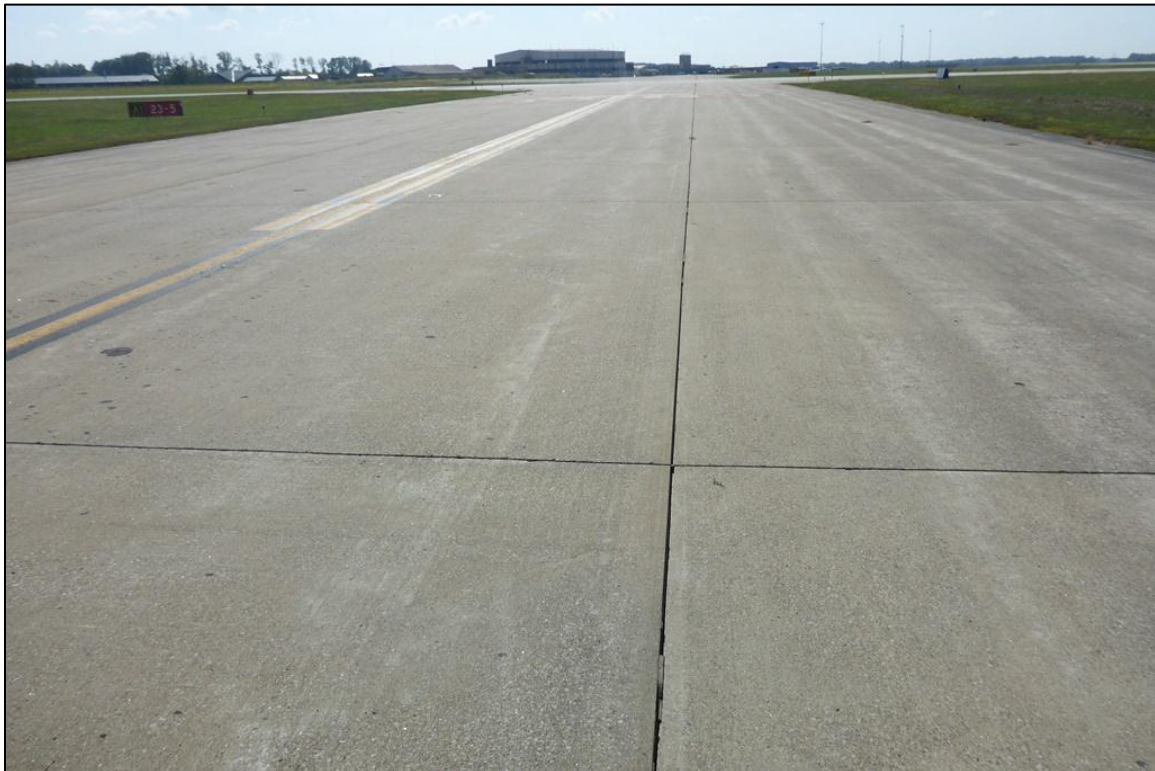
Figure 2-3. Typical PCC Pavement in Good Condition (Feature 106)

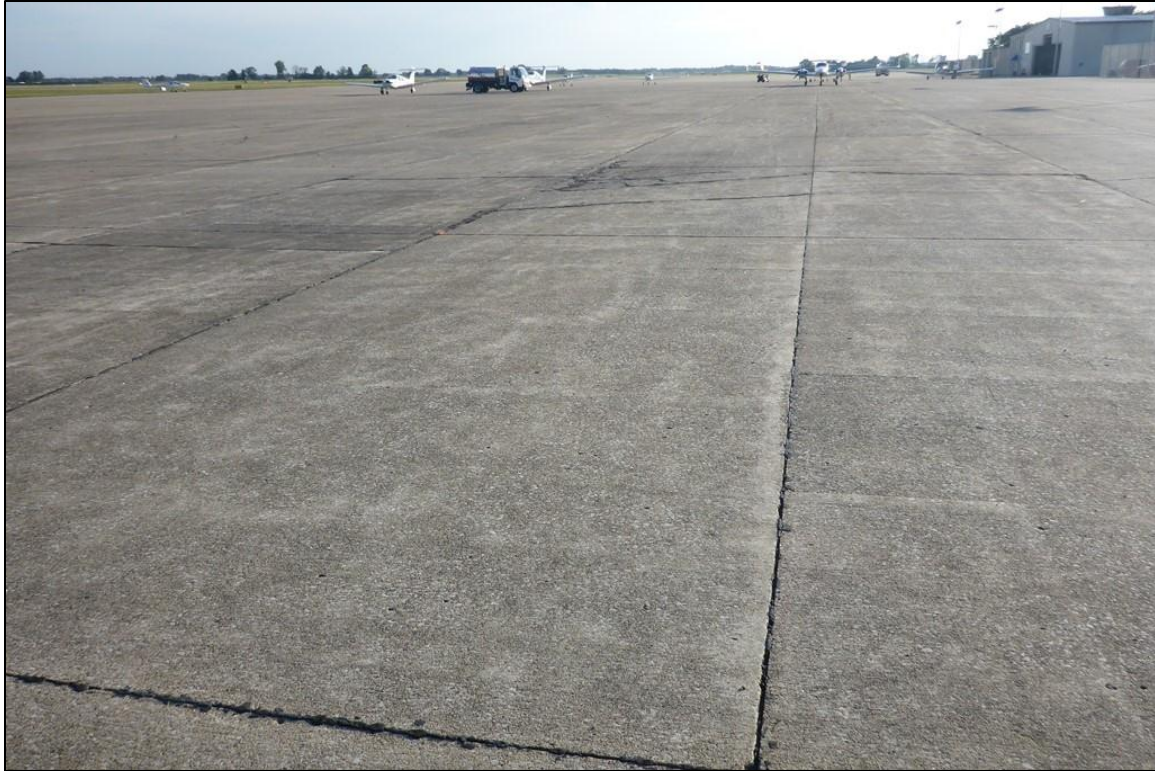
Figure 2-4. Typical PCC Pavement in Fair Condition (Feature 3002)

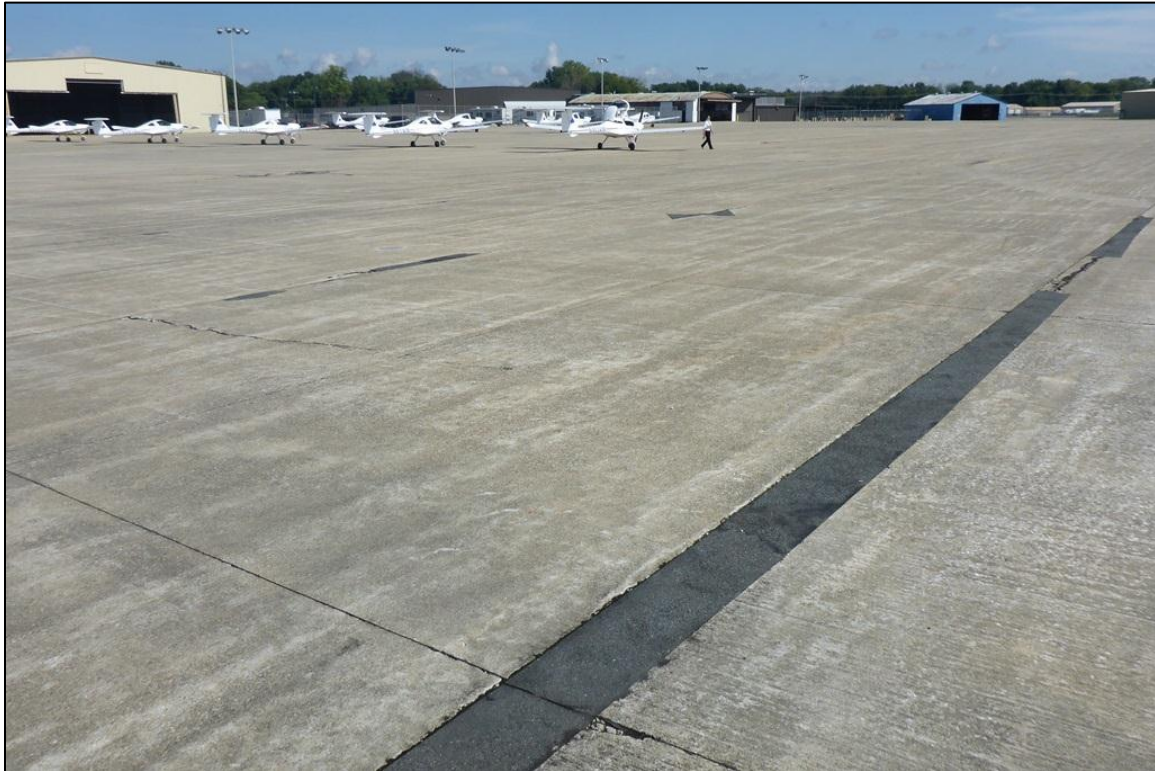
Figure 2-5. Typical PCC Pavement in Poor Condition (Feature 3001)

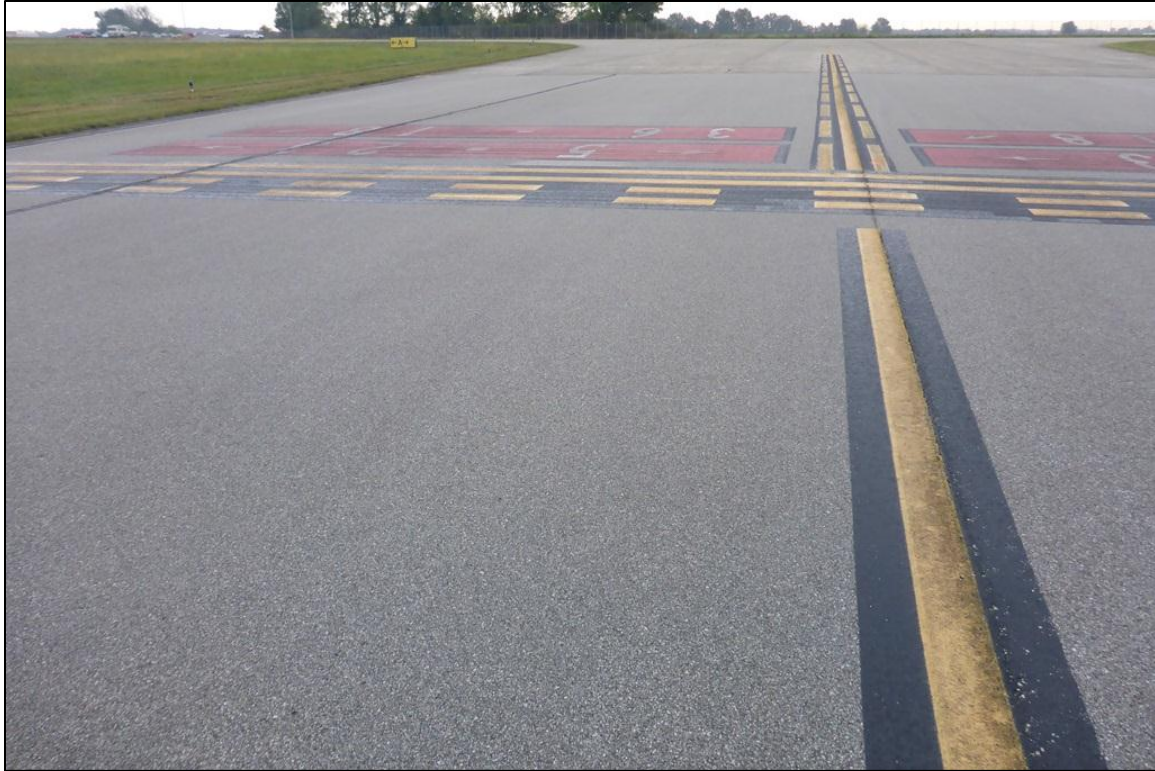
Figure 2-6. Typical AC Pavement in Good Condition (Feature 130)

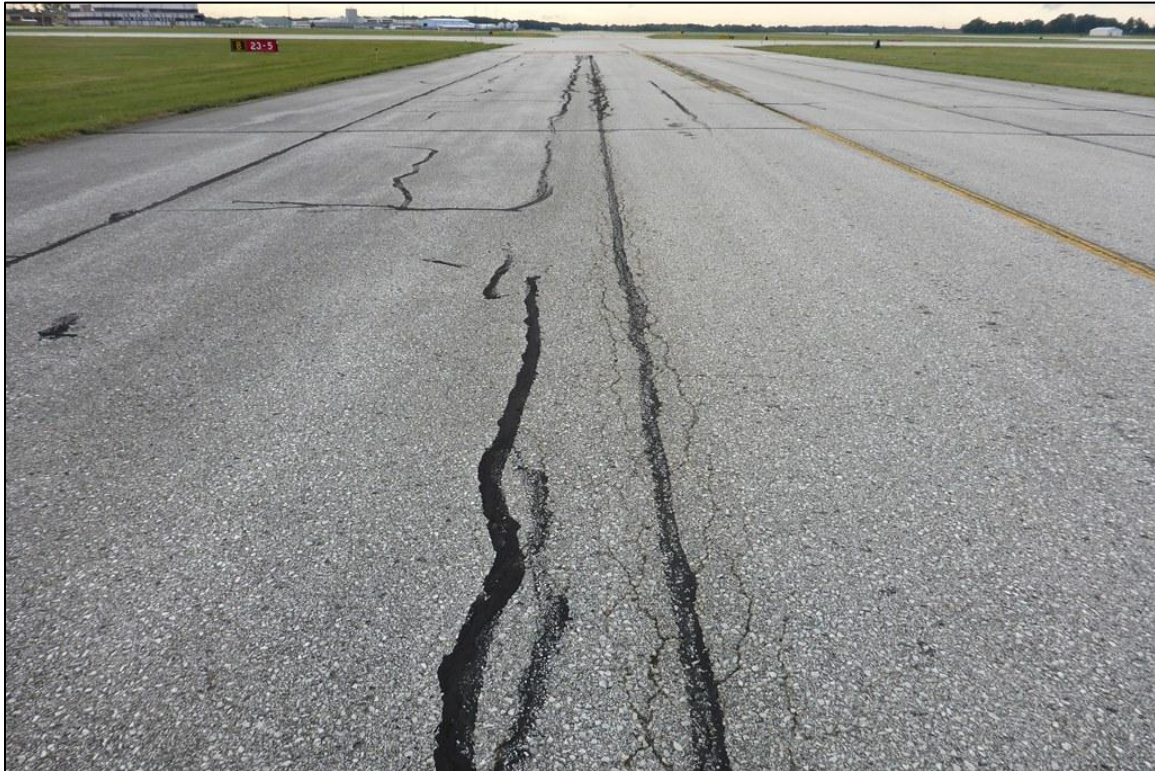
Figure 2-7. Typical AC Pavement in Poor Condition (Feature 202)
