Pavement Condition Report

Wabash Municipal Airport

Project 16801839

January 2016

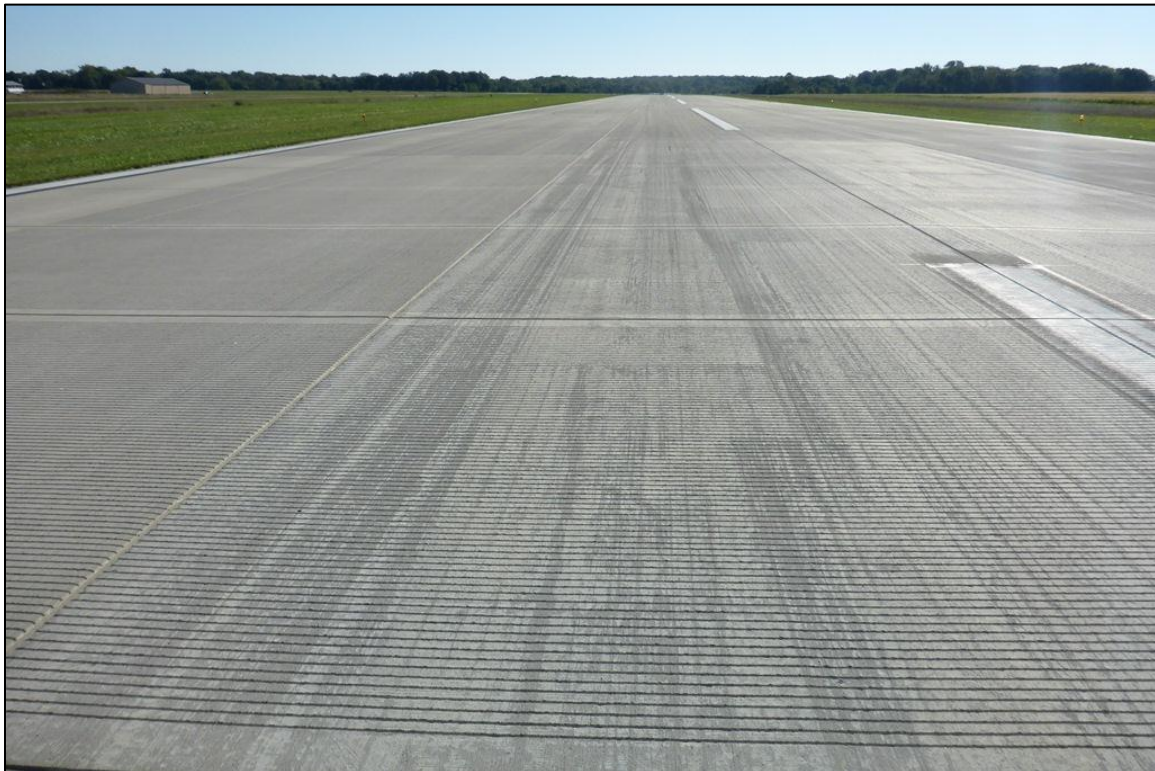
Figure 2-3. Typical PCC Pavement in Good Condition (Feature 6105)

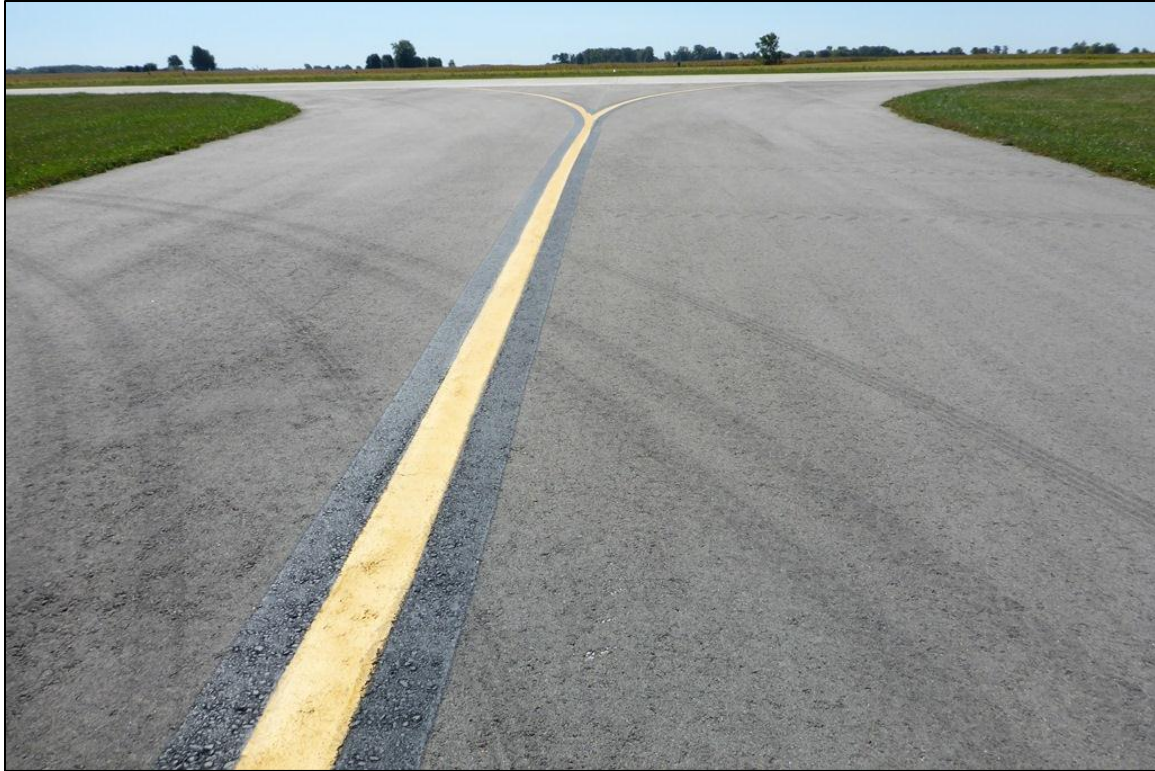
Figure 2-4. Typical AC Pavement in Good Condition (Feature 165)

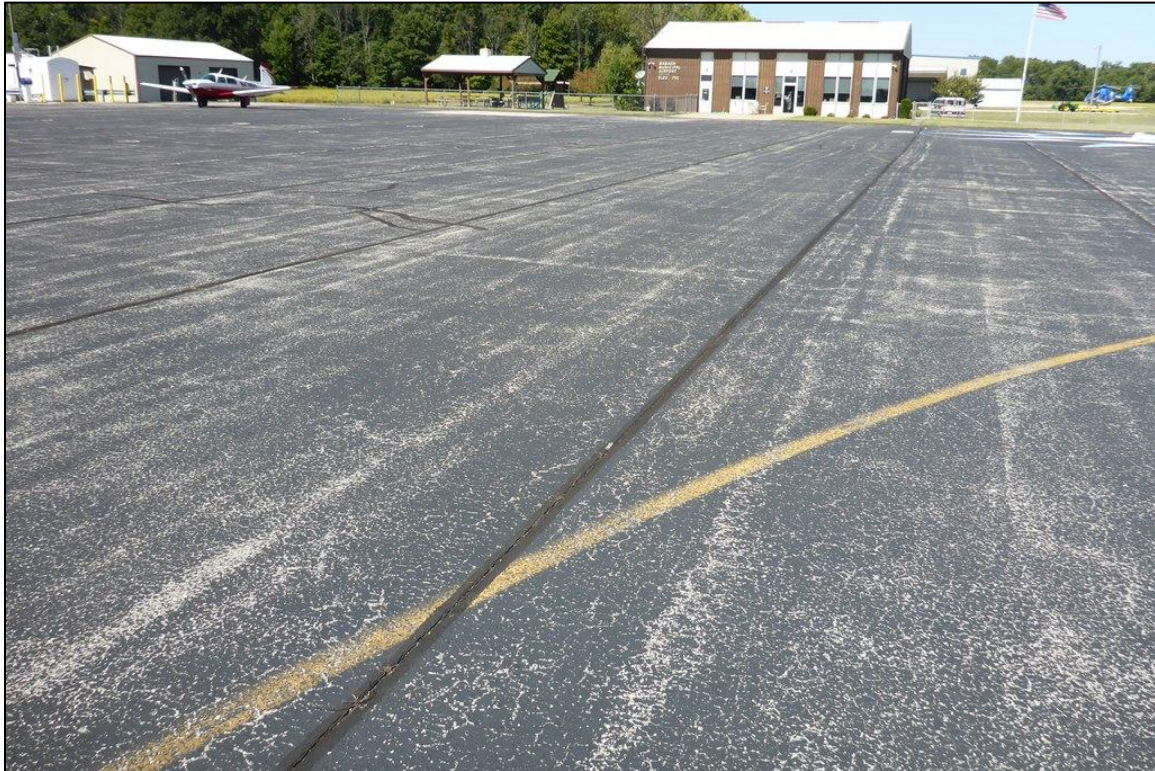
Figure 2-5. Typical AC Pavement in Fair Condition (Feature 3010)

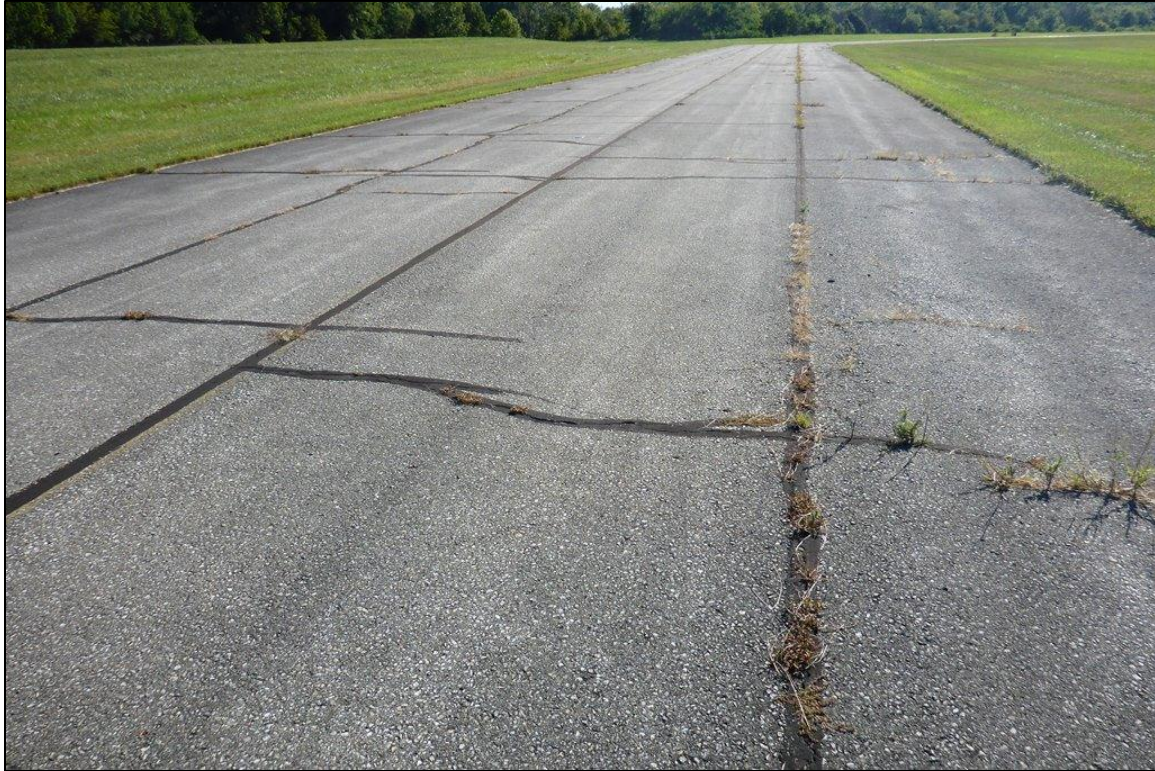
Figure 2-6. Typical AC Pavement in Poor Condition (Feature 105)

Feature 105 was in poor condition with an average PCI of 45. The maintenance analysis shows that it would be possible to restore this feature above the MSL with isolated patching. However, while maintenance could extend the pavement life by several years, it is anticipated that feature 105 would still require major rehabilitation within the current 5-year planning window.
