**ROOT CAUSE ANALYSIS FOR  
CENTER SUBSTATION  
138 kV CIRCUIT BREAKER EVENT  
ON JANUARY 16, 2012**

Issued on March 22, 2012

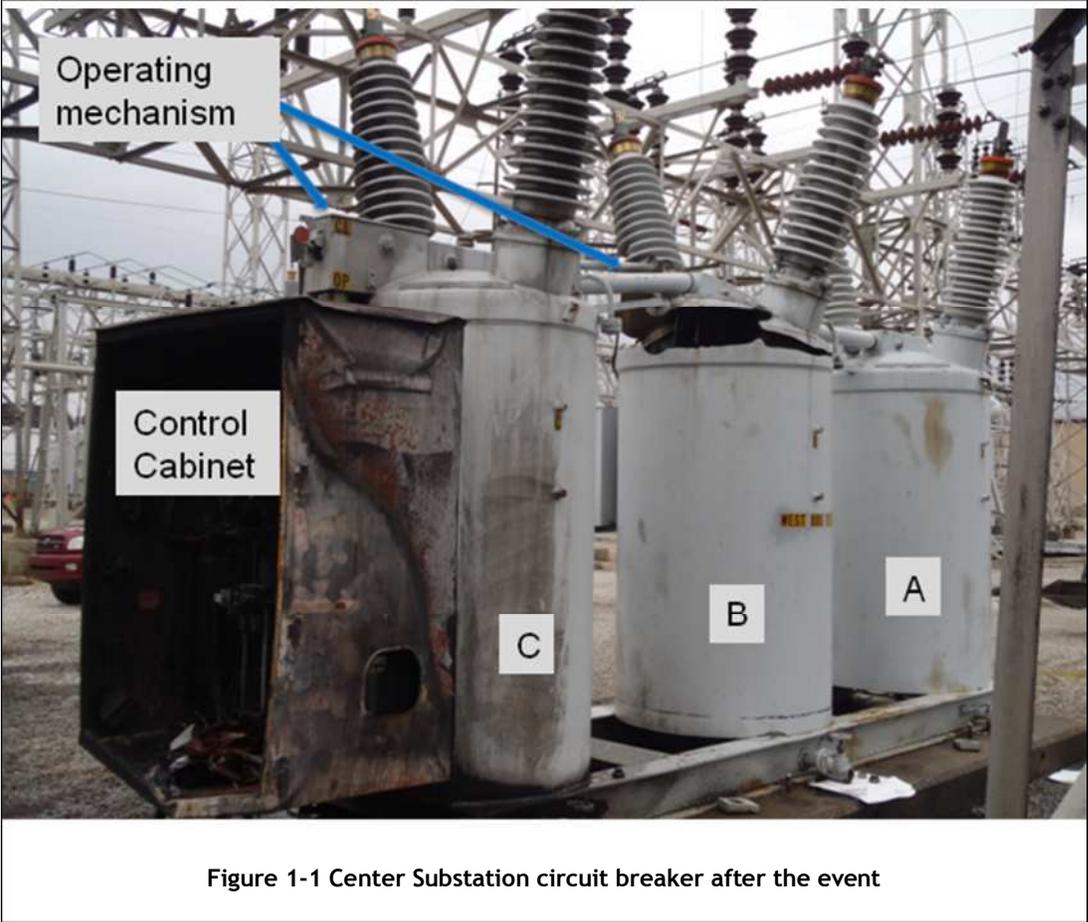
On Monday, January 16, 2012 the 138 kV West Bus Tie Circuit Breaker at the Center Substation experienced an internal phase to ground fault. This circuit breaker consists of three single phase interrupting tanks, a common operating mechanism and a control cabinet. The top of the middle tank, B phase, was breached and the control cabinet doors were ejected. This event caused an oil spill and fire in the substation. The fire in the control cabinet burned until power could be disconnected and then the fire was put out. Labels shown on Figure 1-1 identify key components of the circuit breaker discussed in the root cause analysis.

Figure 1-1 Center Substation circuit breaker after the event

1. Internal arc between the B phase live parts and side of the tank with contacts destroyed
2. Breaker position indicator found in a half open position
3. Top of B phase tank breached directly above location of internal fault

4. Top of C phase tank had small breach at connection support to B phase tank with minor burning of contacts
5. Evidence of flashover between C phase disconnect switch and ground at the base of the switch

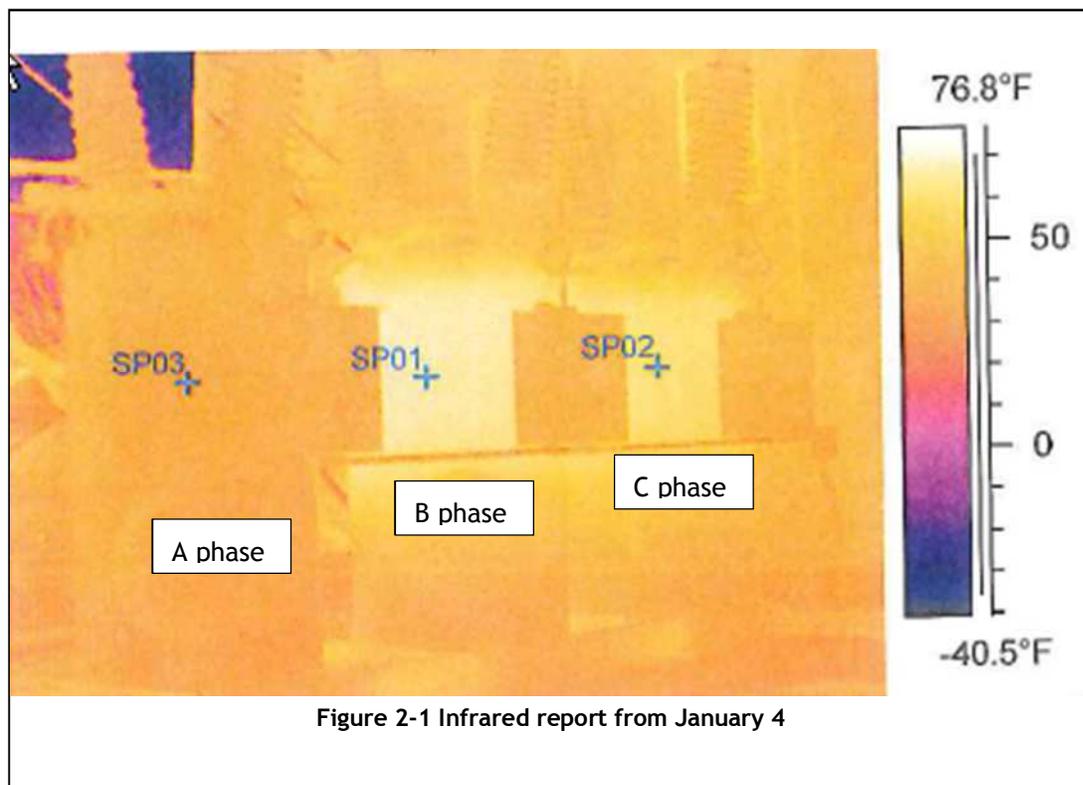
Repair parts were ordered on August 8, 2011, and they were delivered September 6, 2011. An infrared measurement on January 4, 2012 showed abnormal heating in two tanks. Figure 2-1 shows the infrared scan. Previous experience indicated that at these observed temperatures the circuit breaker did not require immediate repair. Maintenance to replace contacts and springs was scheduled in coordination with a planned outage for other equipment.

3. Infrared on January 4, 2012 showed B phase hot (35 degrees F over ambient).
4. Internal and External marks on B phase tank show source of internal fault.

1. Establish formal infrared and ductor criteria to trigger maintenance priorities.
2. Improve readability of maintenance spreadsheet that contains list of circuit breakers to be operated for the month.
3. Create review process to check for outstanding maintenance before issuing maintenance cycling orders to System Operations.
4. Develop a plan to return primary relaying to normal operation.
5. Improve documentation of substation maintenance records.
6. Fully utilize automated asset management tools specifically designed for substation maintenance.
7. Allocate resources and implement tools to assure that substation maintenance activity is adequately tracked a prioritized efficiently.
8. Implement a procedure to track all work scheduling delays and ordering of parts to avoid delays in required maintenance of equipment.
9. Document process for field data review and subsequent work flows.

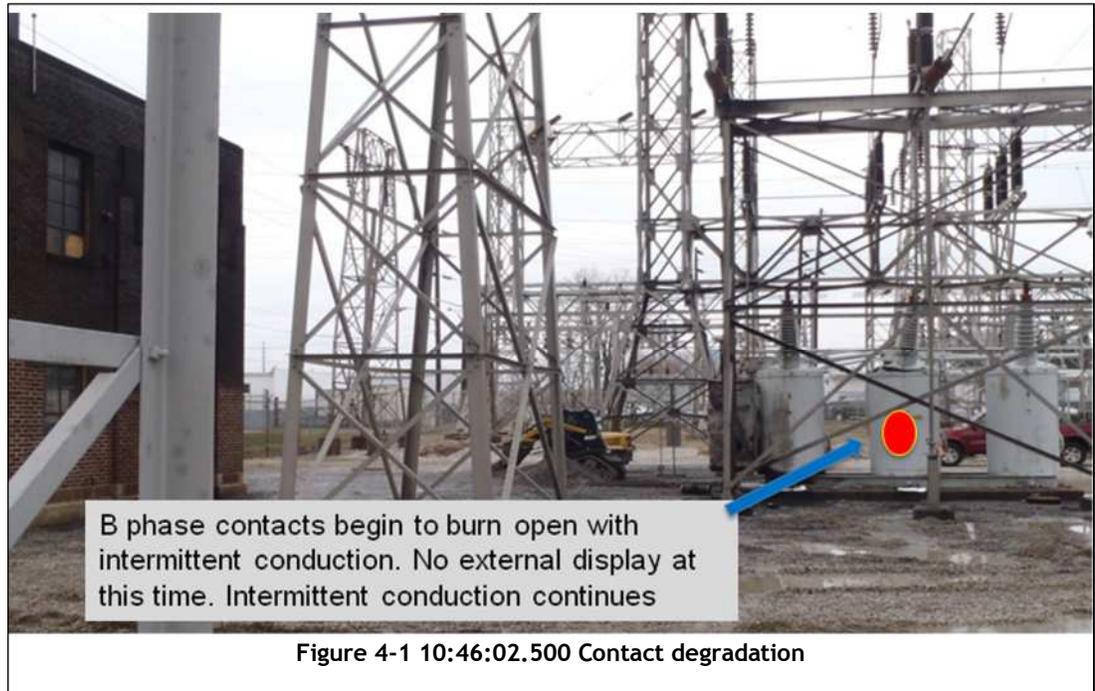
Figure 4-1 10:46:02.500 Contact degradation

After a maintenance circuit breaker operation was completed at 10:39:25.000 B Phase intermittent conduction begins at 10:46:02.500 as shown in Figure 4-1.

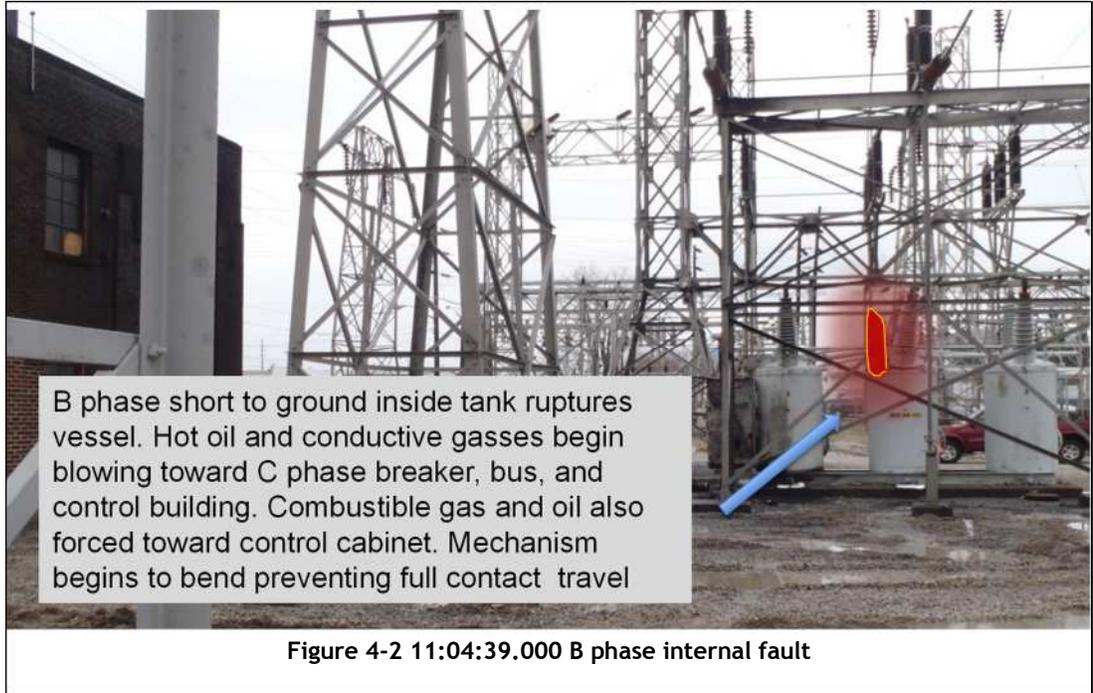
At 11:04:39.000, live parts inside the B phase tank shorted to ground. The internal pressure breached the B phase tank. It also forced oil and gasses through the operating mechanism into the control cabinet. Figure 4-2 shows the beginning of the breach. The upward movement of the top of the B phase tank begins at about this time.

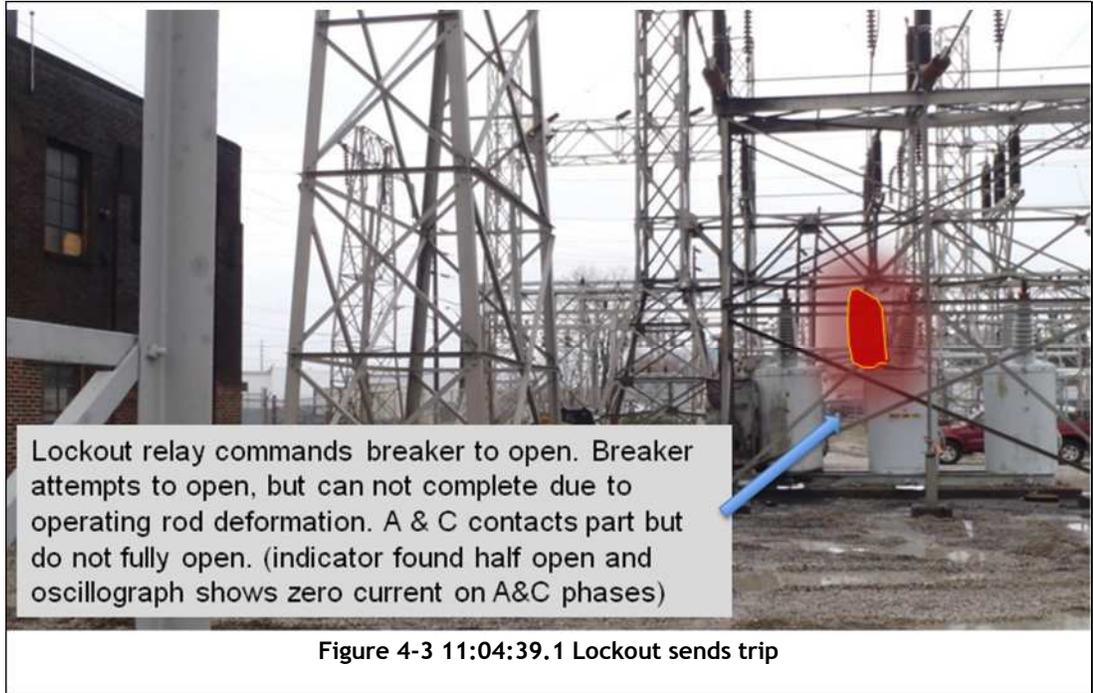
By 11:04:39, a bus protection lockout relay sends trip commands to this circuit breaker and other circuit breakers at the substation. The breaker attempts to open but is stalled as the operating mechanism that spans across the top of the three tanks continues to deform. Data confirms the A and C phase current stopped flowing. The breaker indicator shows half open position after the event. Figure 4-3 shows the approximate migration of the oil and gases.

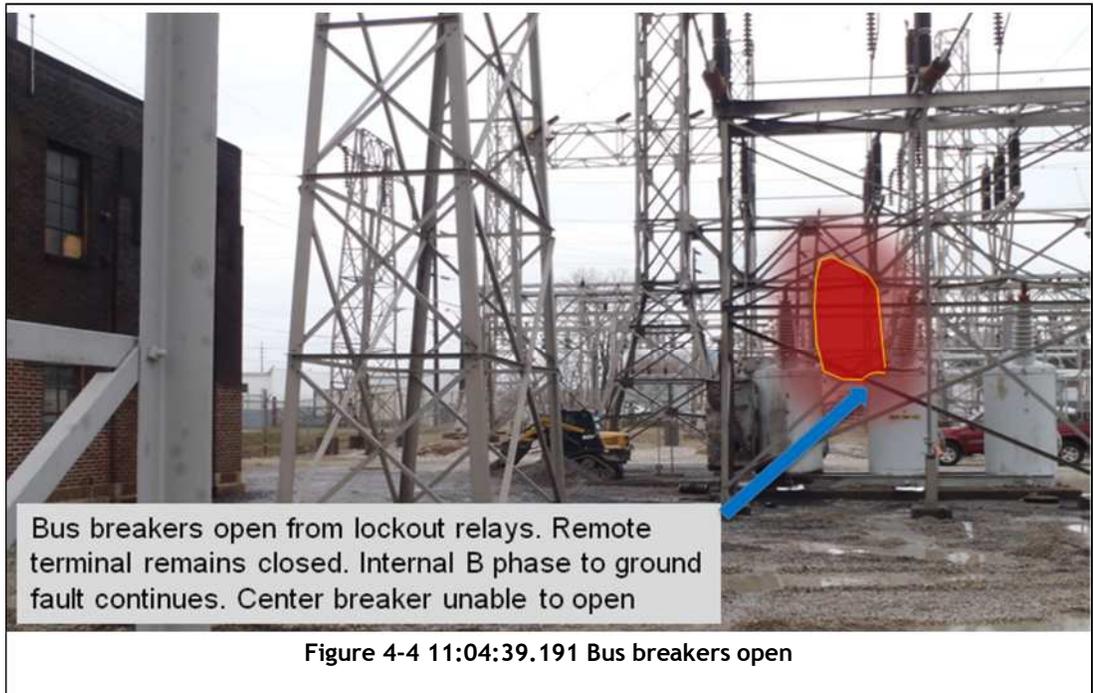
At 11:04:39.191 all other bus breakers open. The remote end terminal has not yet cleared. C phase line disconnect switch is not yet involved as seen in Figure 4-4.

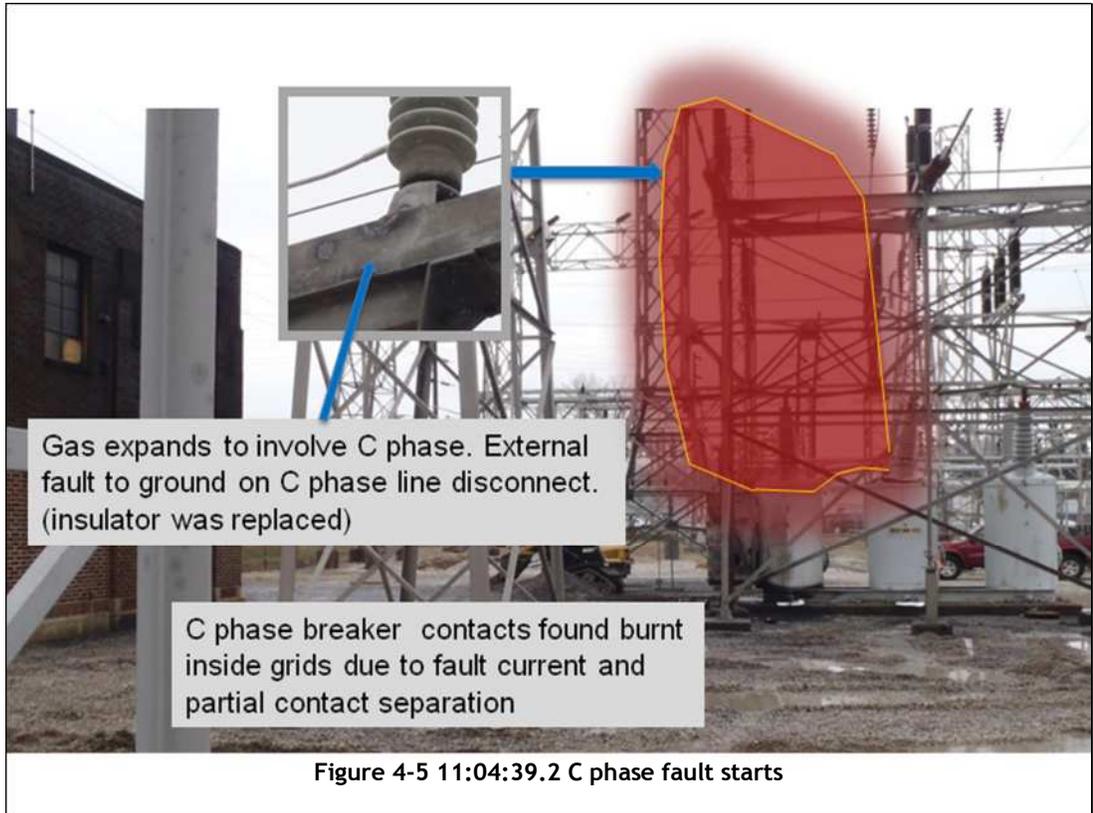
By 11:04:39.2, the conductive gasses and carbon in the oil envelop the C phase bus disconnect causing an external C phase to ground short circuit in addition to the internal short circuit on B phase . Figure 4-5 shows the migration of gasses into the C phase bus disconnect. Figure 4-5 also shows the burn mark at the bottom of the disconnect switch. Inspection inside the C phase tank confirmed no internal short to ground. It should be noted that this second short circuit was a result of the event. It did not affect the amount of oil dispersion, fire or equipment damage.

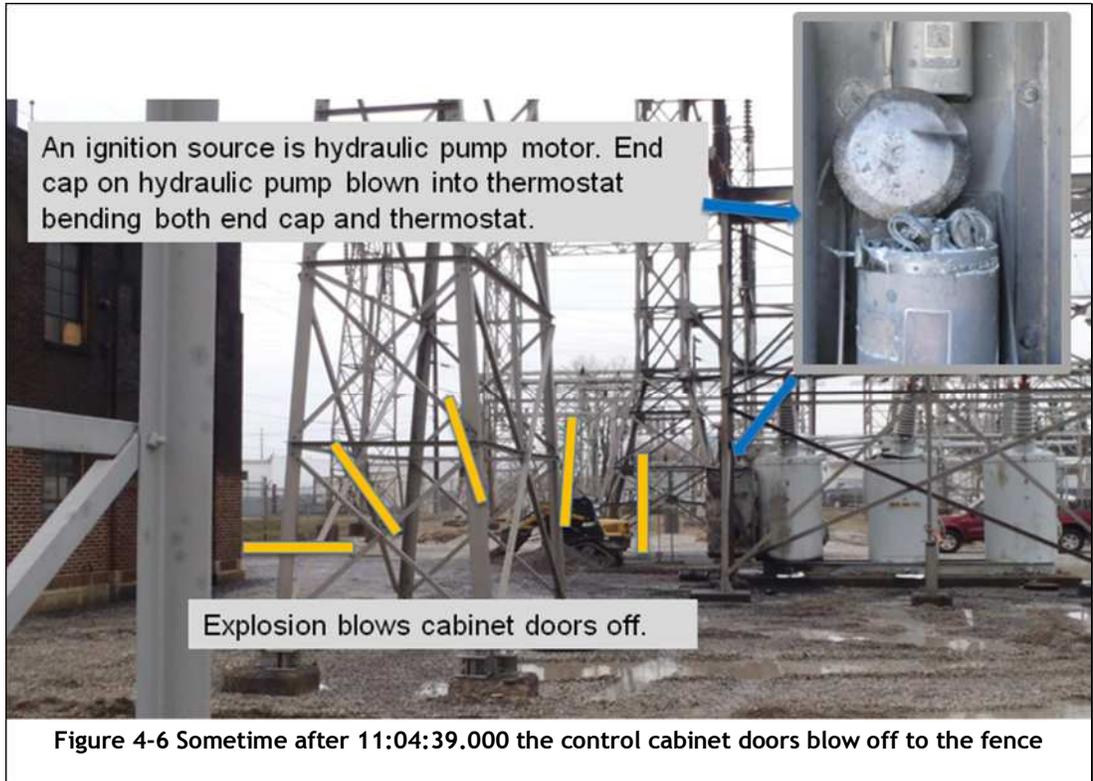
Sometime during the event there was a second source of ignition inside the circuit breaker mechanism cabinet causing the doors to blow off. The hydraulic pump motor attempted to run either due to control or vibration when B phase tank breached. A run switch inside the motor apparently ignited gases and blew the end cap into the thermostat. The end bell of the motor was in the bottom of the cabinet. Figure 4-6 shows the motor, the dented end cap and the thermostat. The thermostat is bent upward consistent with a blow from the end cap.
