May 4, 2012

In accordance with your letter dated April 4, 2012, enclosed please find the responses of Indianapolis Power & Light Company ("IPL") to the Indiana Utility Regulatory Commission's questions regarding IPL's Root Cause Analysis Report on the Center Substation 138 kV Circuit Breaker Event.

**RESPONSE OF INDIANAPOLIS POWER & LIGHT COMPANY
 (“IPL”) TO INDIANA UTILITY REGULATORY COMMISSION QUESTIONS
 ISSUED APRIL 4, 2012 CONCERNING THE
 CENTER SUBSTATION ROOT CAUSE ANALYSIS REPORT**

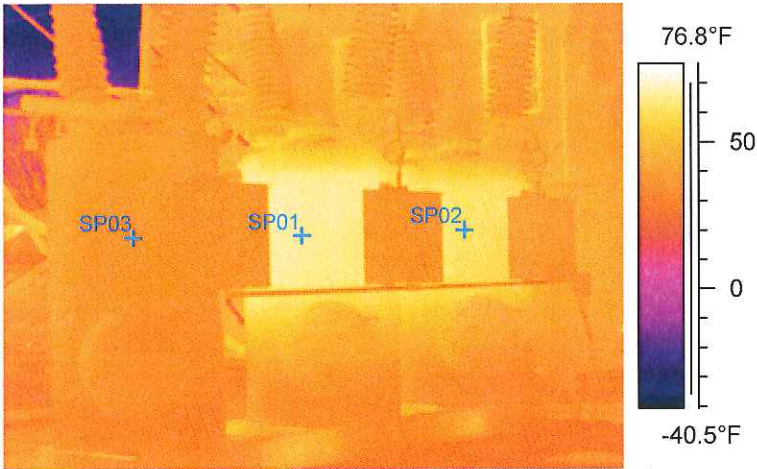
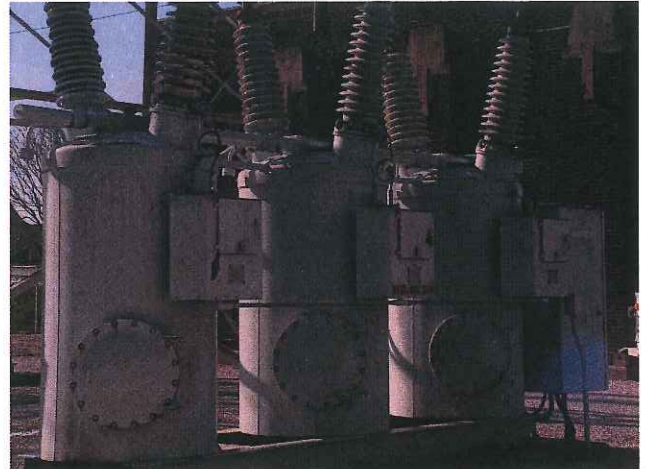
EMPAC #
10-040728

IR information	Value
Date of creation	1/4/2012
Time of creation	11:02:17 AM
File name	C0104-02.img
Object parameter	Value
Emissivity	0.85
Ambient temperature	32.6°F
Label	Value
SP01	68.1°F
SP02	63.3°F
SP03	38.8°F

SPOT1 - AMBIENT =	35.51°F
--------------------------	---------

1 (Intermediate)	100 - 150 Deg. F	Repair in the near future
2 (Serious)	151 - 250 Deg. F	Repair in immediate future
3 (Critical)	> 250 Deg. F	Repair immediately

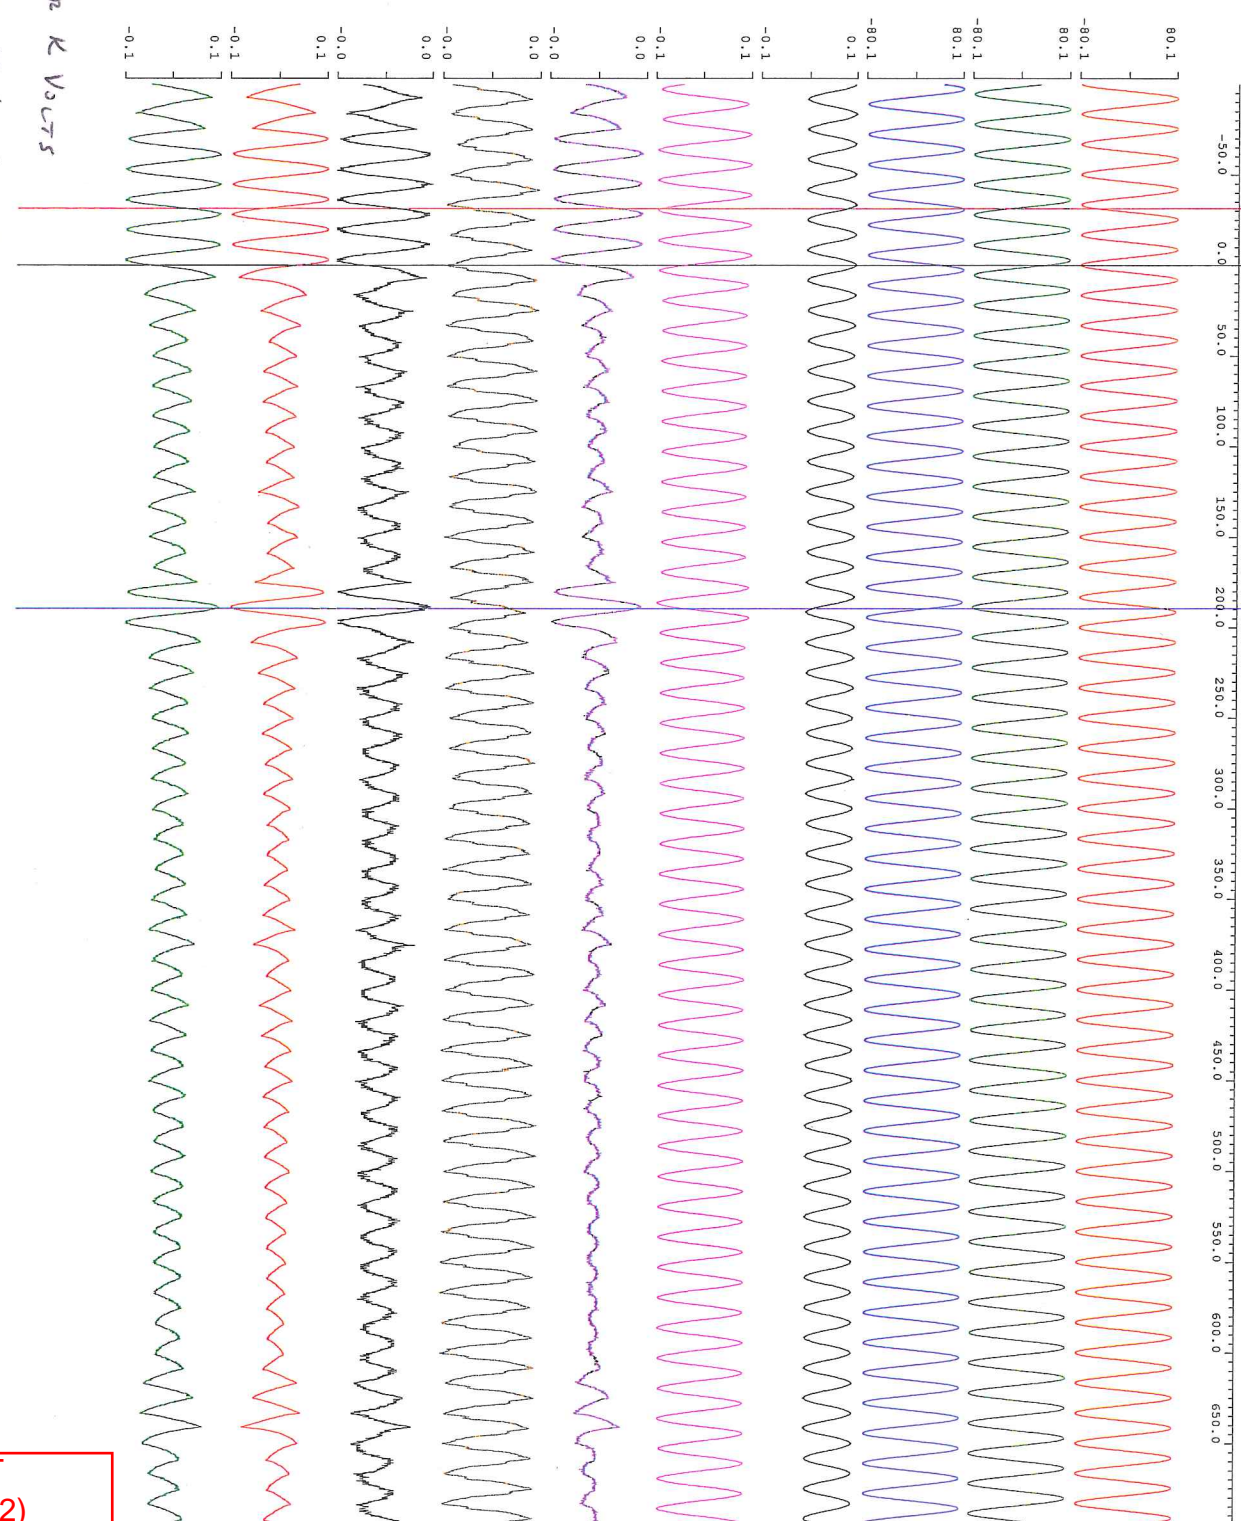
0.119 R 0.114 RkA 132-10 LINE IN

0.089 R 0.086 RkA 132-74 LINE IN

VALUES ARE IN K AMPS OR K VOLTS

$0.104 \text{ kA} = 0.104 \times 1000 = 104 \text{ AMPS}$
 $80.049 \text{ kV} = 80.049 \times 1000 = 80,049 \text{ VOLTS}$
