**ROOT CAUSE ANALYSIS
FOR
150 EAST MARKET STREET
NETWORK EVENT ON
MARCH 14, 2014**

Prepared by T&D Engineering
Issued on July 3, 2014

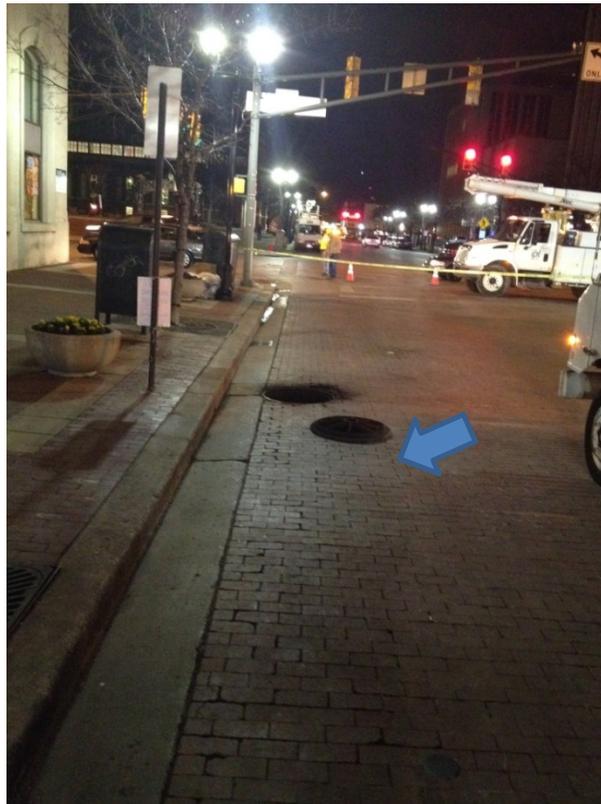
Manhole Cover Dislodged in the Event on March 14, 2014

2. 126 E Market Street Vault
There was no cable damage in the vault.
3. Manhole M21-12
This manhole cover was laying upside down about 18 inches to the northwest of the manhole. There was damage to primary cables for UG 304 and UG 307. Both of these circuits did relay out of service from the damage. There was damage to the jacket on primary circuit UG 701 but it did not relay out of service. No visible damage was noted on primary circuit UG 301. There was damage to the secondary cables in this manhole. One circuit of secondary was burnt in two approximately five feet west of the manhole in the duct line/conduit. It is believed this is where the event started.

1. Continue manhole inspections noting the condition of the cable jacket, where possible. Generally, the cables are wrapped in fire proofing tape making inspection of the cable jacket impossible.
2. Continue installation and review of Swiveloc locking manhole covers. While these covers will not prevent an event from occurring, they will restrain the cover from becoming dislodged if an event does occur.
3. Install Swiveloc locking manhole covers on Market Street in 2014 from the Circle to Alabama Street. This takes the project past the City Market. This will also place Swiveloc covers on the remaining manholes around all four spokes of the Circle in addition to the ones on Market Street. In all about 50 Swiveloc covers will be installed.

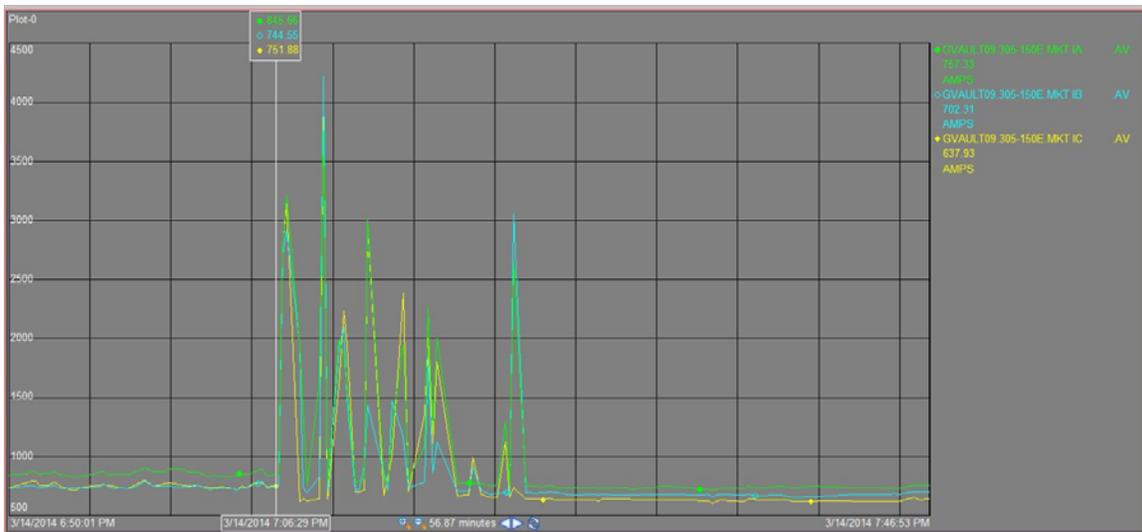
This was the first significant network event since the Network SCADA system was placed in-service in 2013. Analog and status data from the network relays were reviewed following the event. This data was used to help establish the sequence of events and confirm that the secondary network fire did self-clear.

Secondary Currents on UG 305 Unit at 150 E Market Vault

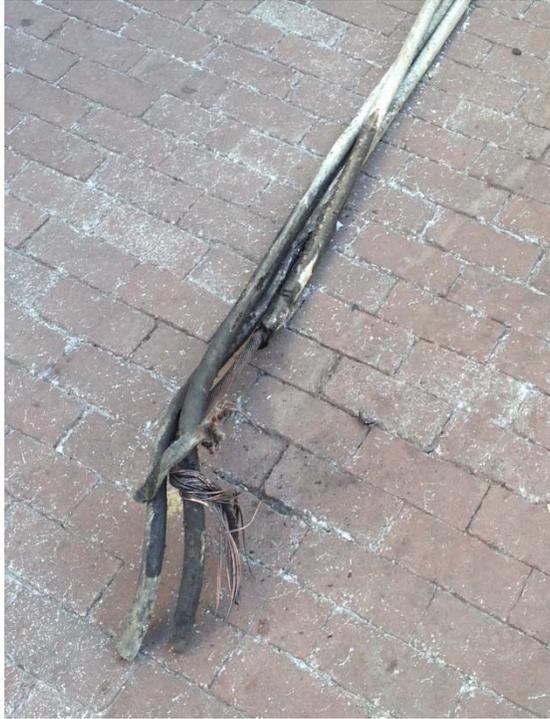
6. Visual inspection of the cables removed from the ductlines did show evidence of corrosion on the outer jacket. Corrosion on the cable jacket will typically be caused by a chemical reaction.

7. Significant amounts of road salts had been put down by the City of Indianapolis during the winter. This would likely result in residual salt contamination in the manhole and in the duct line and could contribute to the corrosion observed on the cable jacket

3. The cable jacket on the one circuit of secondary cable between manhole M21-13 and M21-11 was compromised from the corrosion noted on certain cables removed during repairs. The corrosion is likely from exposure to the road salts over the years.

Picture 1 - Damaged Secondary Cable

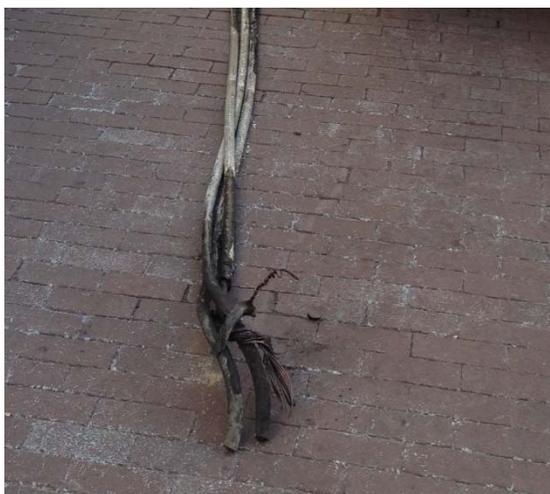
Picture 2 - Damaged Secondary Cable

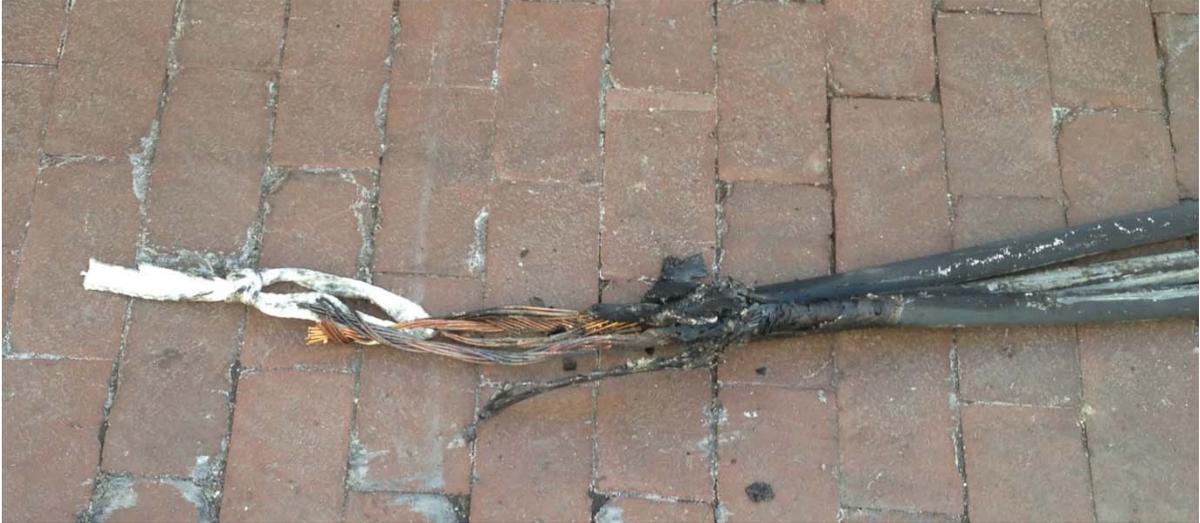
Picture 3 - Damaged Secondary Cable
