**Root Cause Analysis
for
327 East New York Street
Network Event on
November 24, 2014**

Prepared by T&D Transmission Field Operations
Issued on January 9, 2015

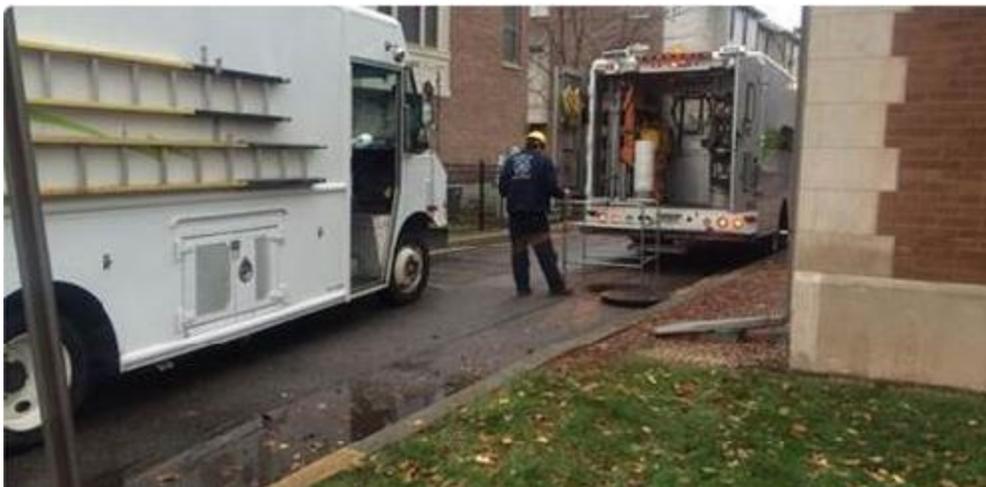
On New York Street looking south down Ogden Street – IPL Crew working at Manhole M42-03

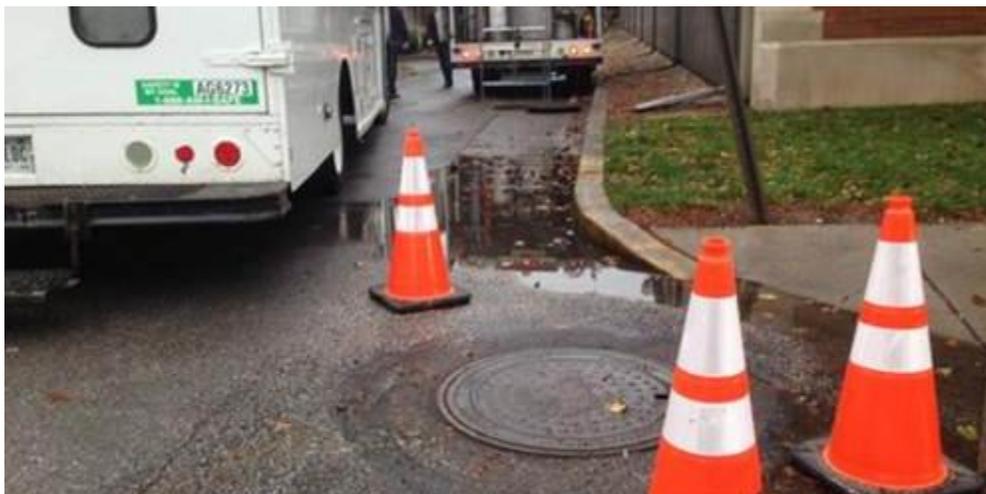
Southwest corner of New York Street and Ogden Street – IPL Manhole M42-02 is in the foreground and M42-03 is shown in the back ground

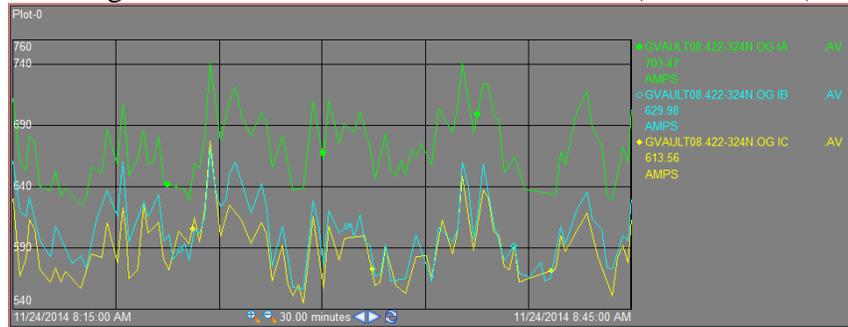
324 North Ogden – UG 422 Transformer – Low Side (120/208 volt) Current

These transformers are electrical and physical the closest to the fault location. Therefore should be providing the most current during the event. By inspection of the charts you will note an increase of current at approximately 08:25. The maximum current observed is approximately 850 amps on the 1,000kVA transformers and 410 amps on the 500kVA transformers. These peak currents represent approximately 50% of full load rating. (i.e. not enough to trigger an alarm indication).

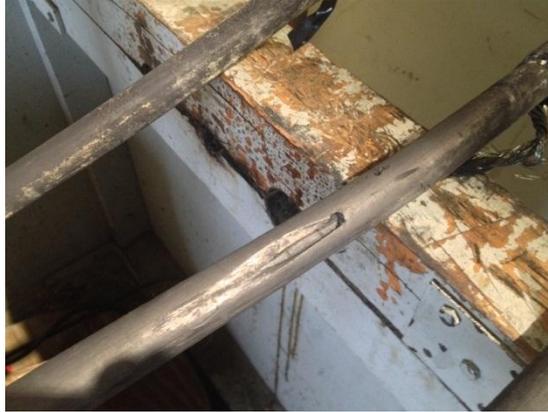
The lead jacket was cleaned with cable cleaner and degreaser and rags. Small voids in the jacket approximately 1/8" in size were noted. These holes did not expose the paper insulation. 2 larger breaches in the jacket were noted approximately 12" from the end of the melted lead area. This breach was 2" long, 1/4" wide. The other breach was about 1/2" in diameter. Paper insulation was exposed at both locations. The longer breach may have been caused

mechanically. When the damage occurred is uncertain. Given the edges of the openings were not shiny before the cable cleaning and degreasing, this damage may have occurred when the cable was installed, not when cable was recently removed after the fault. See picture below.

This breach is located 180 degrees opposite in circumference from where the lead melted away at the fault location of this section of cable. Depending on the orientation of the conductor, it is plausible that oil may have escaped through the breach causing the paper insulation to dry thus degrading the insulation integrity of the paper resulting in the fault.

The cable failure was due to the breach in the lead jacket. Over time the breach allowed insulating oil to seep out of the paper insulation. The paper insulation may have become dry over time and allowed water from the previous day's significant rainfall to enter the paper thus reducing the dielectric properties of the paper which was a catalyst to the secondary cable fault.
