HAZARDOUS AND REGULATED MATERIALS INSPECTION REPORT

1700-1704 Broadway

Gary, Indiana 46407

February 12, 2025

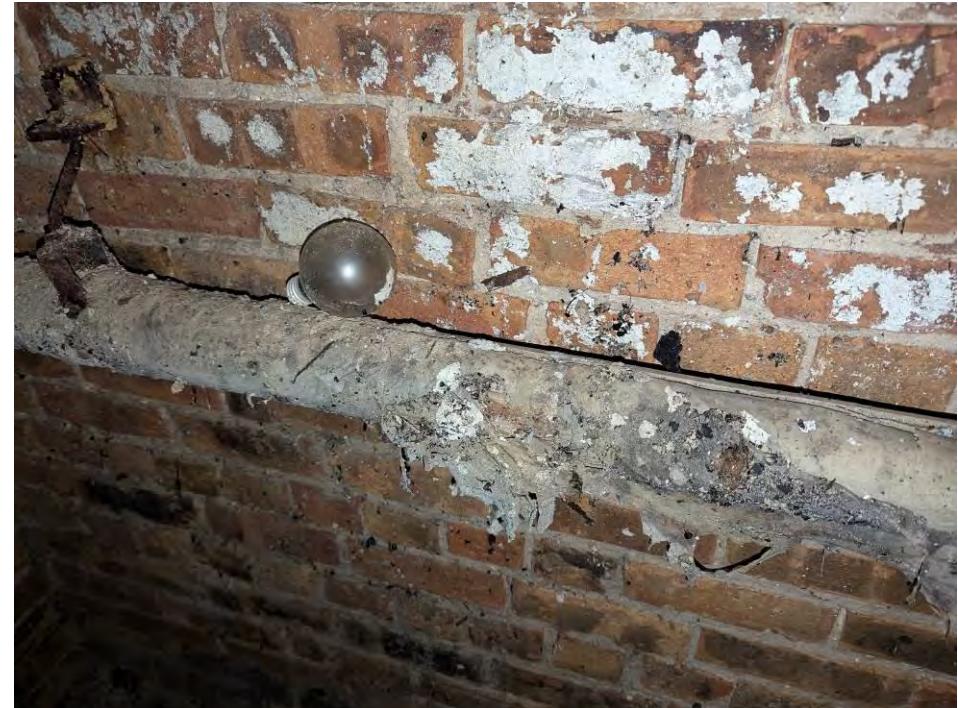
PHOTO: 20

SUBJECT: View of damaged PACM TSI pipe wrap and fittings

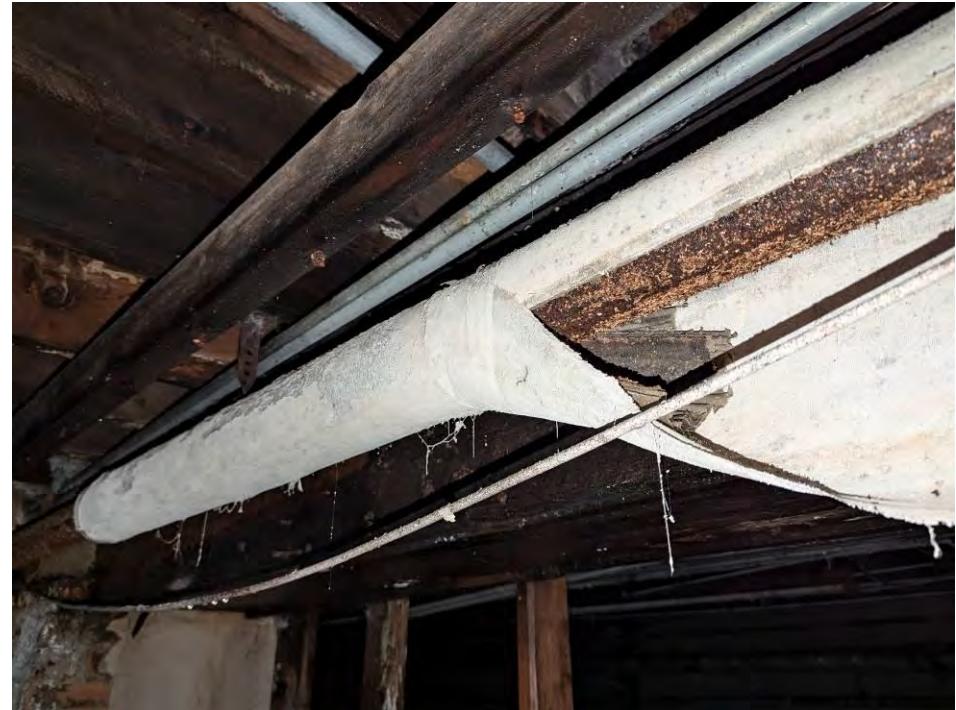
PHOTO: 24

SUBJECT: View of damaged PACM TSI pipe wrap and fittings

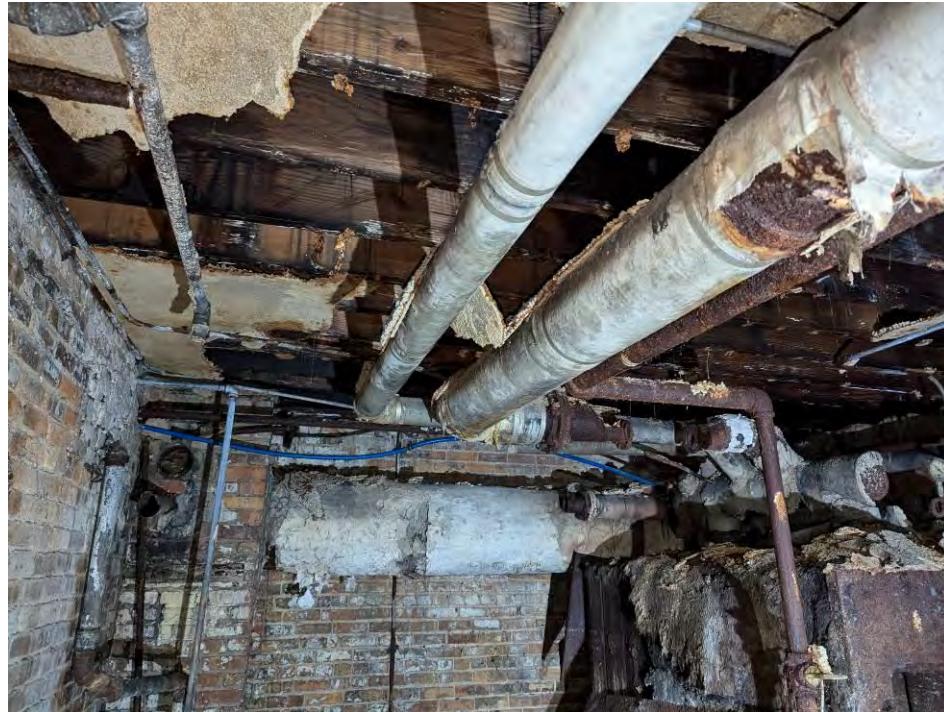
PHOTO: 27

SUBJECT: View of damaged PACM TSI pipe wrap and fittings in boiler room

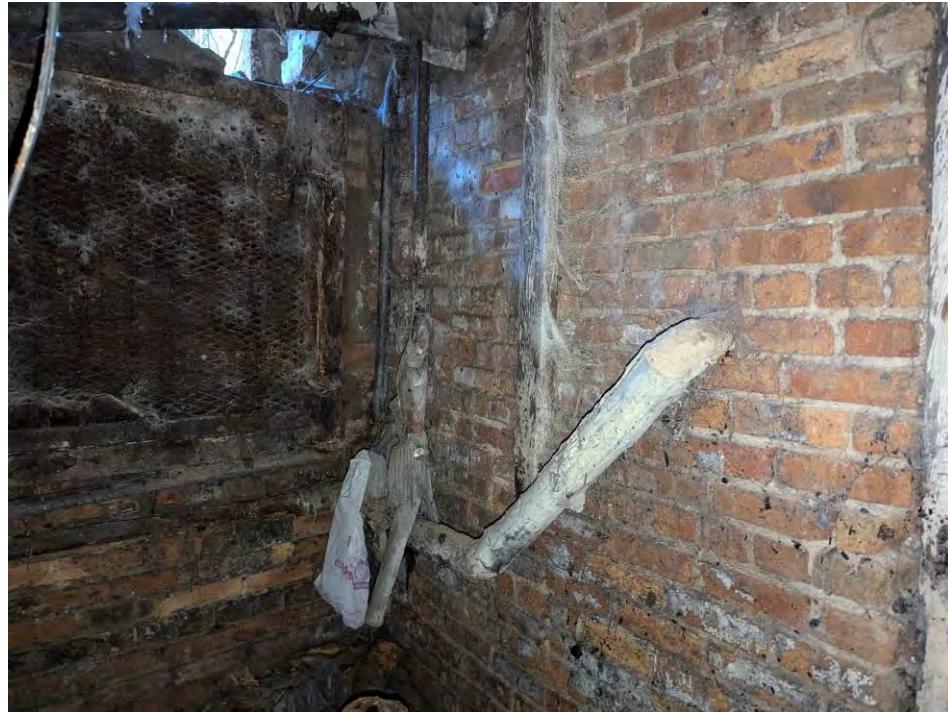
PHOTO: 29

SUBJECT: View of damaged PACM TSI pipe wrap and fittings

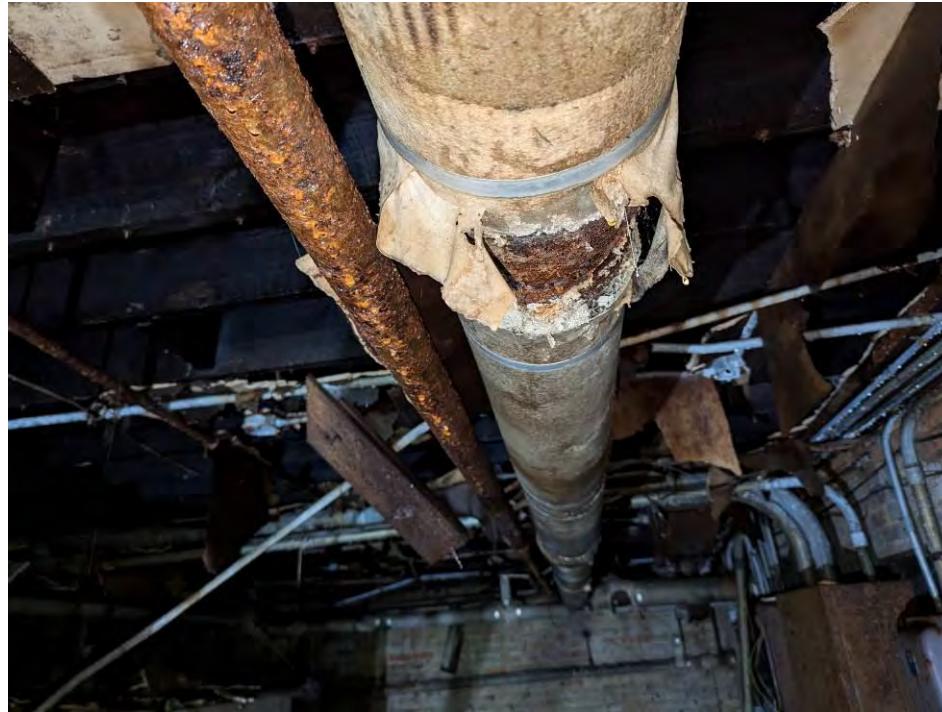
PHOTO: 31

SUBJECT: View of damaged PACM TSI pipe wrap

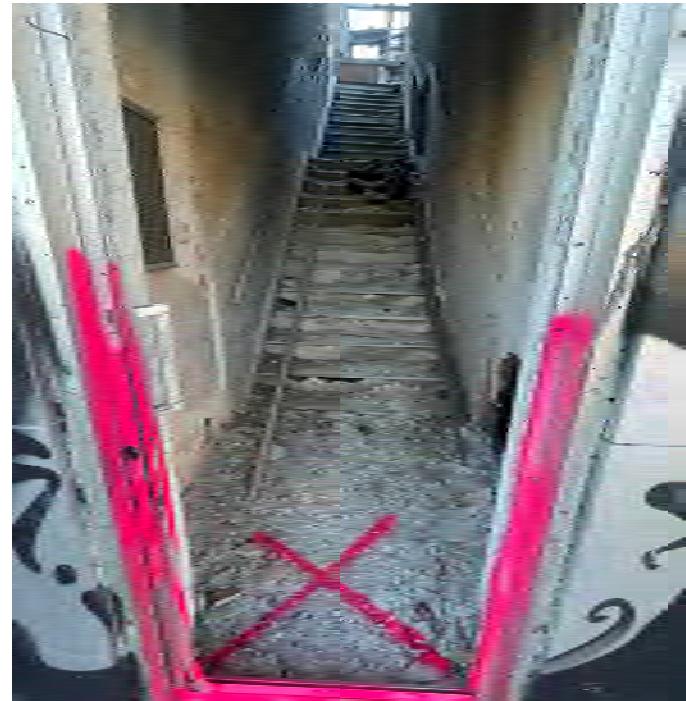
Photo 6: Stairs, 2nd Floor
(Inaccessible)

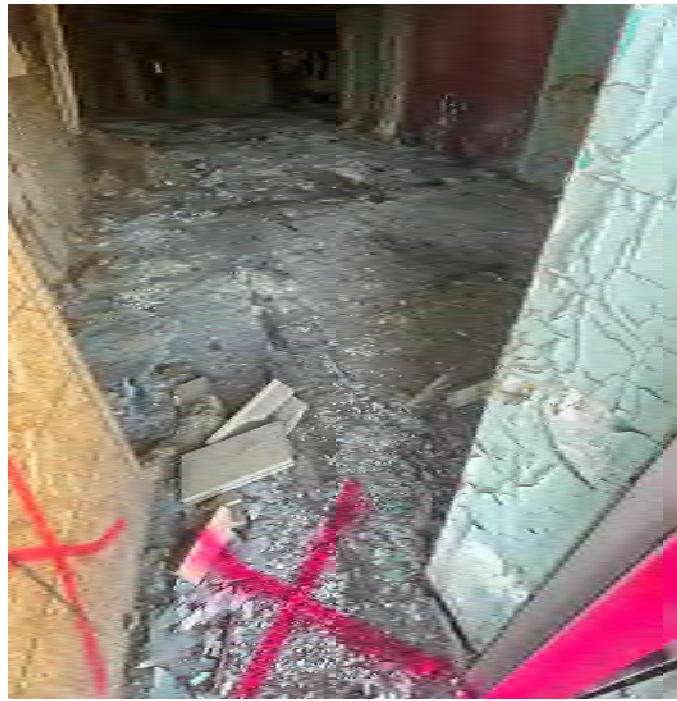
Photo 7: Front Door (Inaccessible).
Floor flex under inspector's weight.

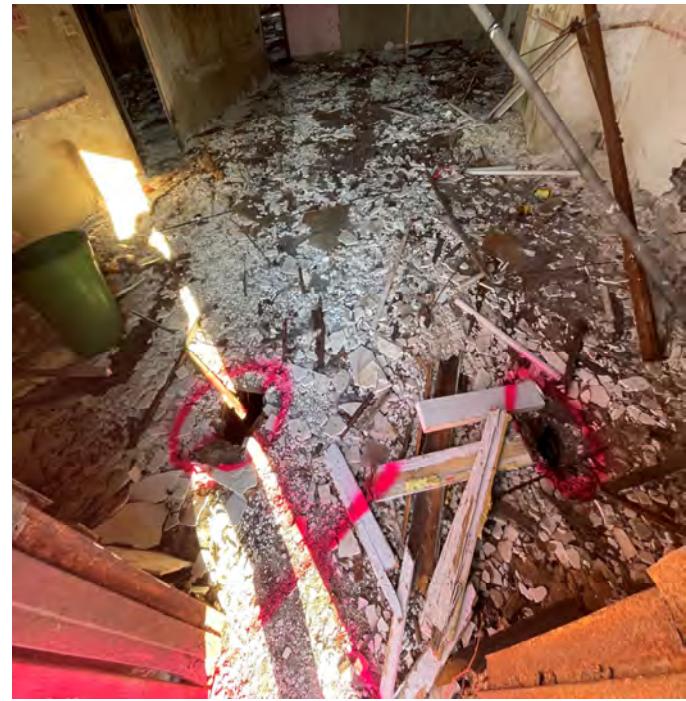
Photo 8: 1st floor punch through
under inspector's weight.

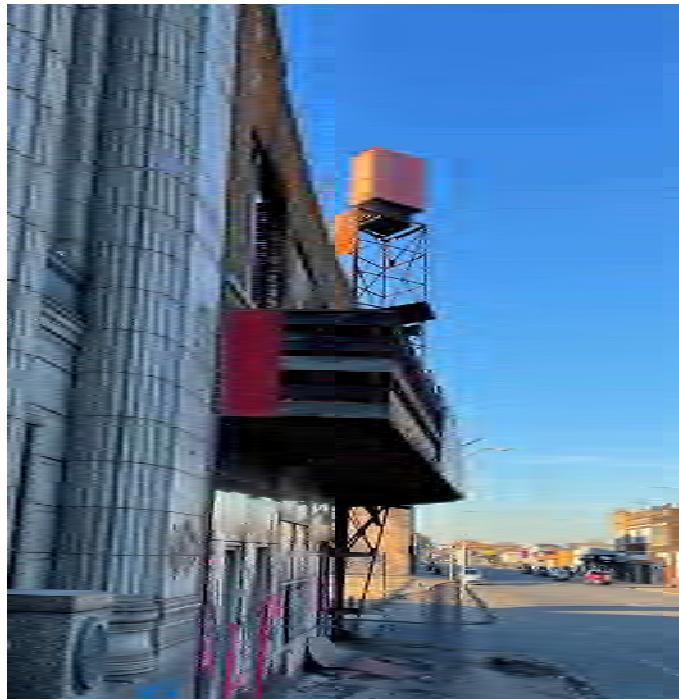
Photo 9: Front of 2nd floor exterior wall bowing inward.

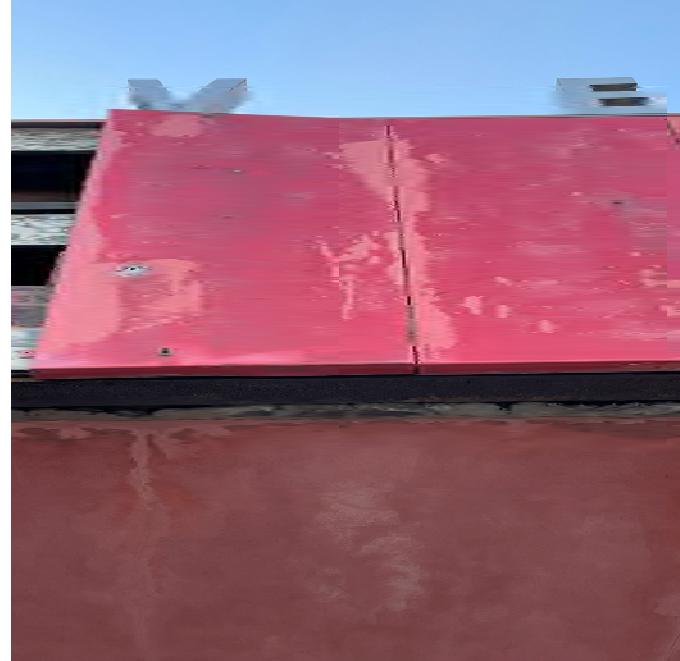
Photo 10: Assumed Caulking

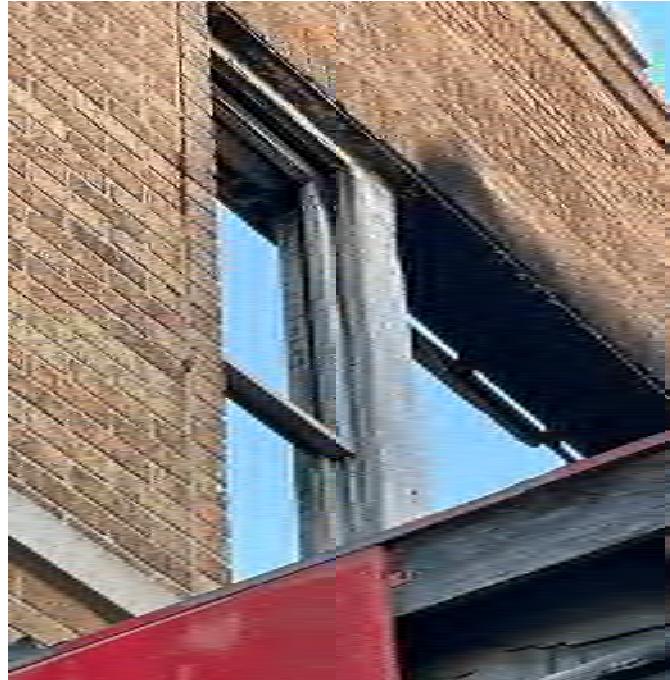
Photo 11: Assumed Window Glaze
