SR 66 Small Structures Replacements (INDOT Des. No. 2100830 and 2100831) Luce and Ohio townships, Spencer County, Indiana Photographs taken on September 14, 2023

Culvert Inspection Report

Structure Information								
Structure:	CV 066-074-51.62		Facility Carried:	SR 66				
Structure Number:	93007883		Features Intersected:	UNT				
Inspection Information								
Inspection Date:	10/16/2024		Lead Inspector:	James Hefferman				
Inspection Type:	Culvert		Additional Inspectors:	Tony Hoover, James Hefferman				
Condition Ratings Summary								
Culvert:		4	Substructure:		7			
Deck:		N	Channel & Channel Protection:		7			
Superstructure:		4						
TO THE TOTAL PARTY OF THE PARTY

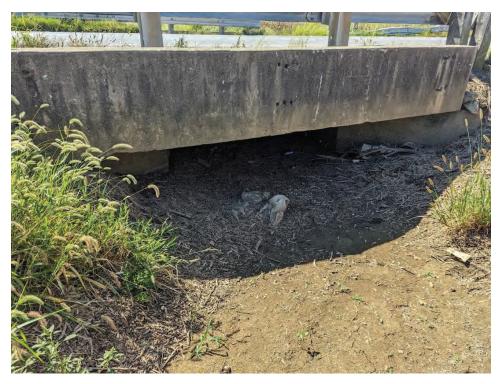
Photograph 43. View of UNT to Willow Pond Ditch with evidence of drift deposits and extreme sedimentation under SR 66 and CV 066-074-51.62, looking southwest.

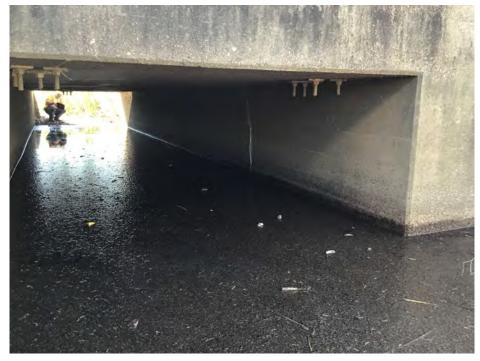
PHOTO 5

(62) Culvert - Rating:	6								
(62) Culvert Rating Comments:	Moderate width vertical largely unchanged since top of box.	crack in west side wall. SE wingwall broke and lea e previous inspection. Minor delamination around g	nning but appears guardrail attachment at						
Deck:	10p 0. 20m

Description Moderate vertical crack in west abutment

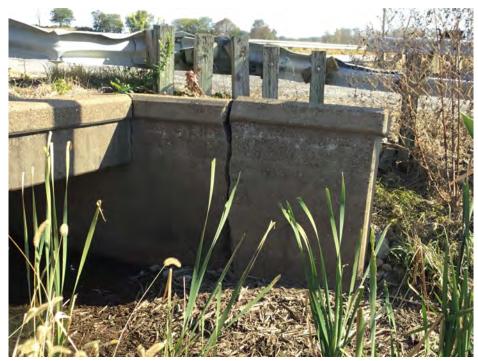
РНОТО 8

Description Southeast wingwall broke off and cracking

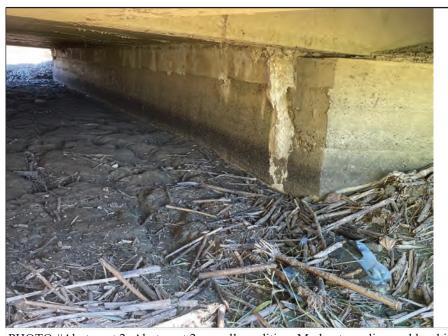
PHOTO #Abutment 2: Abutment 2 overall condition. Moderate scaling and leaching on Abutment 2.

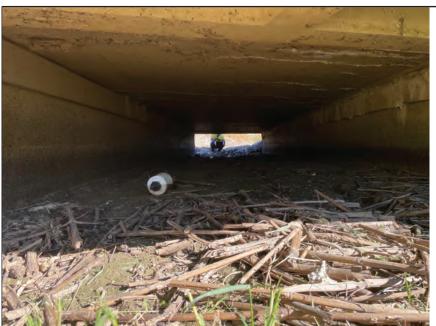
PHOTO #Culvert interior: South interior overall condition. Close spaced longitudinal cracking that runs full length with moderate to heavy efflorescence

Structure is currently programmed in SPMS for Small Structure Replacement under DES No. 2100831, Contract No. R-43979 with a letting date of August 6, 2025. No other work is recommended at this time.

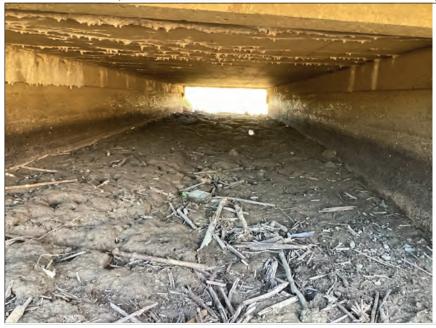
Significant map cracking with severe efflorescence at North coping of original slab. Minor width longitudinal cracking with moderate efflorescence throughout the remainder of slab. In addition, an isolated area of moderate spalling with exposed corroded reinforcement is visible in North widening beam near the drain hole. Both widening beams exhibit small holes; this appears to be for drainage purposes and is not an issue at this time. Moderate leaching is visible on the East abutment seat.

PHOTO #Culvert interior: North interior overall condition. Significant map cracking at north end of slab w/ heavy efflorescence. Minor width longitudinal cracking w/ moderate efflorescence throughout remainder of slab.

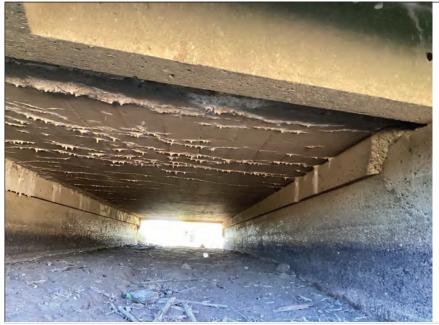
PHOTO #Original Slab.: Underside overall condition. Significant map cracking at north end of slab w/heavy efflorescence. Minor width longitudinal cracking w/moderate efflorescence throughout remainder of slab.

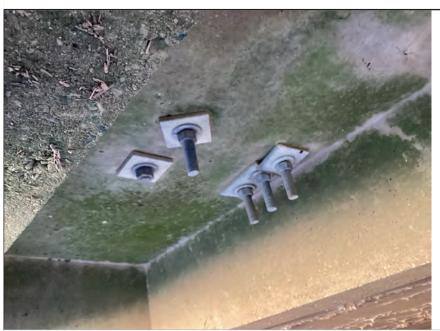
Comments: small spalls with exposed reinforcement and small areas of delamination.

PHOTO #Widening Beam: North widening beam overall condition. Notice some small spalls with exposed reinforcement and small areas of delamination.
