National Register of Historic Places  
Registration Form

historic name Cumberland Historic District  
other names/site number \_\_\_\_\_ 097-144-74000

**National Register of Historic Places**  
**Continuation Sheet – Cumberland Historic District,**  
**Marion County, Indiana**

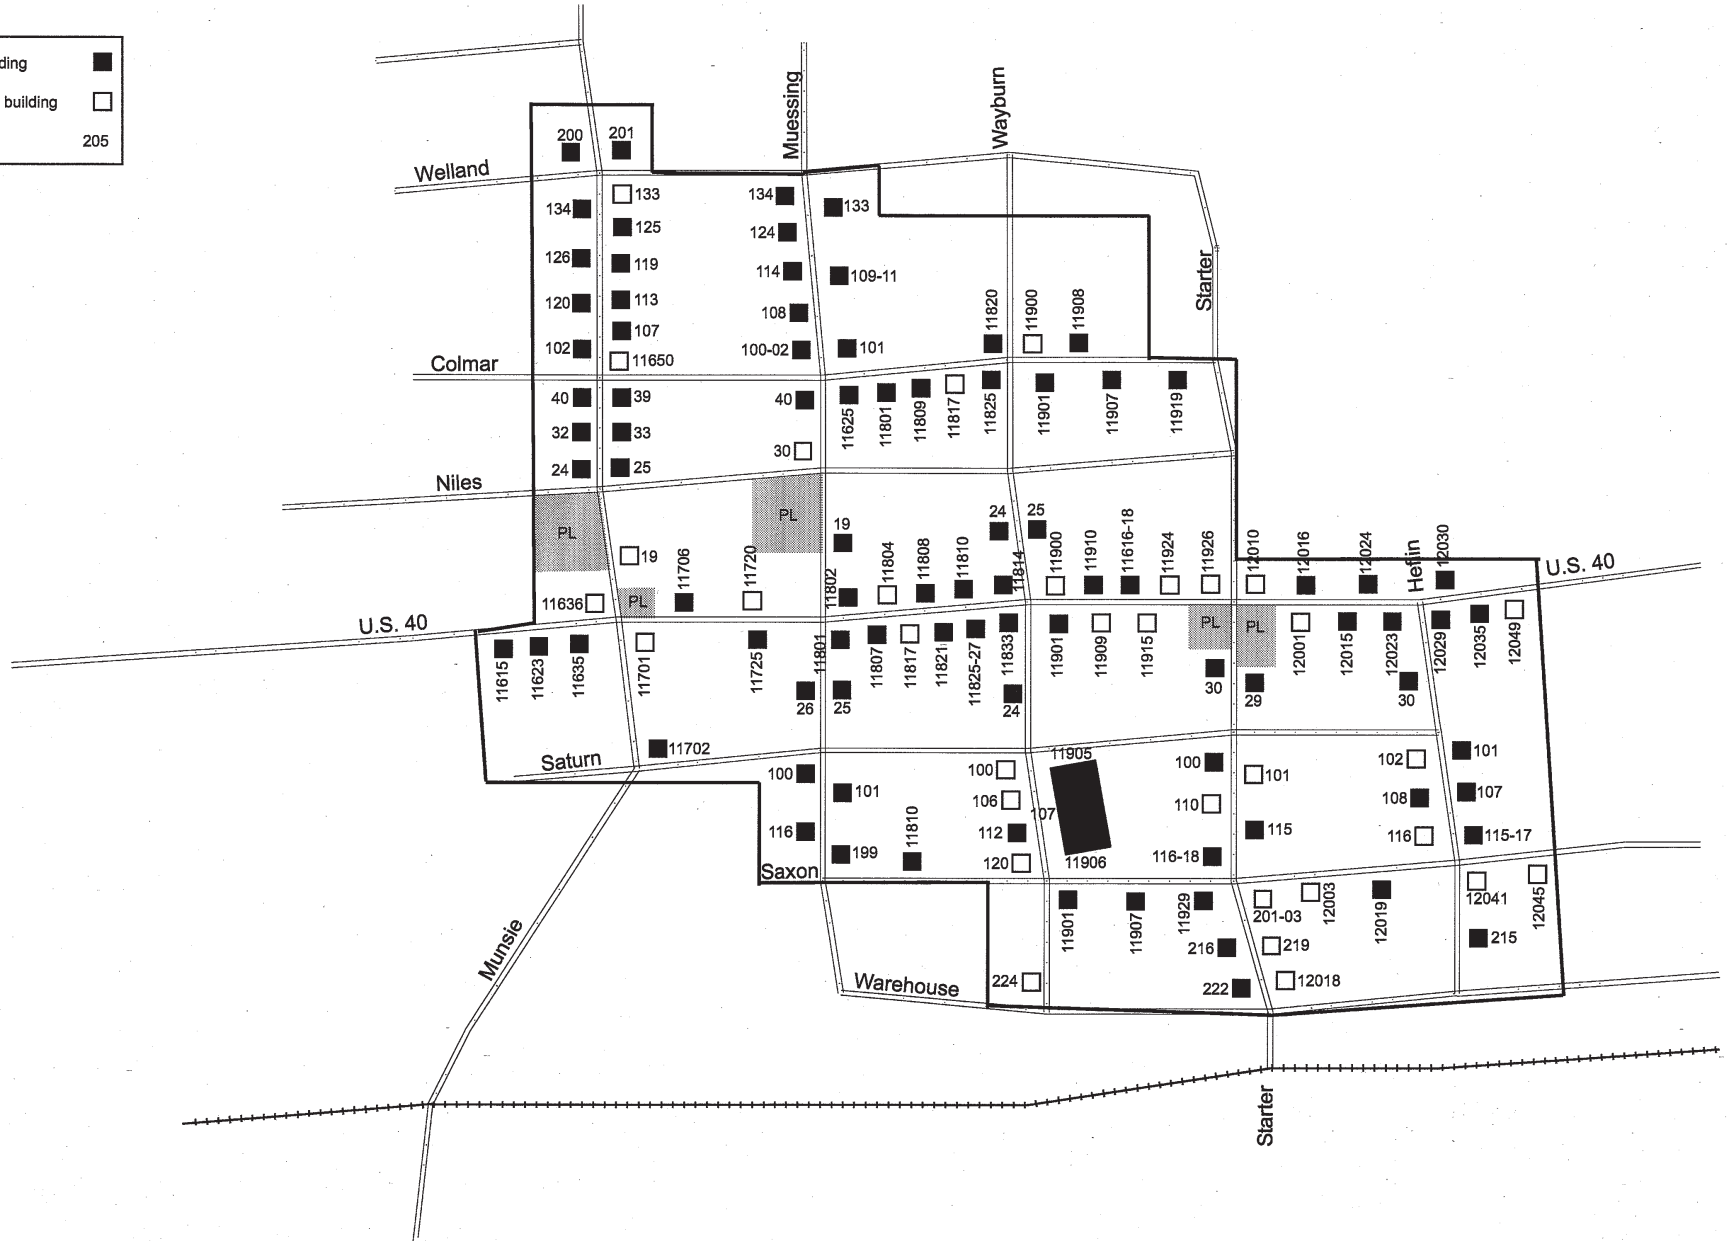
# Cumberland Historic District

Contributing building	■
Non-contributing building	□
Street address	205
