# National Register of Historic Places Registration Form

historic name Vehslage, George H., House

street & number 515 North Chestnut Street

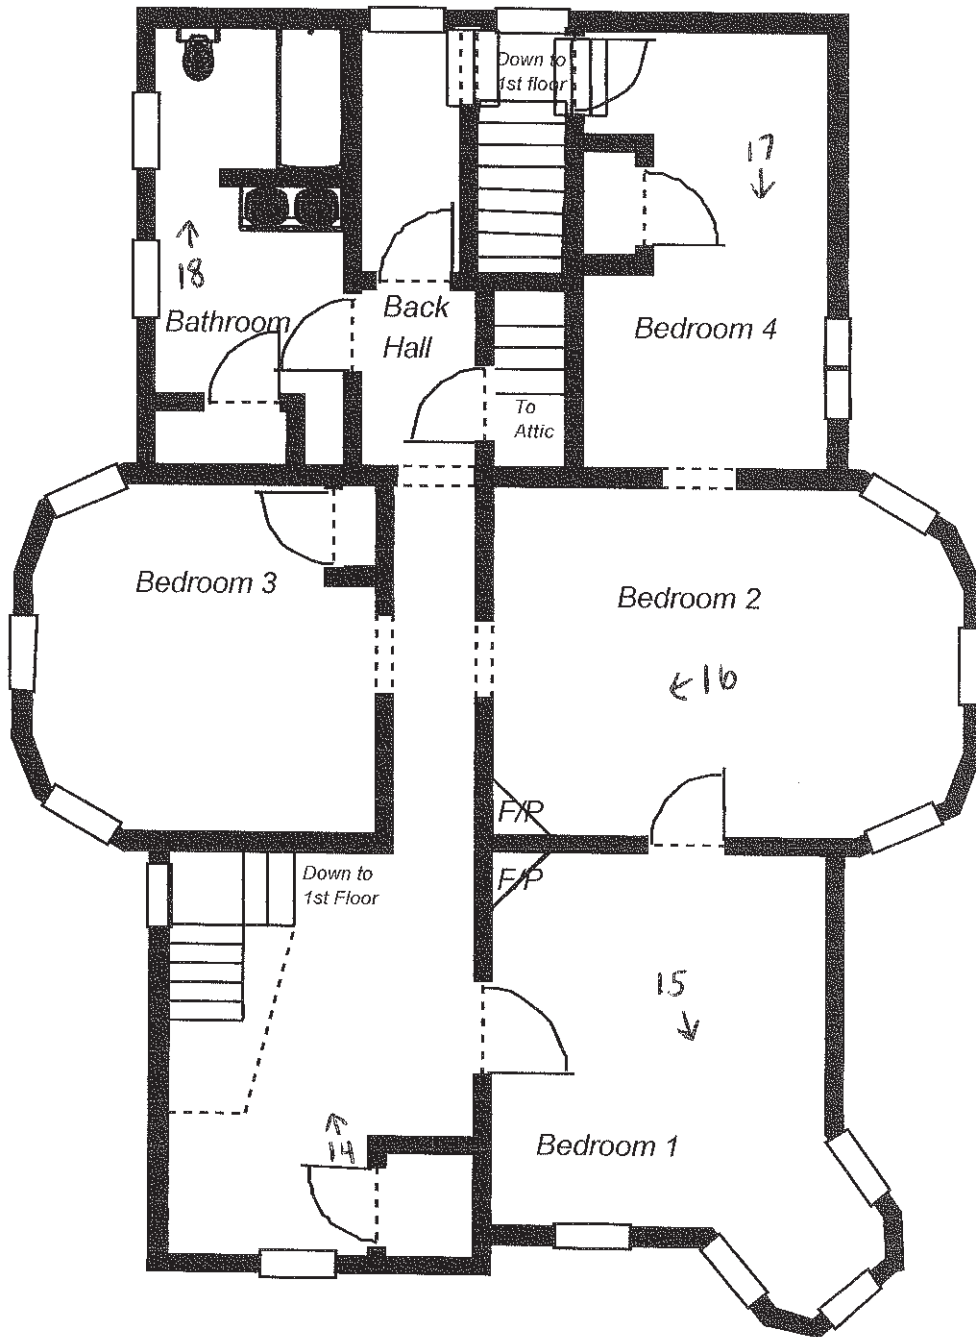
2nd Floor  
 Vehslage House @ 515 N. Chestnut St.  
 Seymour, Jackson County, IN

The home's staircases open onto the 2<sup>nd</sup> floor hallway running east/west through the middle of the plan (photo 14). Four bedrooms and a bath open off the central hall and back stair. Hardwood floors are exposed in the hallway. Doors are a simpler style than those on the 1<sup>st</sup> floor. Throughout the 2<sup>nd</sup> floor, the window and door trim, windows, doors and baseboards have painted finishes.
